COUNTY OF VENTURA  
DEPARTMENT OF PUBLIC WORKS  
VENTURA, CALIFORNIA

REVIEW OF MATILIJA DAM  
1967

Prepared By  
BECHTEL CORPORATION  
SAN FRANCISCO  
AUGUST 1967

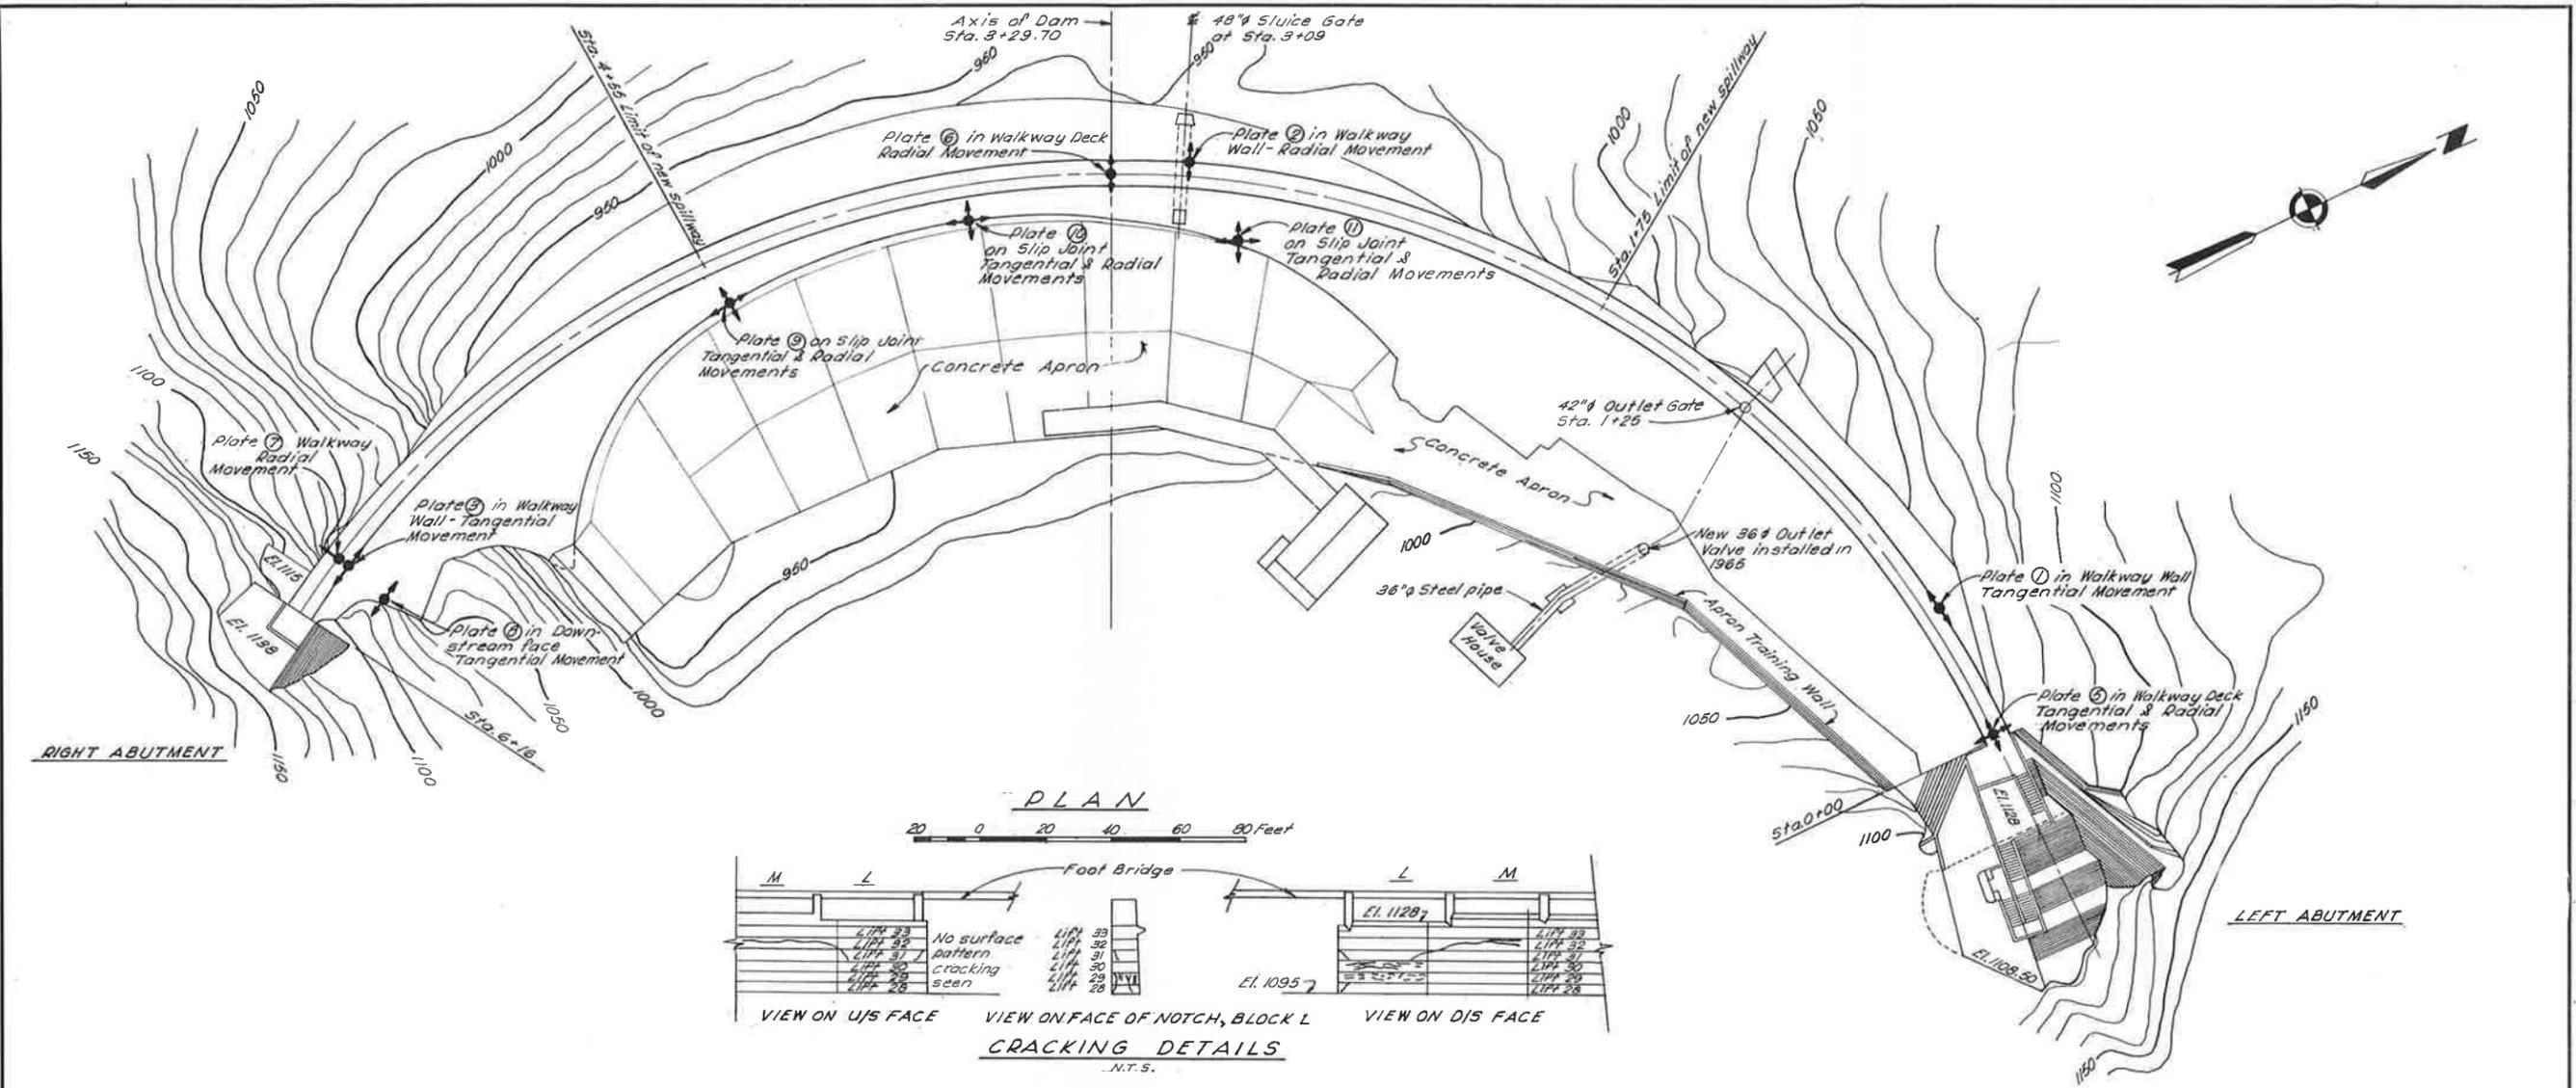
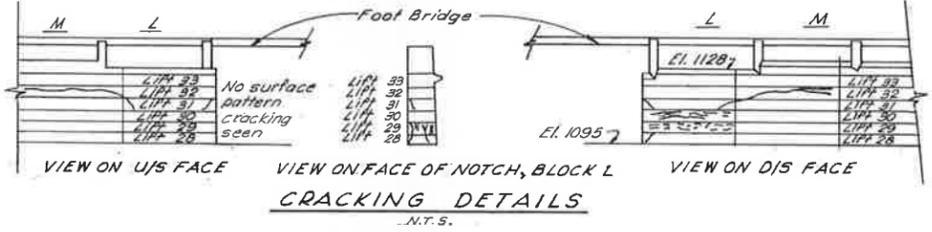
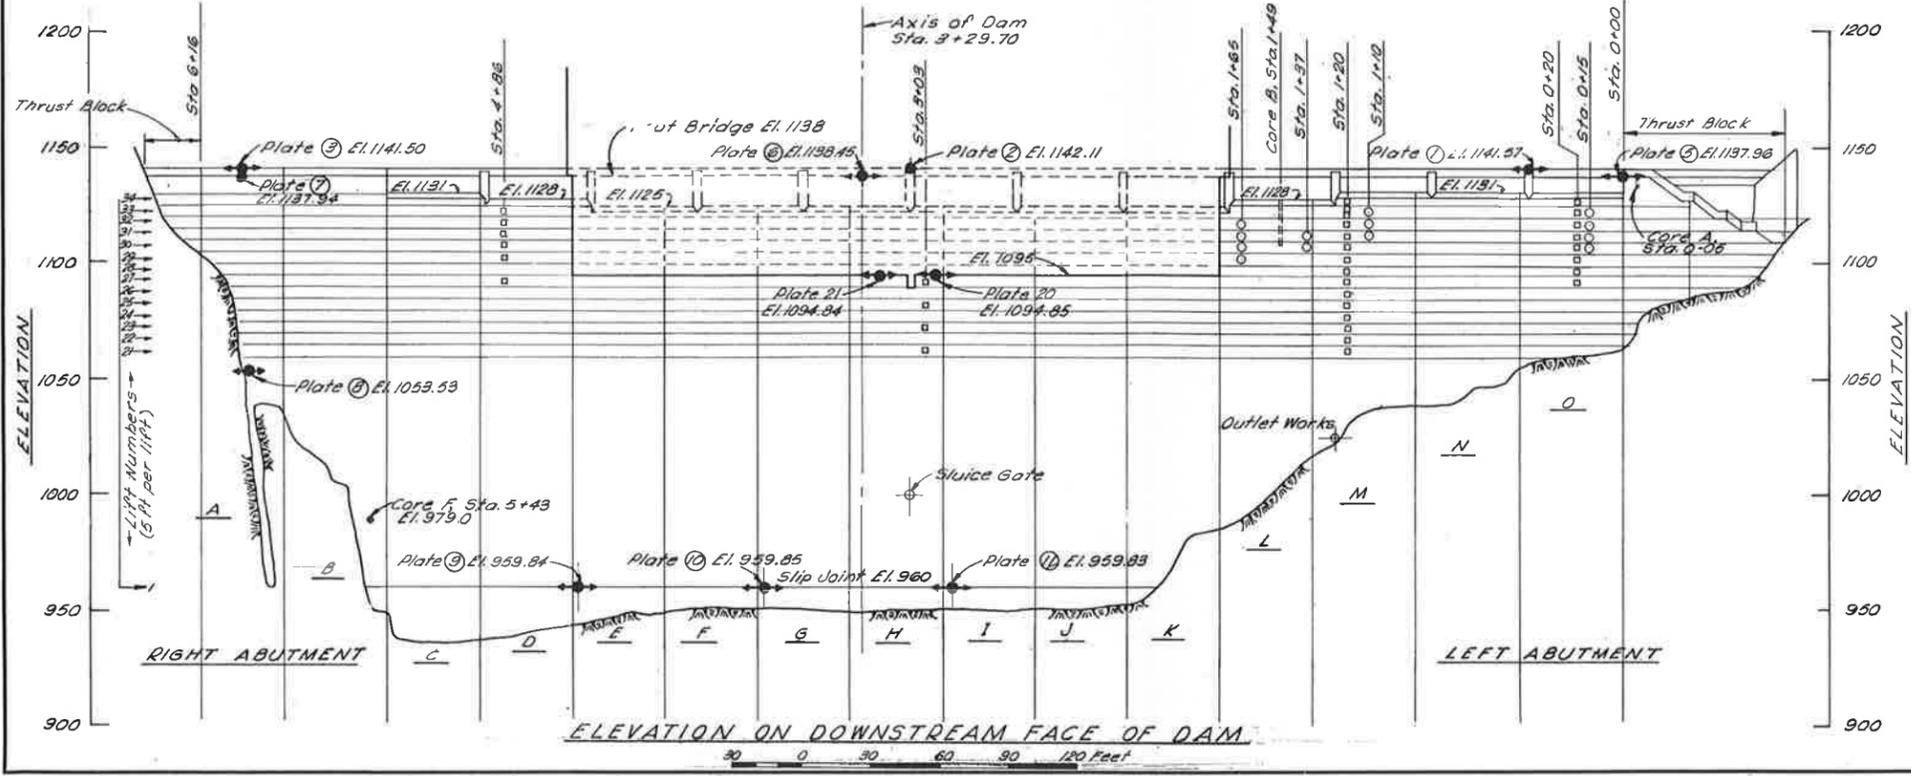
The cracking visible on the face of the dam is shown on Drawing 5716-67-3. The worst crack extends almost horizontally through Lift 32, Block M, into Lift 31, Block L, ending at the base of Lift 31. However, a comparison with records made in 1965 shows that no detectable increase in the extent of this crack has occurred in the interim.

Some new cracks have opened up adjacent to the notch. The new spillway is now accessible by ladder and the pattern of cracking on the left face of the notch has been examined. It is worse in Lifts 29 and 31, and if certain of the cracks enlarge they could cause some concrete to spall off above Elevation 1095.

On the right face of the notch the only crack visible is the opening of the horizontal construction joint at Elevation 1125.

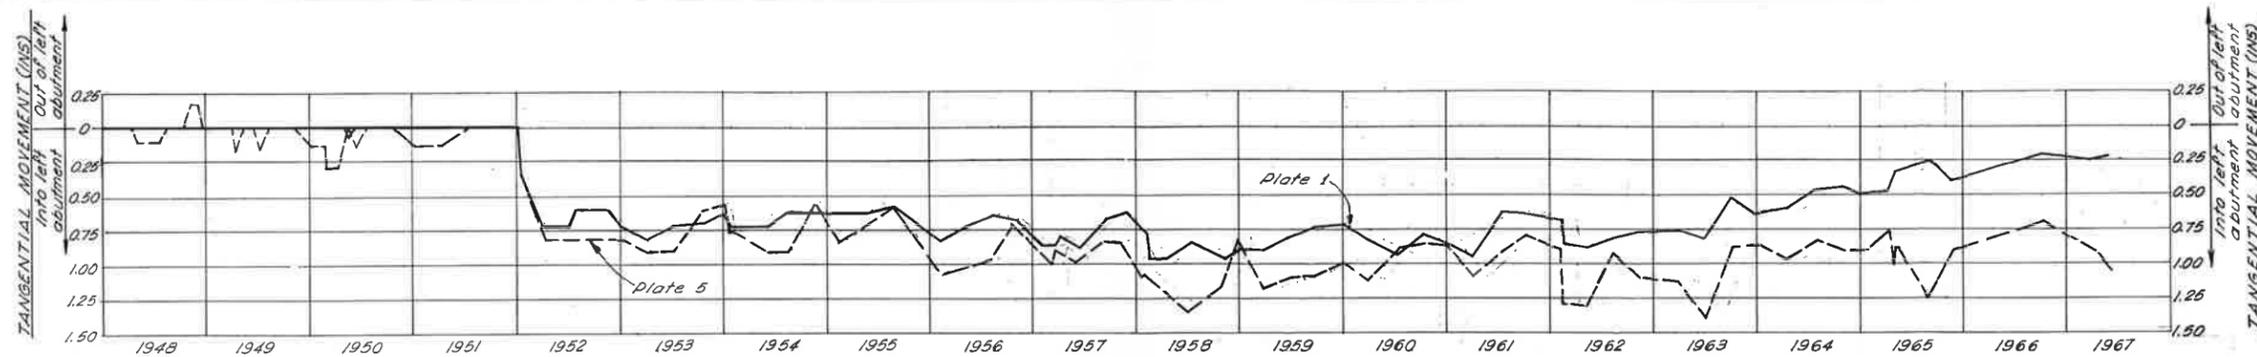
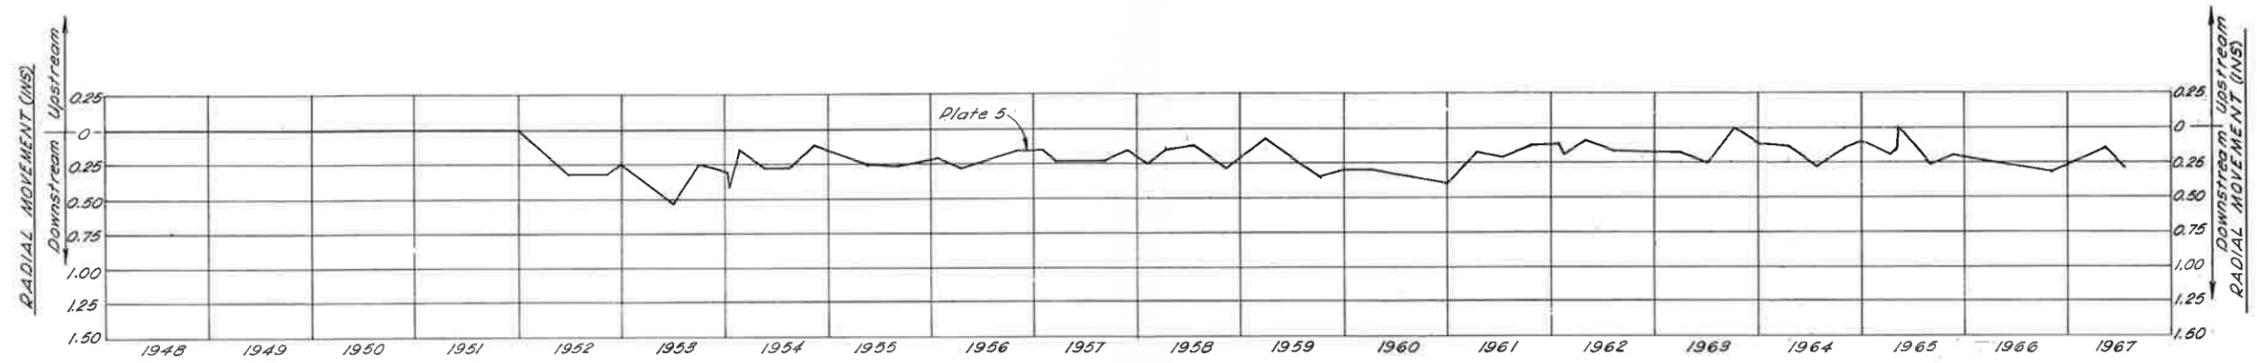
TANGENTIAL MOVEMENT—PLATES 1 & 5

The tangential movements as recorded at Plate 1 and Plate 5 should be equal. Until 1963, within the limits of accuracy of the measurements, this was so. Since 1963, however, the plots of the movements of the points have separated by about 0.50 inch, probably due to the renewed cracking caused by the alkali-aggregate reaction in the concrete.

4.3.1 At both abutments, there were permanent inelastic deformations of the rock during the first complete filling of the reservoir, caused by the closure of any systems of fissures or cracks in the rock. These were about 0.75 inch at the left abutment and 0.50 inch at the right abutment, both values of the order that could be expected for an arch dam of this type. Since that time there have been cyclic movements due to temperature changes.

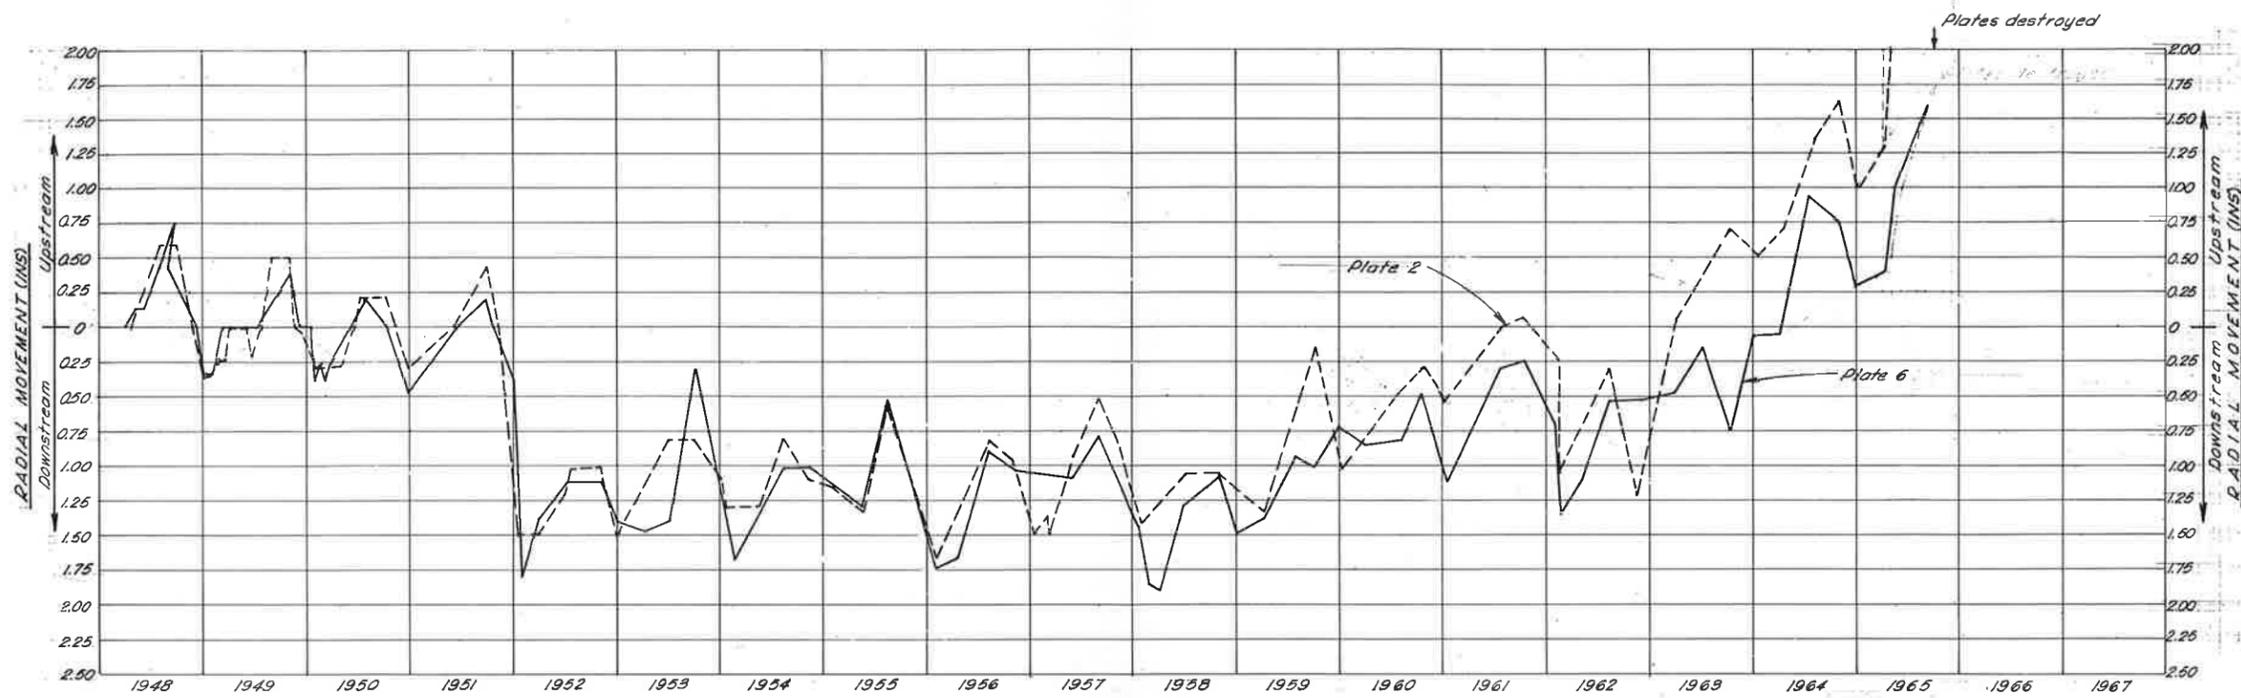
RADIAL MOVEMENT PLATES 2 & 6

A year after the first filling of the reservoir in January, 1952, the dam was found to have moved downstream and out toward both abutments. These movements were partly permanent set and partly elastic deformation. Plate 10 at the crown showed maximum downstream movement of 1.0 inch. Plates 9 and 11 showed components of movement towards the right and left abutments, with 0.5 inch more movement towards the left. This is compatible with the known greater weakness of the left as compared to the right abutment.

This movement was undoubtedly caused by an overall expansion of the dam as a result of the alkali-aggregate reactivity. It is known that the reaction is still continuing in the concrete in what remains of the upper lifts of the dam, as shown by the increased cracking discussed in Section 5. It is not known what the movement upstream was during 1965-1967, nor is there sufficient survey data presently available to determine if the movement upstream is continuing.

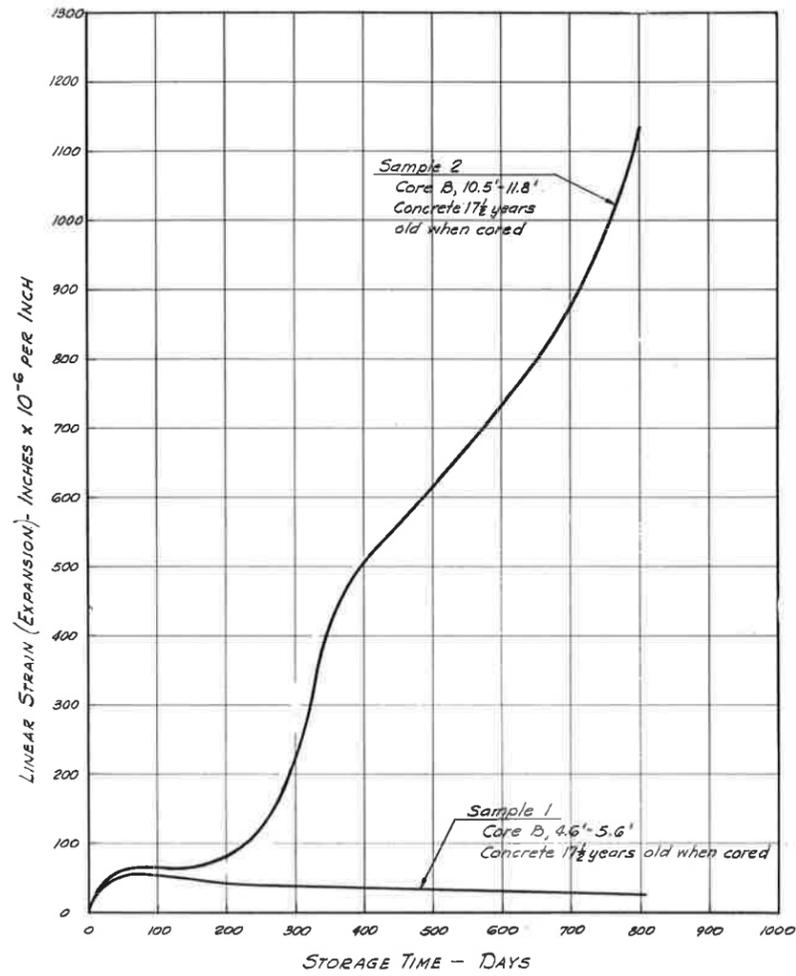
EXPANSION OF CONCRETE FROM MATILIJA DAM

Plots of linear strain with time for both samples are shown on Drawing 5716-67-7. This shows that Sample 1 (Lift 33) exhibited no growth, while Sample 2 (Lift 32) has shown an expansive strain of  $1100 \times 10^{-6}$  millionths in/in, or 0.11%, a growth undoubtedly caused by an alkali-aggregate reaction.

There are far too many factors involved for it to be suggested that Matilija will follow this same pattern exactly. However, the behavior of Sample 2 in the Matilija tests show that it still has a high potential for growth, and it has definitely not reached a dormant condition.

The lack of movement in Sample 1 suggests that reactive minerals in sufficient quantities to cause disruptive growth were unevenly distributed in the dam. However, it is concluded that where reactive minerals do occur they would still have a potential for expansion, causing movement

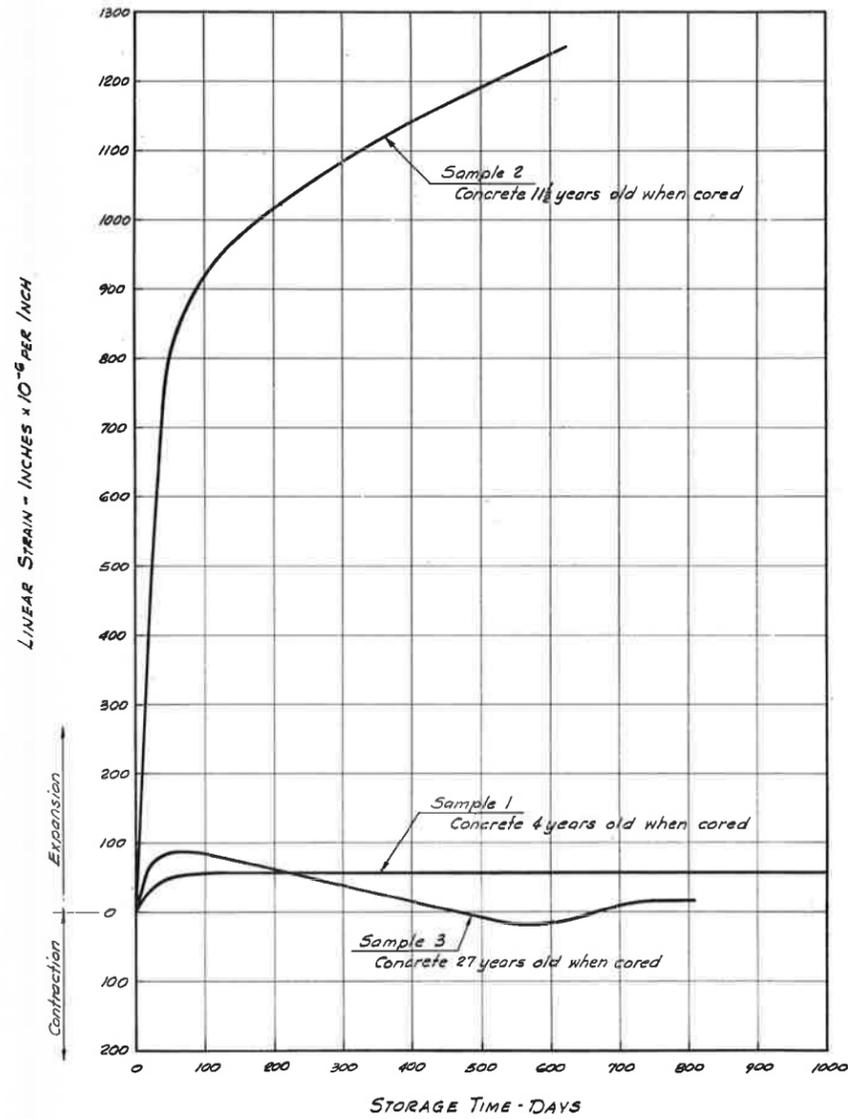
EXPANSION OF CONCRETE FROM DAM X  
FOR COMPARISON PURPOSES

Drawing 5716-67-7 also shows for comparison purposes the results of volume change tests which had previously been made on concrete cores from another concrete arch dam which also contained reactive minerals in the aggregates. This structure, referred to as Dam X, also developed systems of cracks varying from open cracks to micro-cracks and showed movement upstream against the water load.
