1997 SUPPLEMENT TO
MATILIJA DAM

1996 CONCRETE EVALUATION

VENTURA COUNTY PUBLIC WORKS AGENCY
VENTURA COUNTY FLOOD CONTROL DISTRICT
NOVEMBER 1997

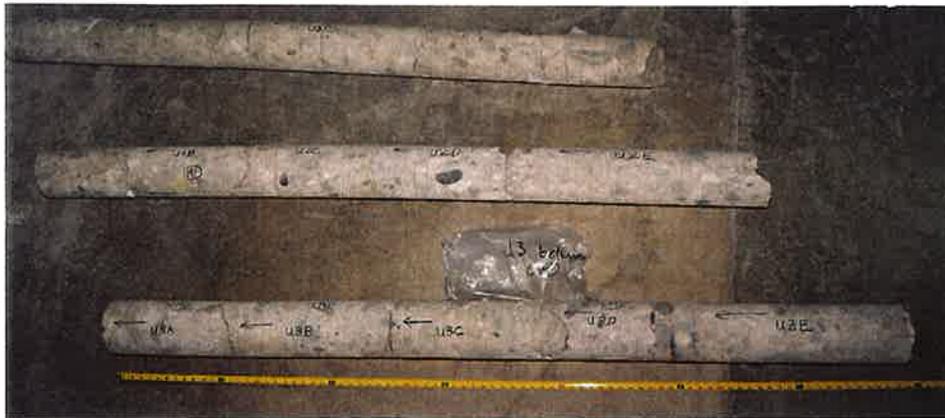
Core U1 Cored from upstream face of the dam at elevation 1068 and approximately station 5+10. The core had considerable cracking, however, segments remained intact except the last segment which separated into several pieces. Total length of core U1 was approximately 7 feet.

Core U2 Cored from upstream face at elevation 1068 and approximately station 3+40. The core was removed in 5 segments, all of which exhibited some cracking but remained intact for testing. Total core length was approximately 7 feet.

Core U3 Cored from upstream face at elevation 1068 and approximately station 1+89. Total core length was also approximately 7 feet and though the core exhibited some random cracking, it was the most sound of the upstream cores.

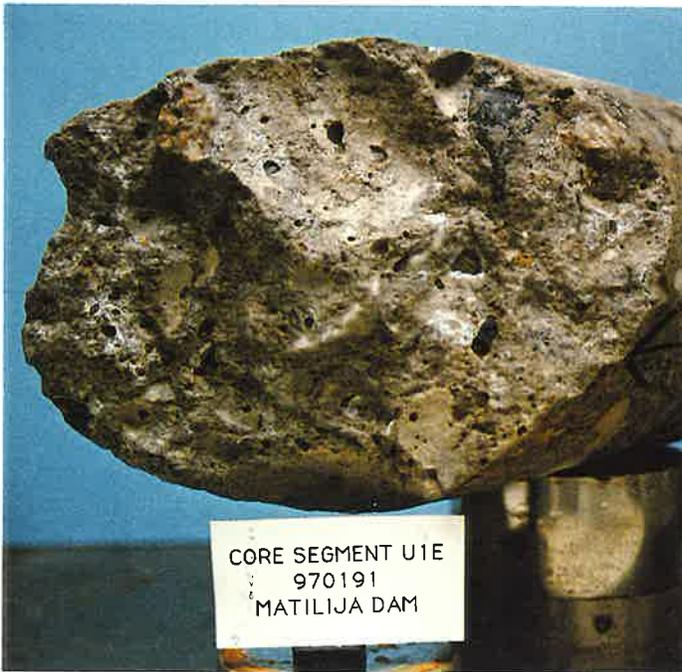
Core Segment U1E: This is the end of the segment closest to the dam face. One large rock socket is visible top at center. This area, under UV light, shows residue from gel which flowed around the large rock which originally occupied the socket.

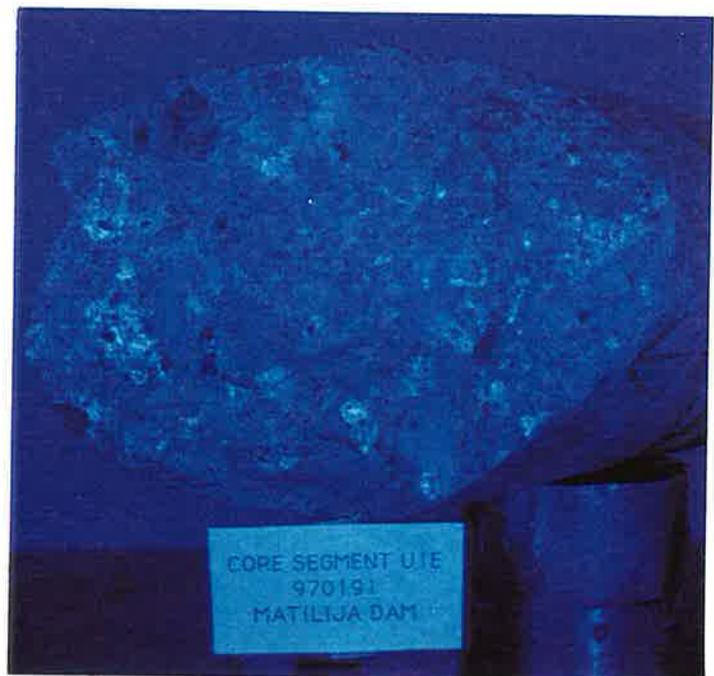
The U1E segment: Under UV light, shows numerous particles of various sizes in various stages of reaction. Gel flows are also visible on right and left side, as well as in the rock socket mentioned above.

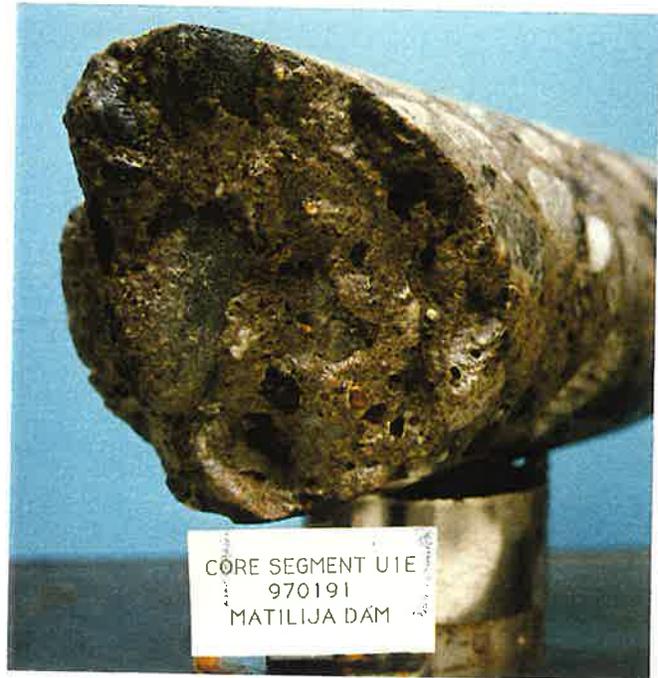
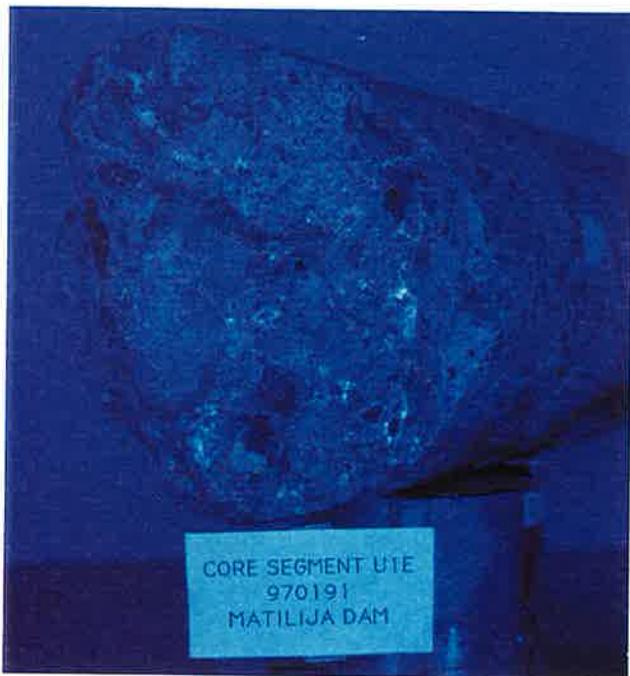
Core segment U1E: This is the fractured end of the segment farthest from the upstream dam face.

The U1E segment fracture, under UV light, showing particles in various stages of reaction and some gel flows. The small bright area, at about three o'clock, is fresh gel which exuded after lime water soak.

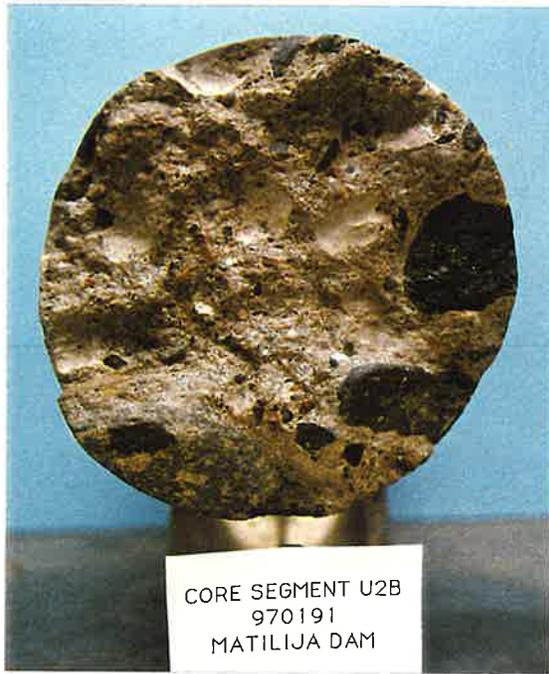
Core segment U2B: This end of the segment is about 10" in from the dam's upstream face. This portion of core U2 had several significant fractures, some of which exhibited ASR gel deposits within the cracks.

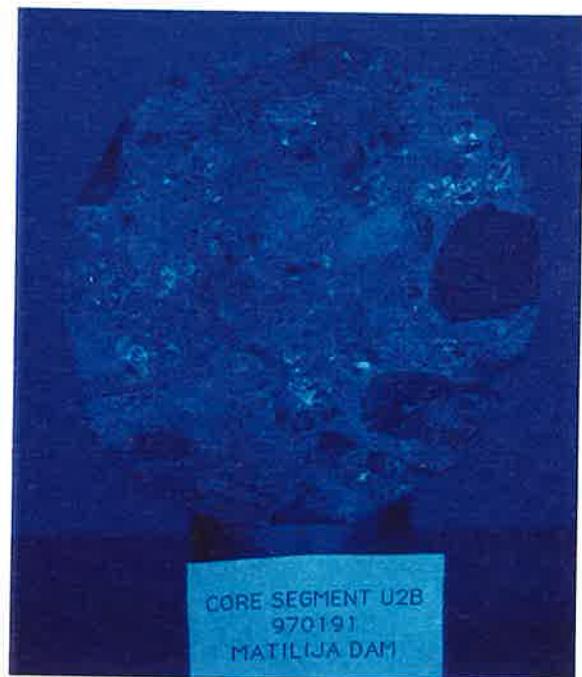
U2B segment fracture face under UV light. Not as many particles reacting as in segment from core U1. However, a significant number of small aggregate is reacting as well as signs of minor gel flows.

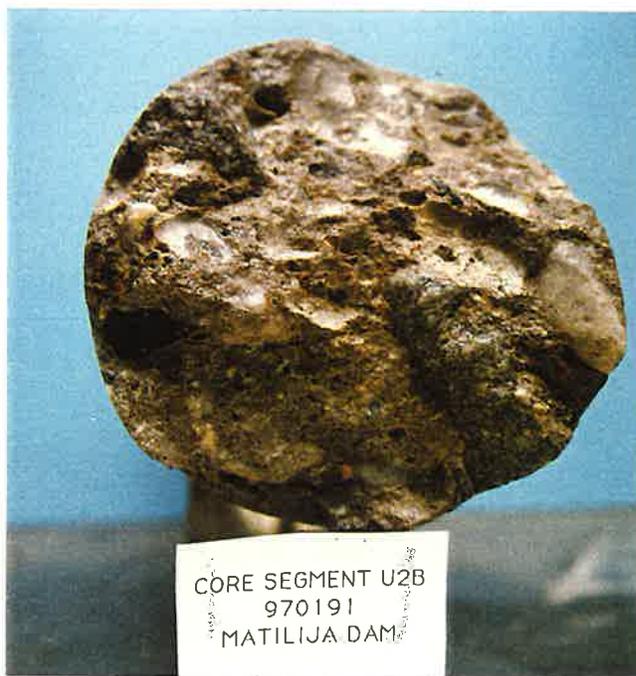
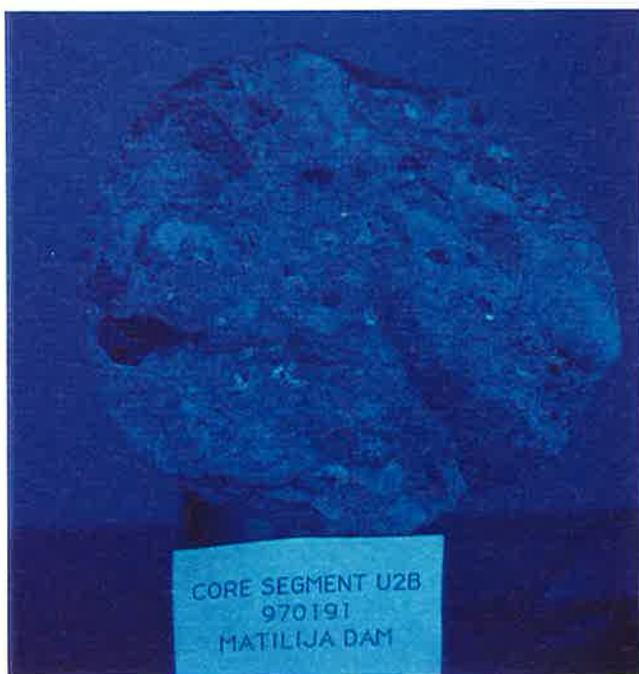
Core segment U2B: This is the opposite end of the segment which would be located approximately 24" in from the dam face.

This end of the core segment under UV light has less particles reacting but some light gel residue is visible at six o'clock and in a rock socket at about nine o'clock.

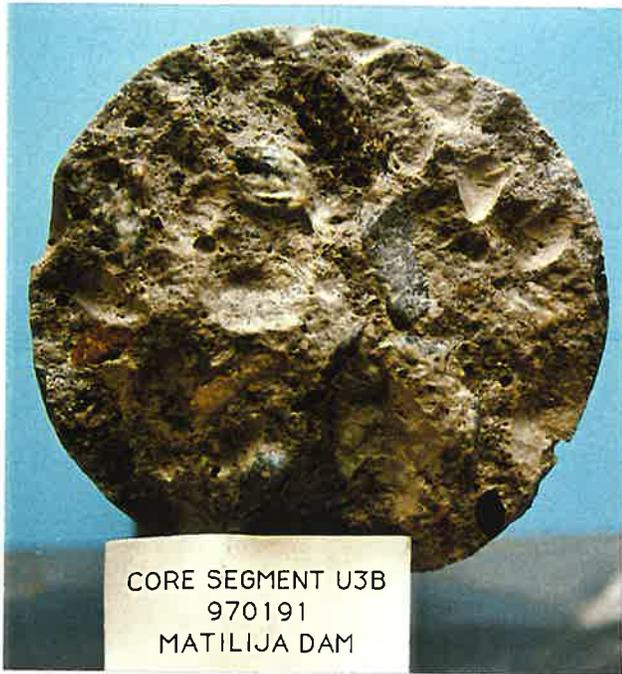
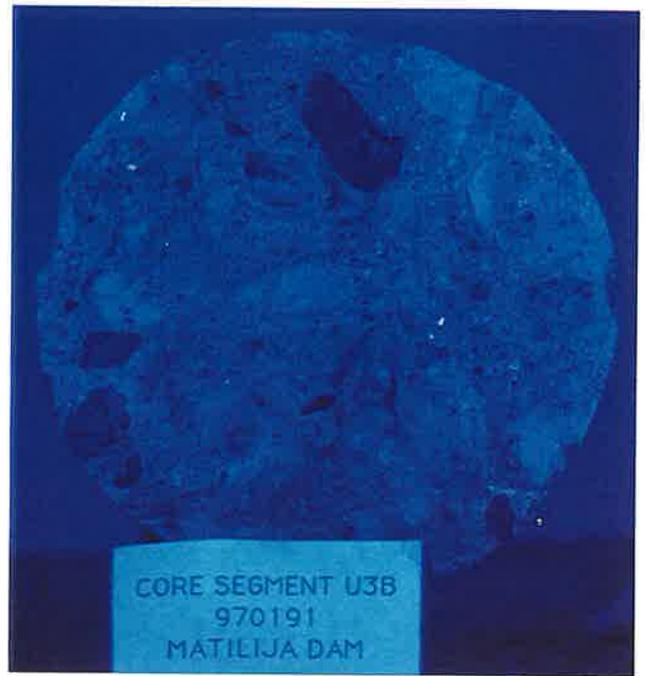
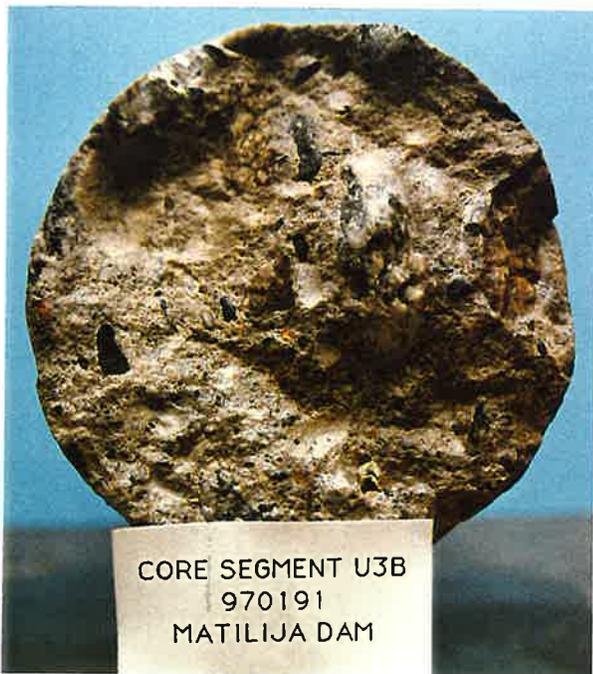
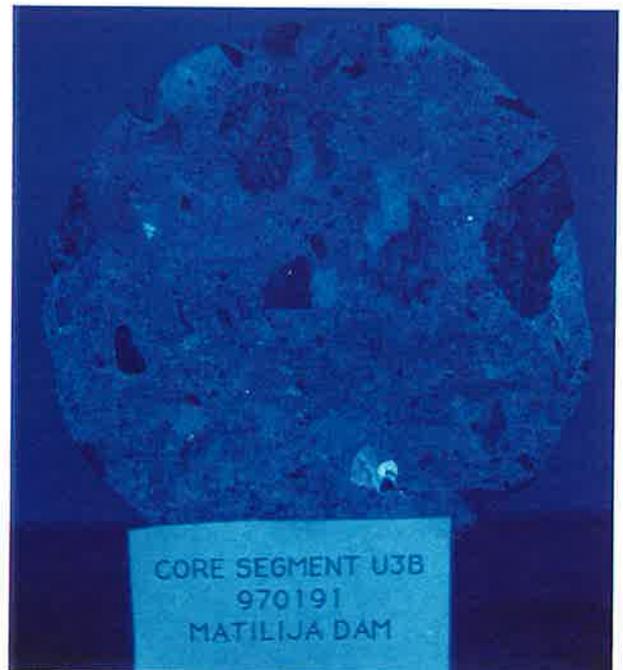
Core Segment U3B: The upper photos are of the fractured end which is approximately 13" in from the upstream dam face. Photos below are of the fracture located approximately 31" in from the face. Both fractures under UV light exhibit few reacting particles and no areas of gel flow were observed. Fresh gel is visible in the UV photo below which exuded during lime water soak.

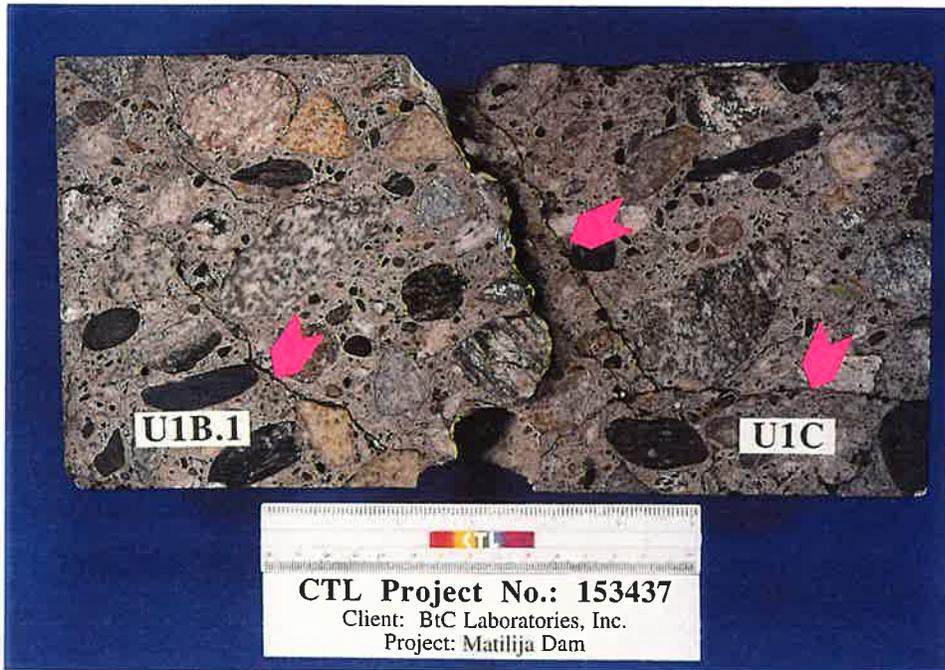
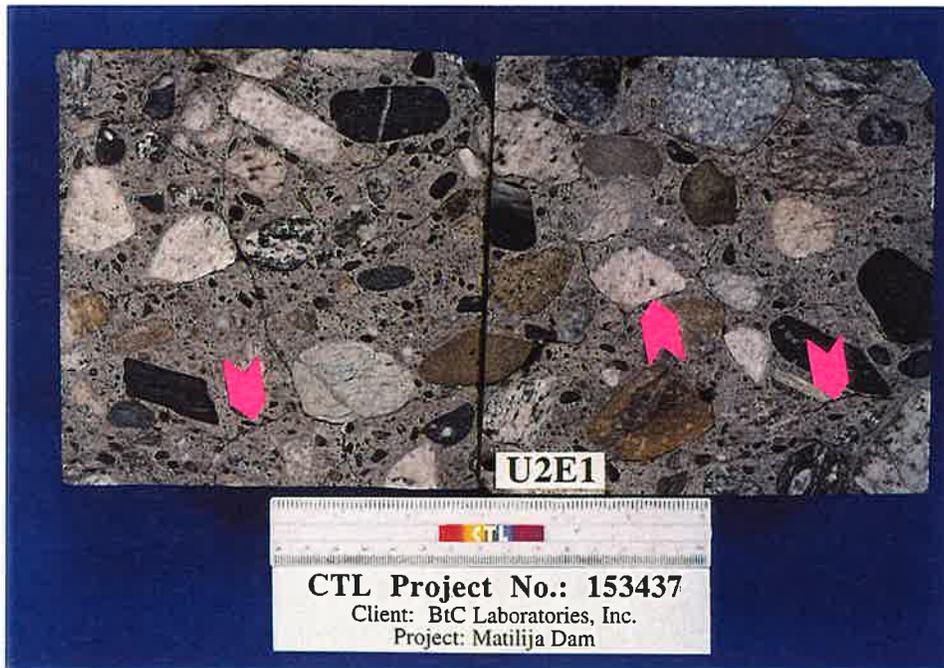
1. Evidence of alkali-silica reaction (ASR) is observed in each of the three examined concrete segments. Damage attributed to ASR ranges from moderate (Core Segments U1B/U1C and U2E1) to minor (Core Segment U3D). Concrete segments from moderately damaged areas each exhibiting several continuous and discontinuous cracks, hairline cracks, and microcracks (Fig. 4). Concrete from least damaged area (Core U3D) exhibits a few discontinuous hairline cracks and microcracks, but no major cracks or evidence of serious ASR-related distress (Fig. 5).

2. Damage exhibited in Core Segments U1B/U1C and U2E1 consists of a connected network of cracks that appears to originate and radiate from alkali-silica reactive fine aggregates (Fig. 6). Core U1B/U1C was received transversely fractured into two pieces. Otherwise, most of the cracks appear to be oriented roughly perpendicular or diagonal to the dam face and pass mainly around coarse aggregate particles. These crack patterns are fairly characteristic of ASR-related damage in larger concrete structures and likely reflect the degree and direction of internal restraint within the structure.

Fig. 4 Lapped longitudinal cross sections of Core Segments U1B/U1C (reassembled) and U2E1, showing ASR-related cracking in each sample. The surfaces were treated with black ink to enhance view of cracks, examples of which are marked with arrows.

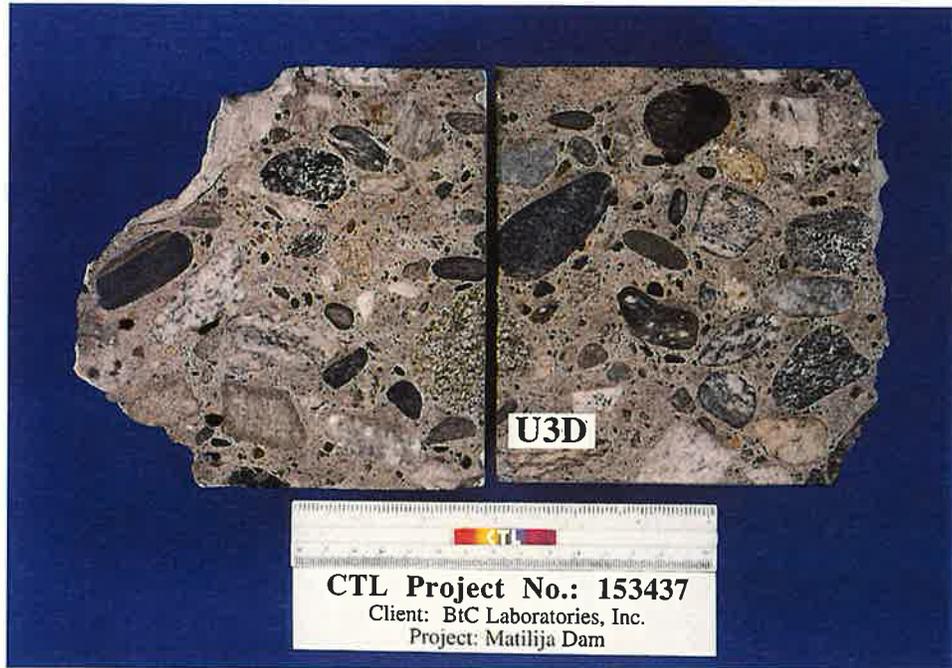
Fig. 5 Lapped longitudinal cross section of Core Segment U3D showing relatively few hairline cracks and the comparatively good condition of the concrete. The surface was also treated with black ink.

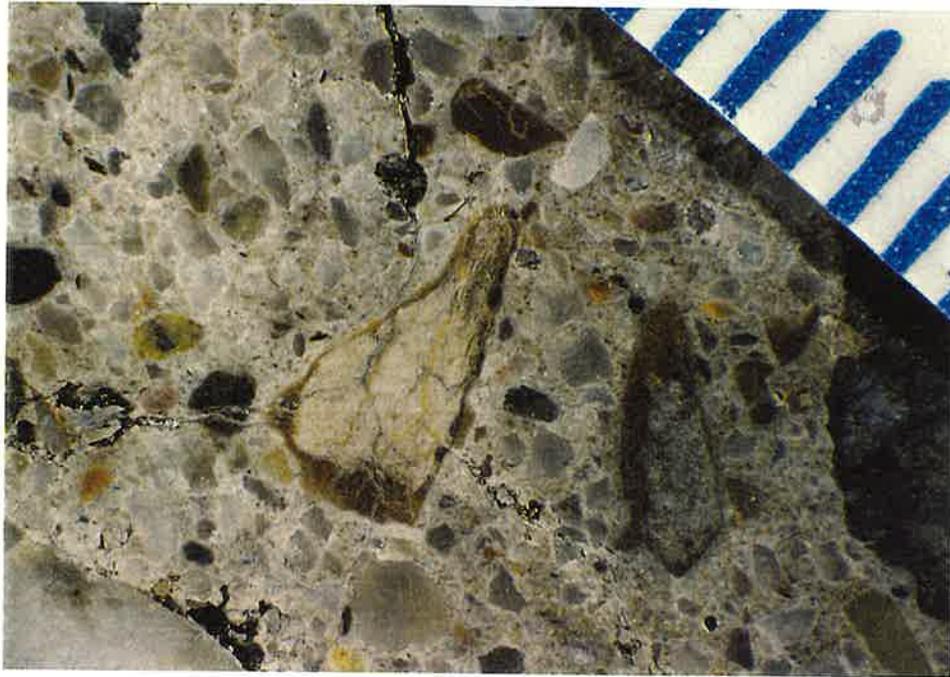
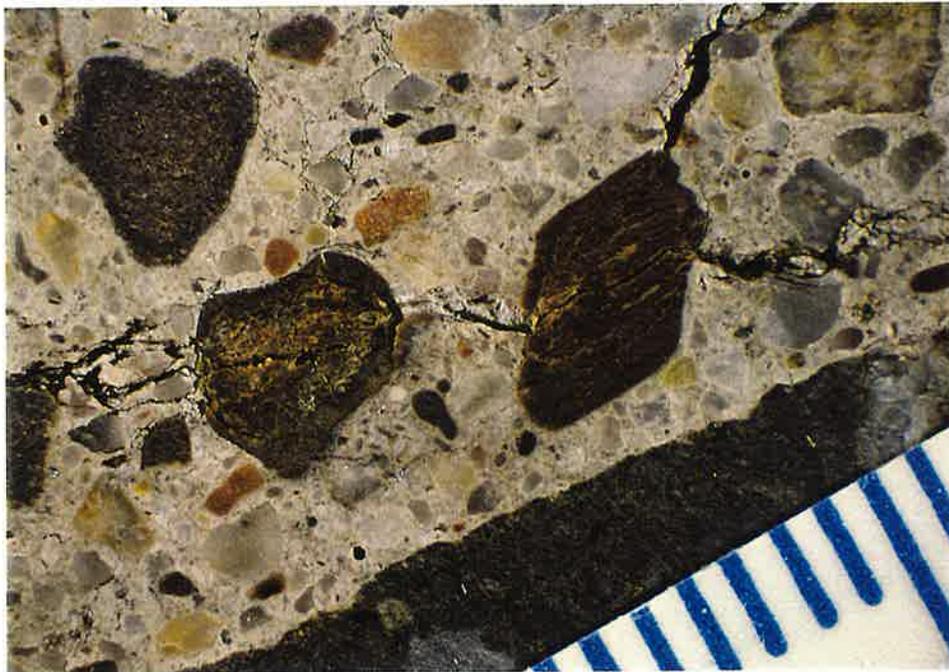
3. Aggregates affected by ASR appear to include mainly coarse sand particles composed of chert and shale (Fig. 6). These cherts and shales appear to contain some opal (hydrous amorphous silica) as well as microcrystalline quartz (Fig. 7), both of which are considered potentially reactive with alkalis. Most of the reactive aggregates exhibit features typical of ASR, including the presence of ASR gel, alkali reaction rims, and multiple internal cracks, many of which extend into the surrounding cement paste (Fig. 8). The coarse aggregate used in the concrete includes siliceous metamorphic rocks that contain stained quartz, as well as some altered volcanic rocks. These rock types may be susceptible to reaction with alkalis in the cement paste. A few of the metamorphic rocks exhibit apparent alkali-reaction rims and internal cracks consistent with ASR. However, most of the coarse aggregate does not appear to have been significantly affected by ASR.

Fig. 6 Selected area of the lapped surfaces of Core Segments U1B/U1C and U2E1 showing hairline cracks radiating from within ASR-expanded coarse sand particles of shale.

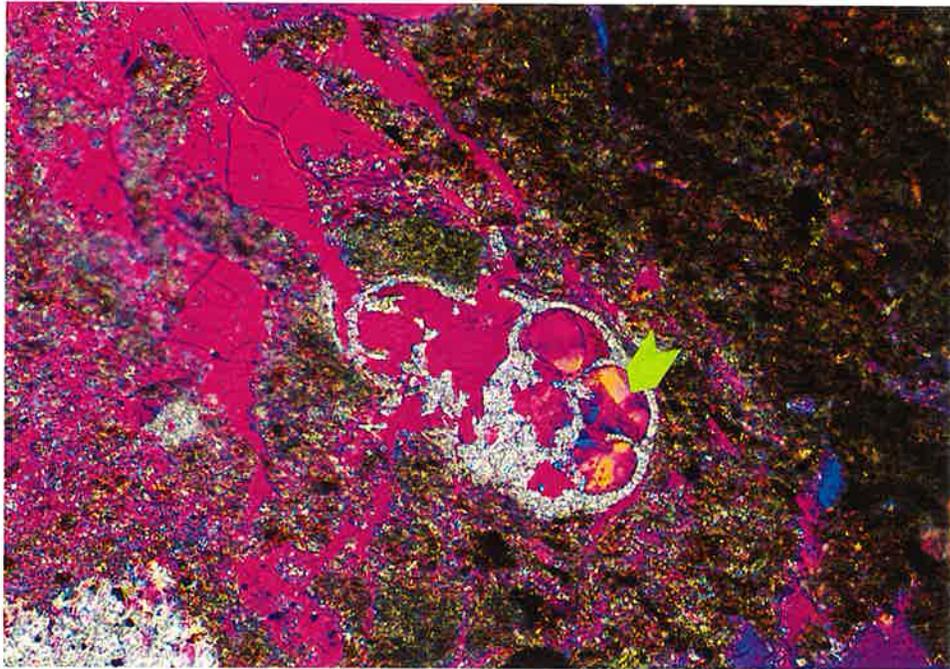
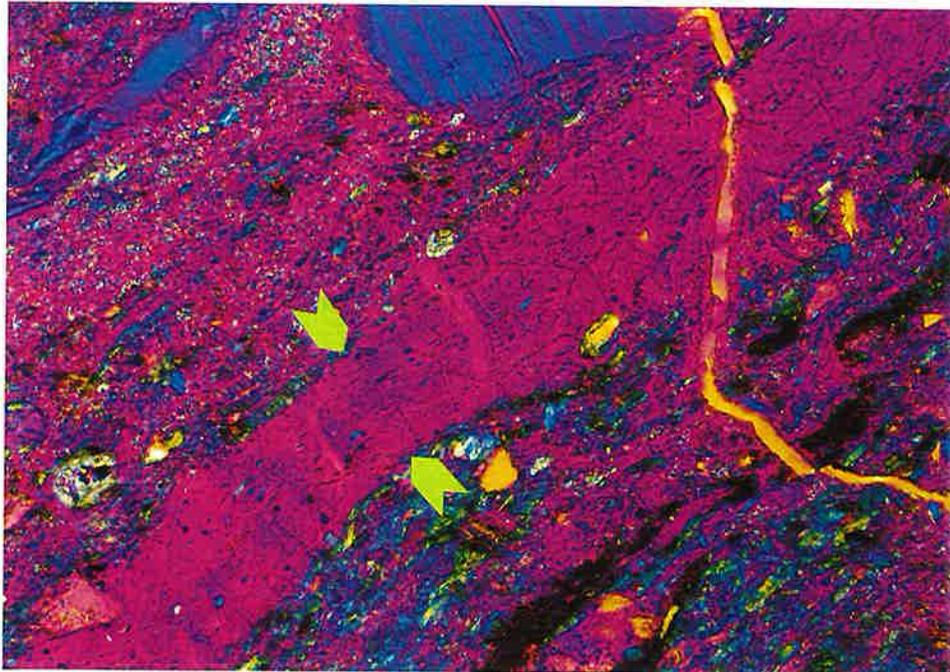
Fig. 7 Thin section photomicrographs showing opaline and microcrystalline material (marked with arrows) within two reactive sand particles in Core Segments U1B/U1C and U2E1. Cross-polarized light with first-order wave plate. The length of each field shown, left to right, is approximately 0.6 mm.

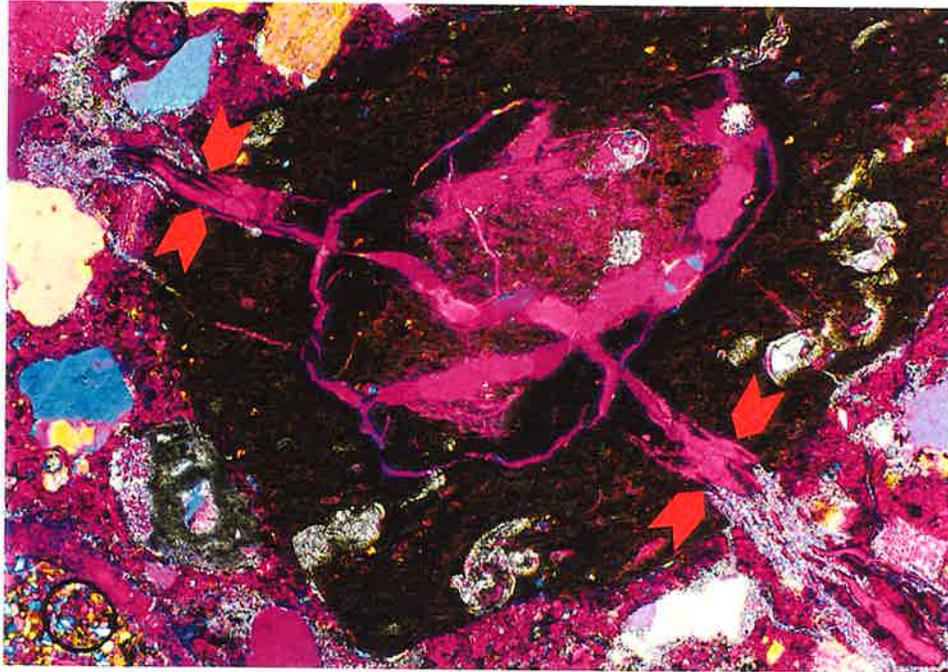
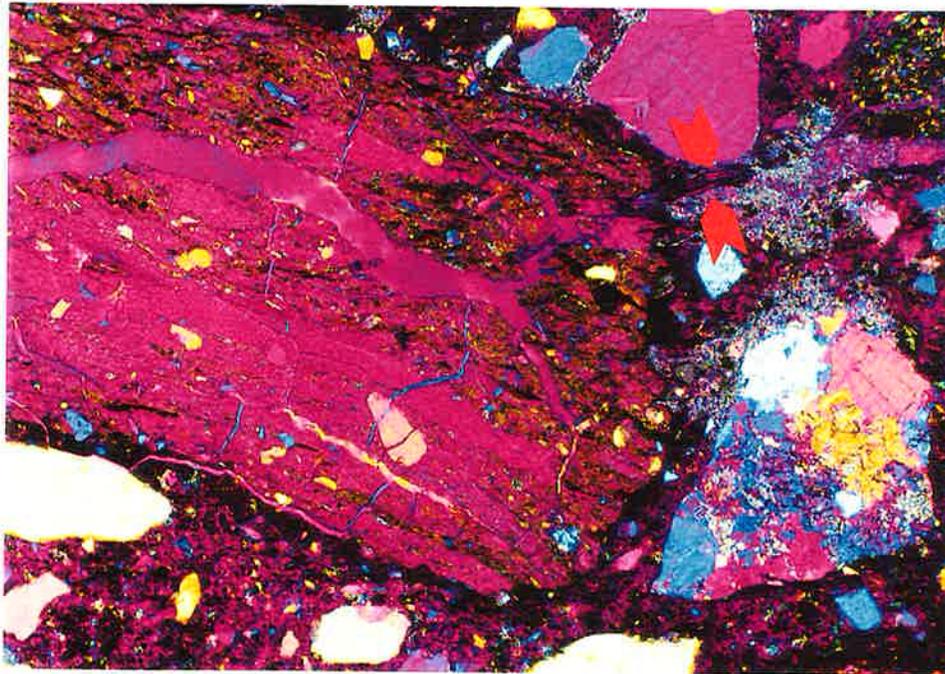
Fig. 8 Thin section photomicrographs showing ASR gel (marked between arrows) filling cracks radiating from within expanded coarse sand particles of shale in Core Segments U1B/U1C and U2E1. Cross-polarized light with first-order wave plate. The length of each field shown, left to right, is approximately 3 mm.
