**FEMA Levee Certification
Ventura County, California**

**Ventura River Levee and Floodwall (VR-3)
At Live Oaks**

**Evaluation Report
February 13, 2009**

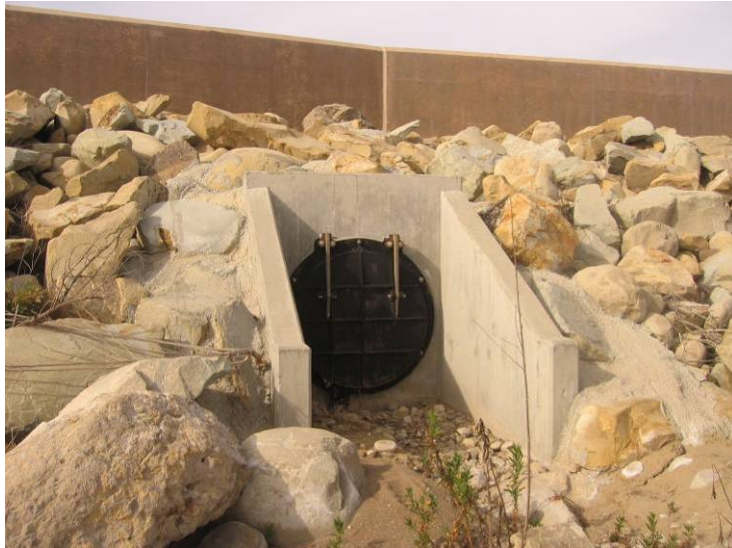
Ventura River Levee and Floodwall (Photo No. P1) – 48” RCP with a concrete outlet structure and Flap Gate

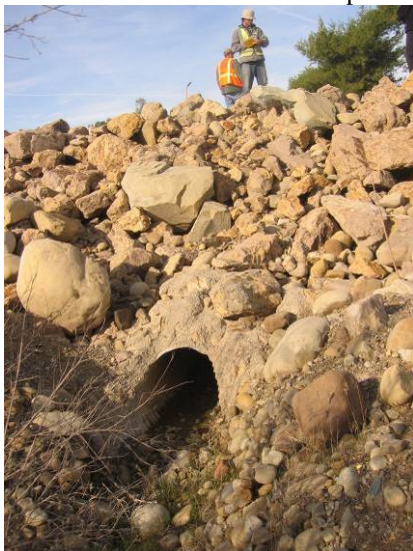
Ventura River Levee and Floodwall (Photo No. P2) – 24” CMP w/o a closure device

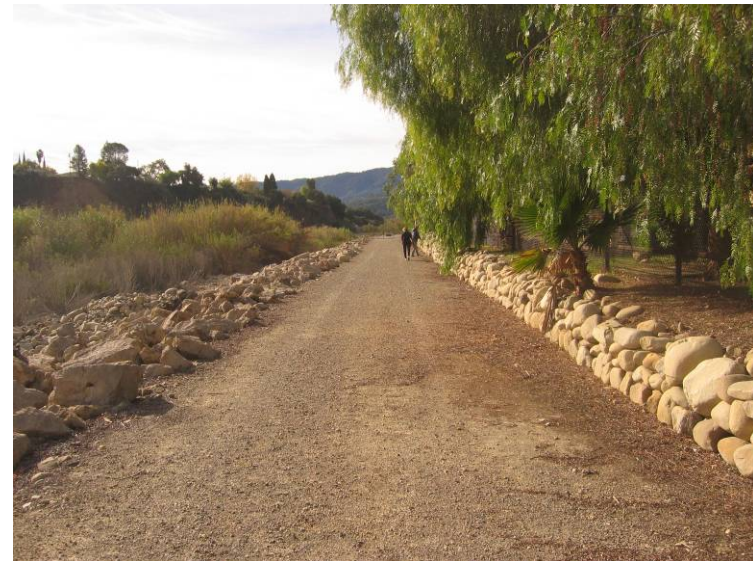
Ventura River Levee and Floodwall (Photo No. F1) – Looking downstream along a top of levee along Ventura River

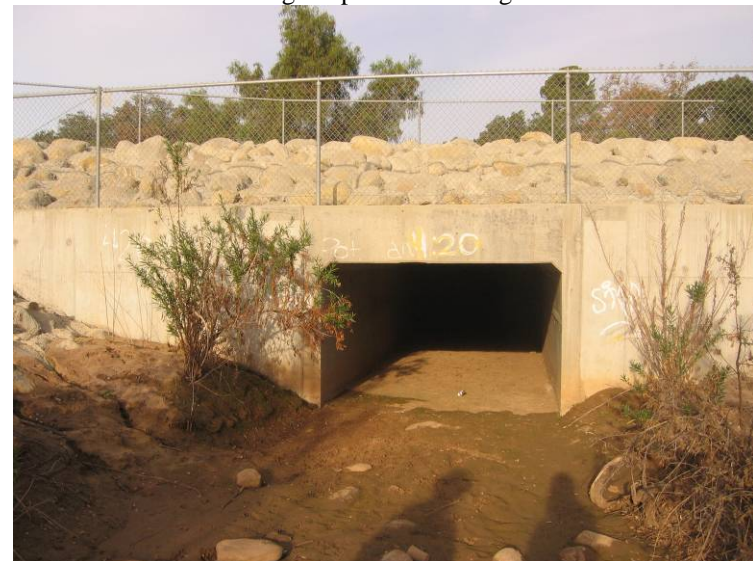
Ventura River Levee and Floodwall (Photo No. F2) – D/S face of 9’x5.6’ RCB outlet for the Live Oak Creek Diversion under Burnham Rd Bridge

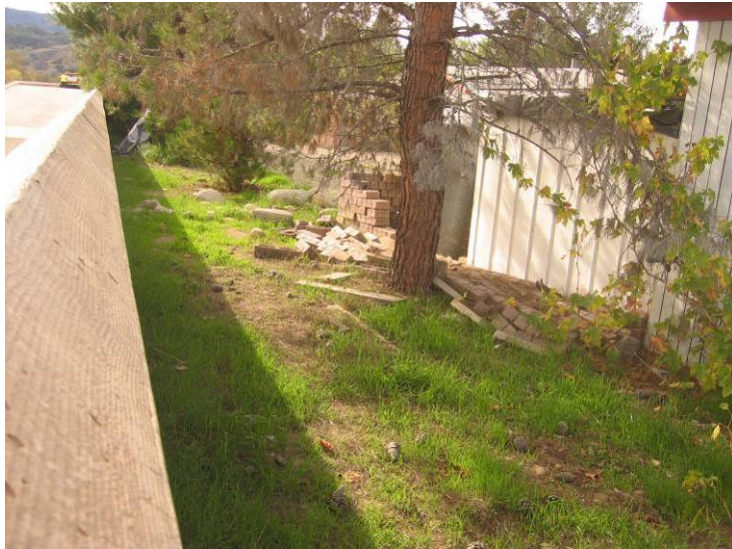
Ventura River Levee and Floodwall (Photo No. M1) – Vegetation within 15' of Toe (Landward Side)

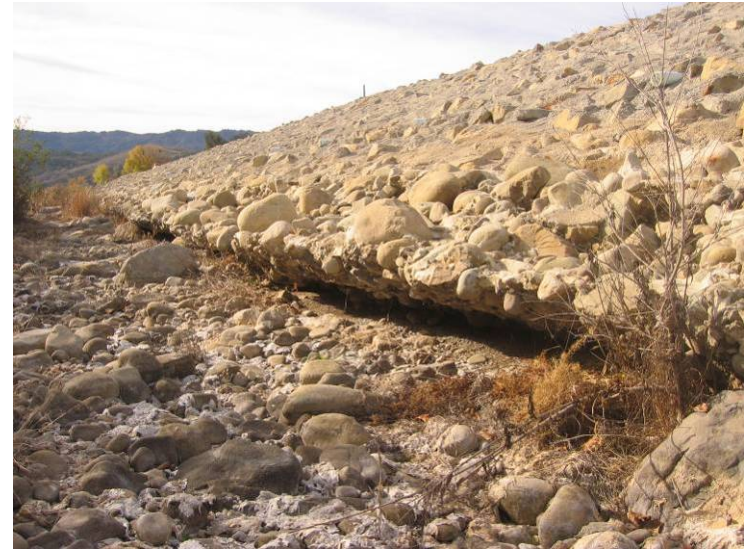
During the site visit, erosion at the toe of the riverside levee slope was observed and erosion of the toe was undermining the revetment. Evaluation of this erosion should be conducted.

Ventura River Levee and Floodwall (Photo No. M3) – Erosion along levee toe below revetment (Riverward side)

M3	Erosion along levee toe below revetment (Riverward side)	Re-establish bank revetment with adequate toedown protection. Additional engineering analysis recommended.	C3/C4	E3	Endangered species habitat			
Ventura River Levee and Floodwall (VR-3) - Along Live Oak Diversion Outlet Channel, Category 3								
M4	Encroachment. Structures and trees within 15' of toe (Landward Side)	Remove structures and trees within the 15'-zone as appropriate.	C5 - letter to landowners before removing trees, and structure	E2	Try to avoid removing large oaks	X		
M5	Vegetation within 15' of toe (Landward Side)	Remove vegetation and root ball, fill voids with impervious material and firmly compact. Remove irrigation lines within levee embankment.	C2, C5 - Mitigation project, work with Pam	E3	WPD mitigation site, will need to replace veg elsewhere	X	Definition of impervious material	For all vegetation removal under 4" trunk diameter, no documentation is necessary. For larger rootball removal where excavation & compaction is required, documentation of the impacted material shall be conducted by a certified testing & materials lab familiar to the District. The documentation shall include a report provided by the lab. AMEC will periodically observe these locations & will require a copy of the report for documentation & review. Figure 2 attached outlines the excavation & compaction details. Documentation of the removal & replacement/re-compaction of the impacted material shall be conducted by a certified testing & materials lab familiar to the District. The documentation shall include a report provided by the lab. AMEC will periodically observe these locations & will require a copy of the report for documentation & review. In-kind backfill would be materials free of organic or deleterious debris that has similar or lower permeability than the levee material. These materials could consist of excavated soil, imported soil, concrete, or slurry, & shall be evaluated by the lab.

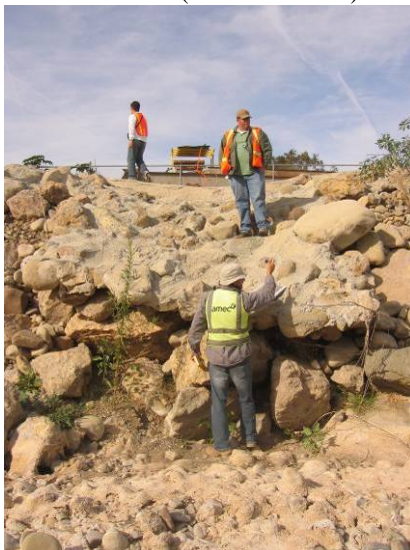
Ventura River Levee and Floodwall (Photo No. M2) – Undercut at the bottom of grouted stone apron of the levee top drain

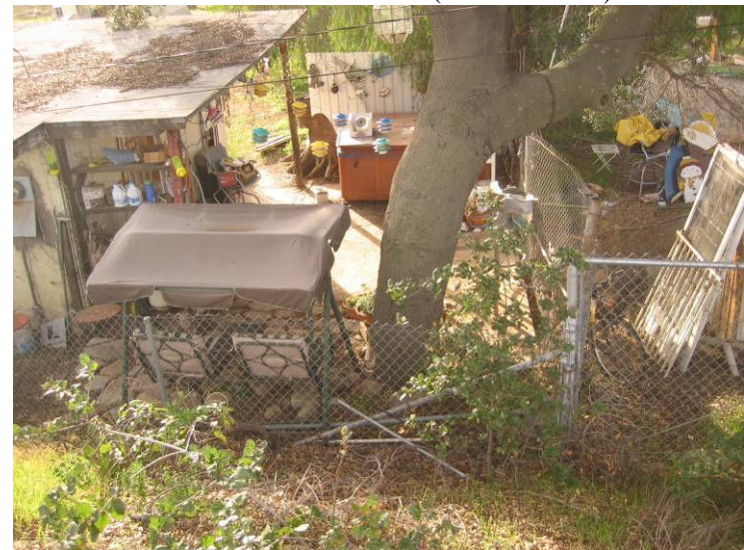
Ventura River Levee and Floodwall (Photo No. M4) – Encroachment. Structures within 15' of toe (Landward Side)

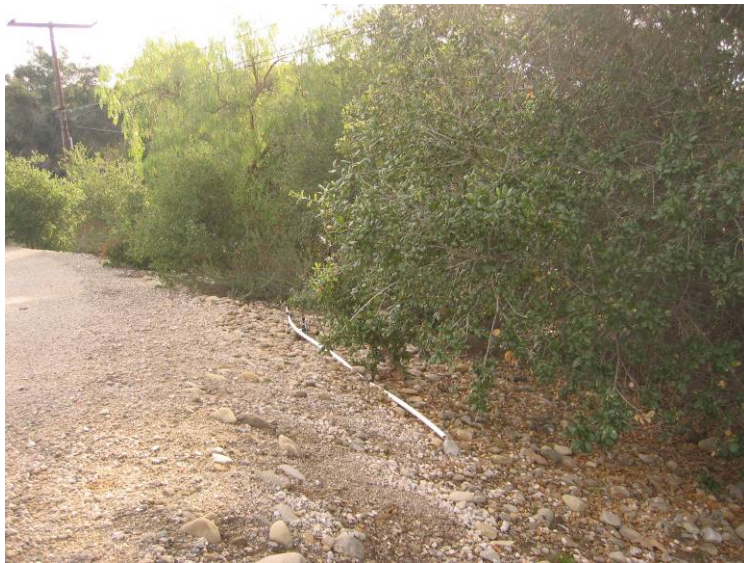
Ventura River Levee and Floodwall (Photo No. M5) – Vegetation within 15' of Toe (Landward Side)

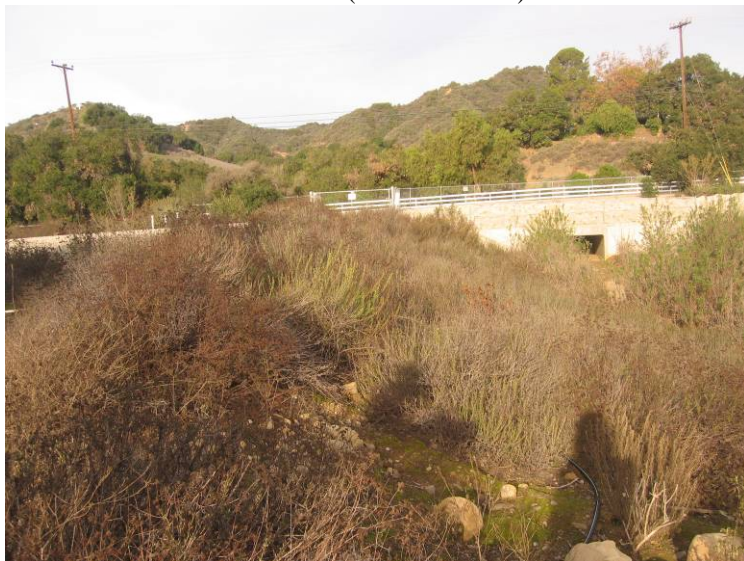
Ventura River Levee and Floodwall (Photo No. M6) – Vegetation on Levee embankment and toe (Riverward Side)

M6	Vegetation on Levee embankment and toe (Riverward Side). Vegetation is currently maintained by the County.	Remove vegetation and root ball, fill voids with impervious material and firmly compact. Remove irrigation lines within levee embankment.	C2, C5 - Mitigation project, letter to landowners, work with Pam	E3	WPD mitigation site, will need to replace veg elsewhere	X	Definition of impervious material	For all vegetation removal under 4" trunk diameter, no documentation is necessary. For larger rootball removal where excavation & compaction is required, documentation of the impacted material shall be conducted by a certified testing & materials lab familiar to the District. The documentation shall include a report provided by the lab. AMEC will periodically observe these locations & will require a copy of the report for documentation & review. Figure 2 attached outlines the excavation & compaction details. Documentation of the removal & replacement/re-compaction of the impacted material shall be conducted by a certified testing & materials lab familiar to the District. The documentation shall include a report provided by the lab. AMEC will periodically observe these locations & will require a copy of the report for documentation & review. In-kind backfill would be materials free of organic or deleterious debris that has similar or lower permeability than the levee material. These materials could consist of excavated soil, imported soil, concrete, or slurry, & shall be evaluated by the lab.
