ALKALI-SILICA REACTIVITY IN FIVE DAMS IN SOUTHWESTERN UNITED STATES

July 1985 Engineering and Research Center

Bureau of Reclamation

REC-ERC-85-10

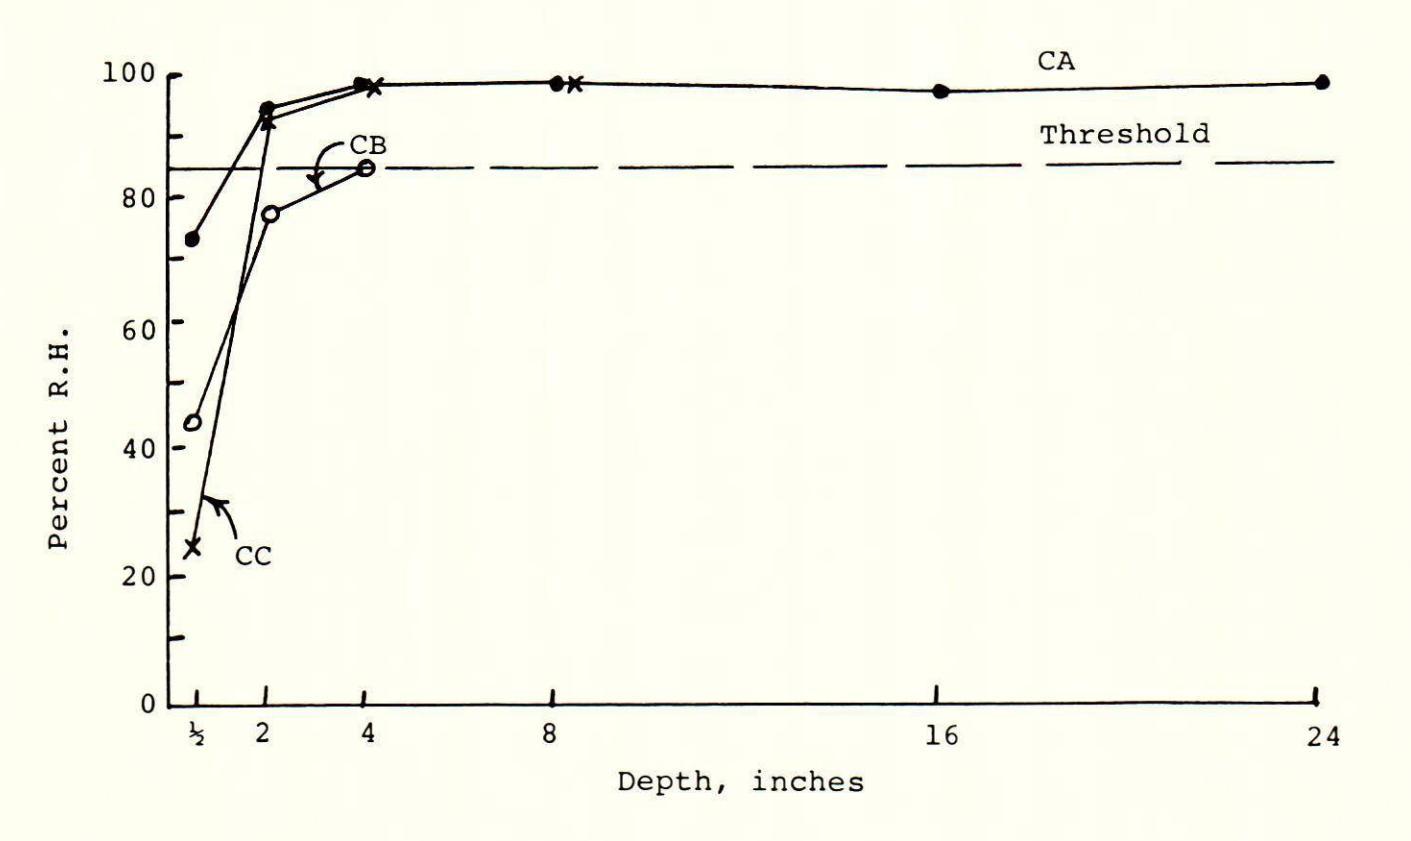
FIG. Al - RELATIVE HUMIDITY DATA FOR COOLIDGE DAM

Relative Humidity. – Measurements shown on figures A1 and A2 indicate that atmospheric drying has reduced RH values to below the threshold level for expansive reactivity only within several inches of exposed concrete surfaces. At the five locations sampled, RH values ranged from 25 to 75 percent at the $\frac{1}{2}$ to 1-inch-depth; this is below the 85 percent threshold value. At three of the five sample locations (CA, CC, and CD), RH values exceeded the threshold level at the 2- to $2\frac{1}{2}$ -inch-depth, and remained at 98 to 99 percent at greater depth. At location CE, the threshold level was reached at about the 16- to $16\frac{1}{2}$ -

Based on RH measurements from a variety of exposure conditions, most of the concrete in Coolidge Dam appears to contain enough moisture to permit expansion if alkali-silica reactivity occurs.

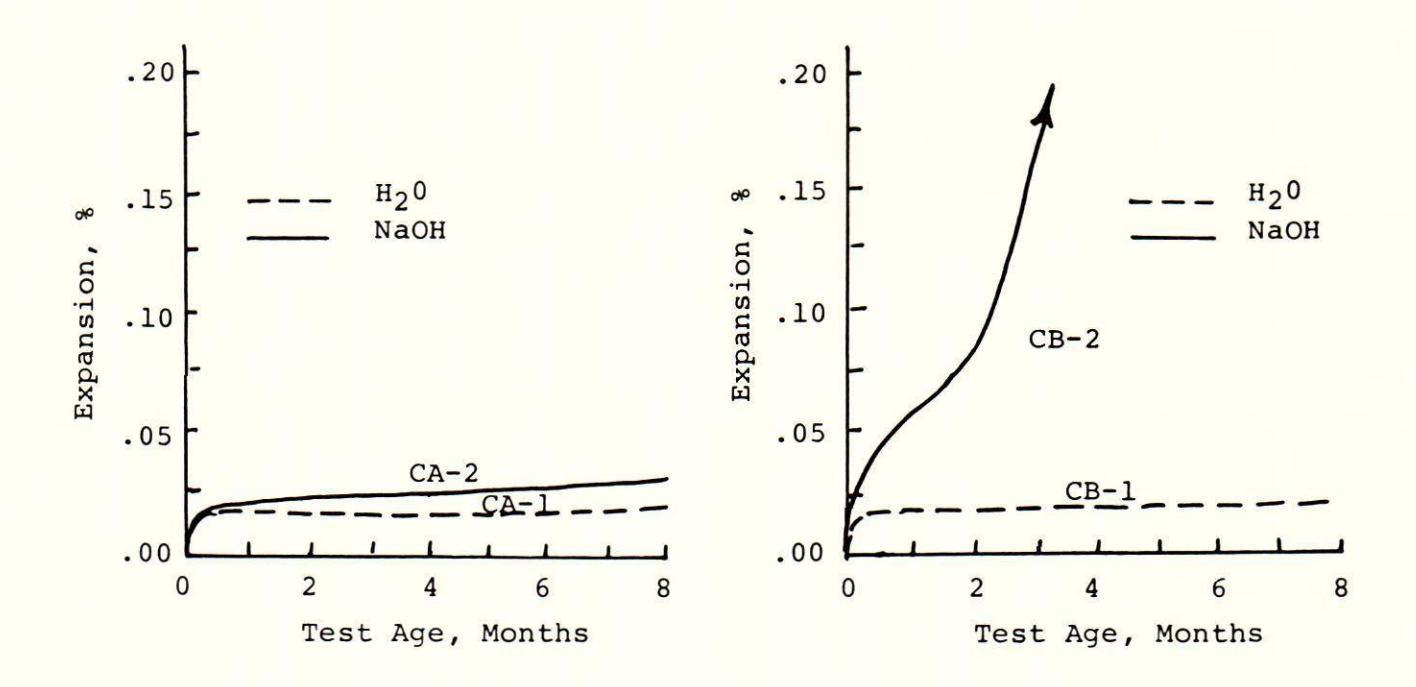
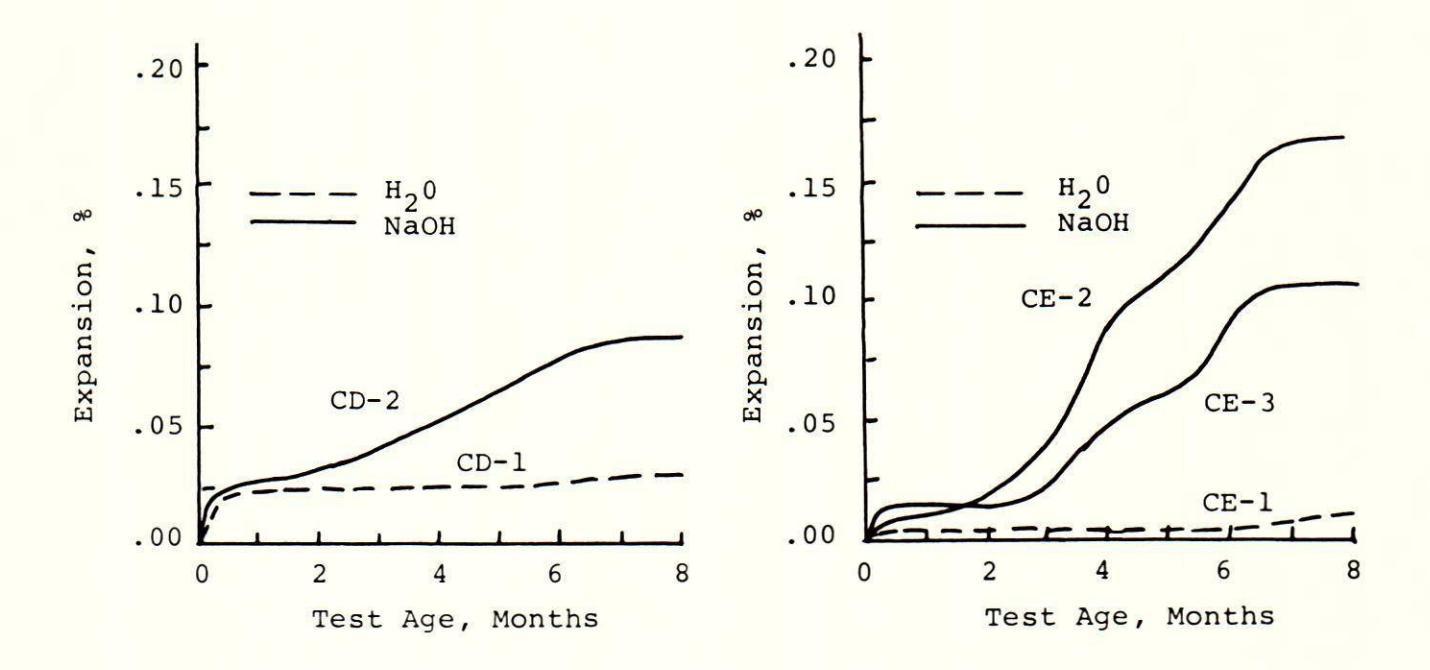
FIG. A5 - LENGTH CHANGES OF COOLIDGE DAM CORES IMMERSED IN WATER OR IN NAOH SOLUTION AT 100°F

At location CB, where high-alkali cement was also reportedly used, there was no potential for further expansion without additional alkali. This is reflected in the contrast between the 0.380 percent expansion reached by the core immersed in 1N NaOH solution, and the 0.022 percent expansion reached by the core immersed in water. These results imply that unreacted but potentially reactive aggregate exists in the concrete, but that reactivity causing excessive expansion and cracking has been arrested by reduction of the available alkali in the concrete.

Results for concrete from locations CD and CE, presumably where low-alkali cement was used, revealed significant potential for excessive expansion from alkali-silica reactivity. This is indicated by the relatively large expansions of cores immersed in alkali compared with the expansions of cores immersed in water. Because the petrographic examination failed to disclose evidence of significant reactivity, it was concluded that the use of the lower-alkali cement has, thus far, effectively inhibited expansive reactivity in this concrete.

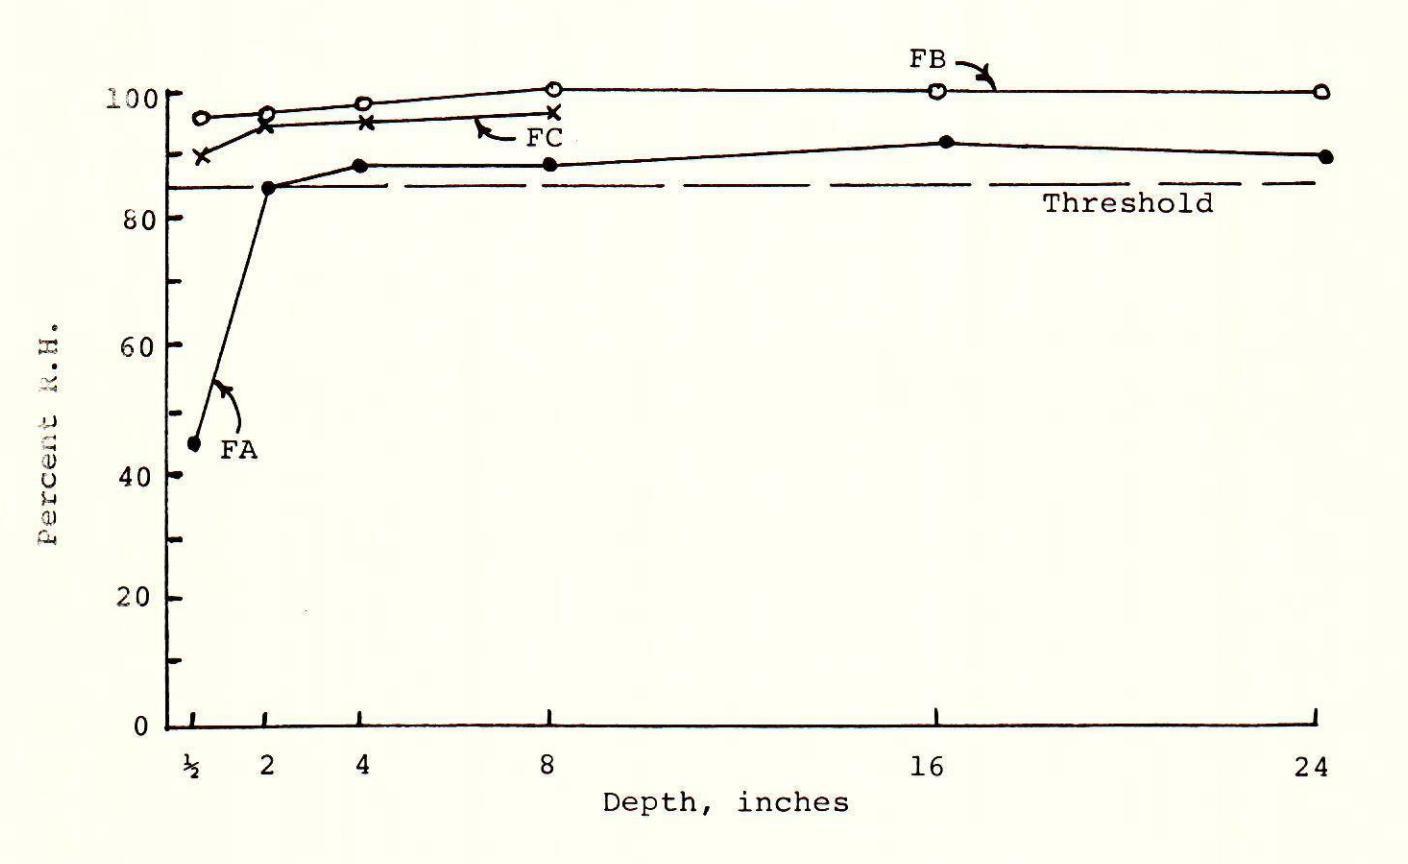
FIG. B1 - RELATIVE HUMIDITY DATA FOR FRIANT DAM

Relative Humidity. - The results of RH measurements shown on figures B1 and B2 indicate that atmospheric drying has had only superficial effect in reducing the RH of concrete at the sample locations. At the 1/2- to 1-inch depth, RH values ranged from 45 to 96 percent, but at the 2- to 21/2-inch depth at each location, values reached or exceeded the 85 percent threshold level, and remained well above that level at depths up to at least 24 inches. At four of the five locations sampled, RH values were consistently close to 100 percent. From this it was concluded that similarly high RH levels persist at greater depths from exposed surfaces. It should be noted that measurable rain had fallen two days before sampling, which may have partially accounted for high RH values at the 1/2- to 1-inch depth at some locations. However, the rainfall is not believed to have influenced measured RH values at depths greater than 4 to 41/2 inches.

From these results, it was concluded that most concrete in the dam contains enough moisture to permit expansions to develop if alkali-silica reactivity occurs.

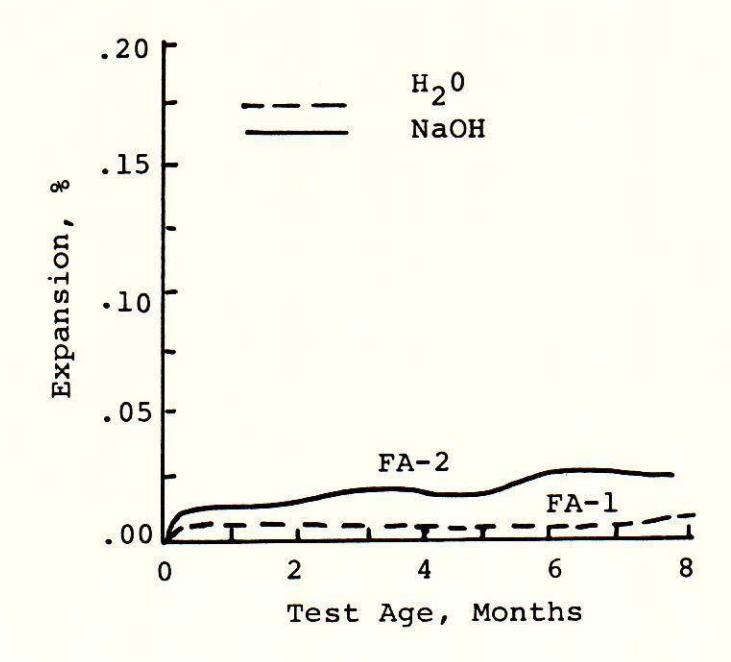
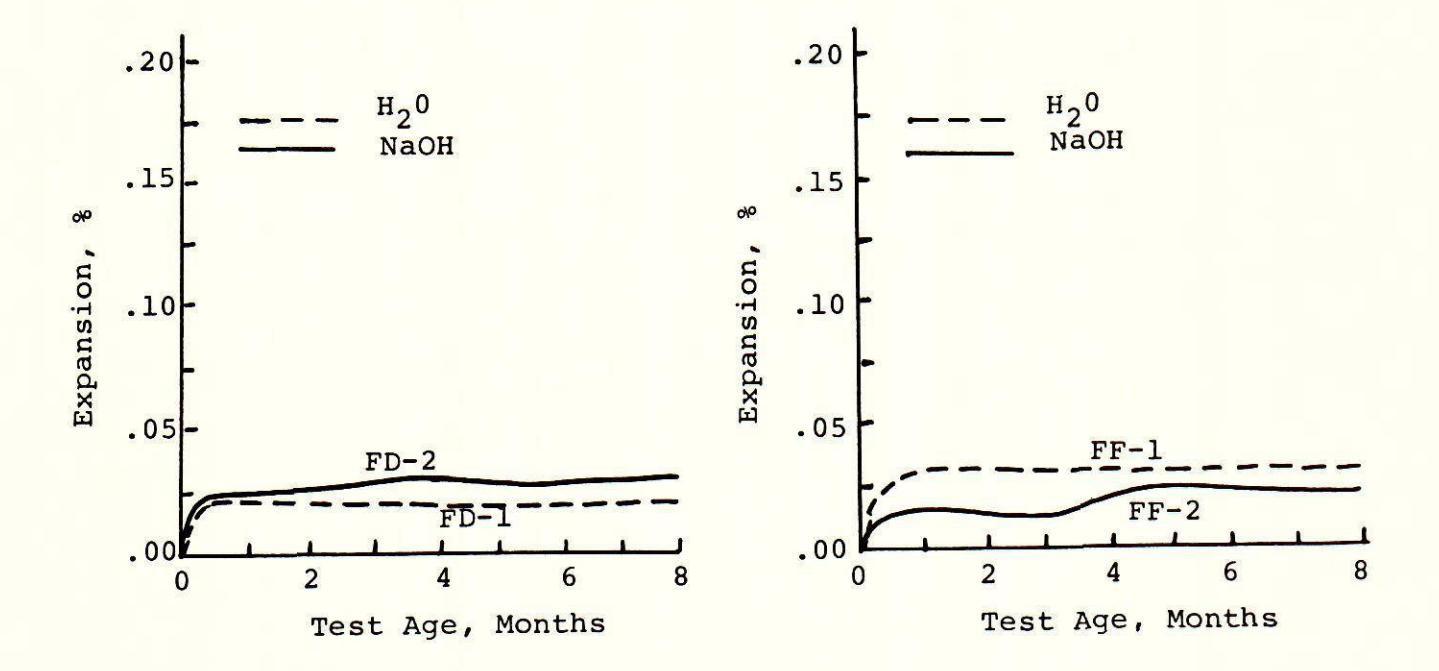
FIG. B5 - LENGTH CHANGES OF FRIANT DAM CORES IMMERSED IN WATER OR 1N NAOH SOLUTION AT 100°F

Cores taken at location FF in the roadway at the top of the dam showed somewhat different results. Core FF-1, immersed in water, expanded 0.043 percent; whereas, core FF-2, immersed in 1N NaOH solution, expanded 0.021 percent. This suggests rehydration of existing gel in core FF-1, and no potential for further expansive reactivity in core FF-2. Map-cracking was observed at this location in the roadway, and minor evidence of reactivity was noted in the petrographic examination of a core from this location. Results suggest that, although previous reactivity had developed, there is little or no potential for expansive alkali-silica reactivity.

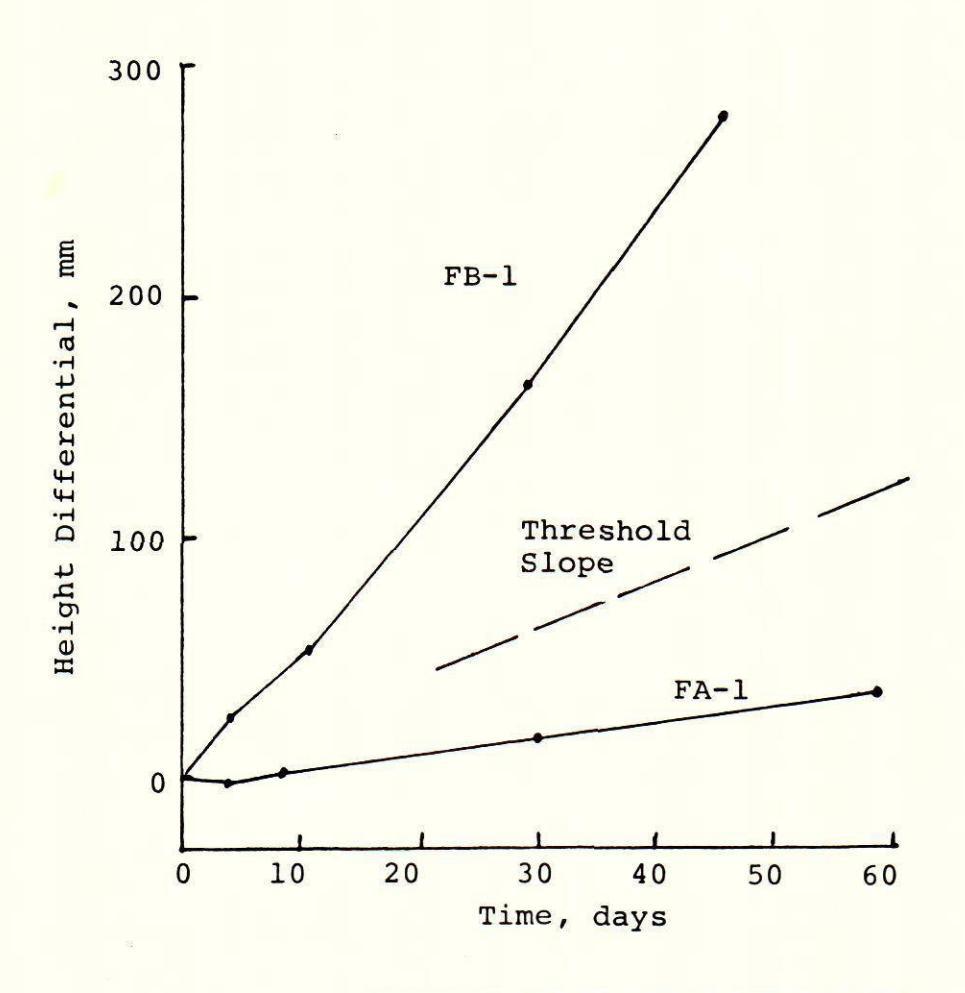
FIG. B6 - RESULTS OF OSMOTIC CELL TESTS FOR AGGREGATE FROM FRIANT DAM

Osmotic Cell Tests. – Two andesite coarse aggregate particles were tested in the osmotic cell. The results are given on figure B6. Andesite particle FA-1, taken from concrete in the face of the dam, was found to be nonreactive. This particle showed no evidence of previous reactivity in the concrete, and the petrographic examination did not reveal evidence of previous reactivity in the concrete core. But, andesite particle FB-1, taken from concrete in the stairway that displayed severe map-cracking, was found to be potentially reactive. It displayed evidence of previous reactivity in the concrete core.

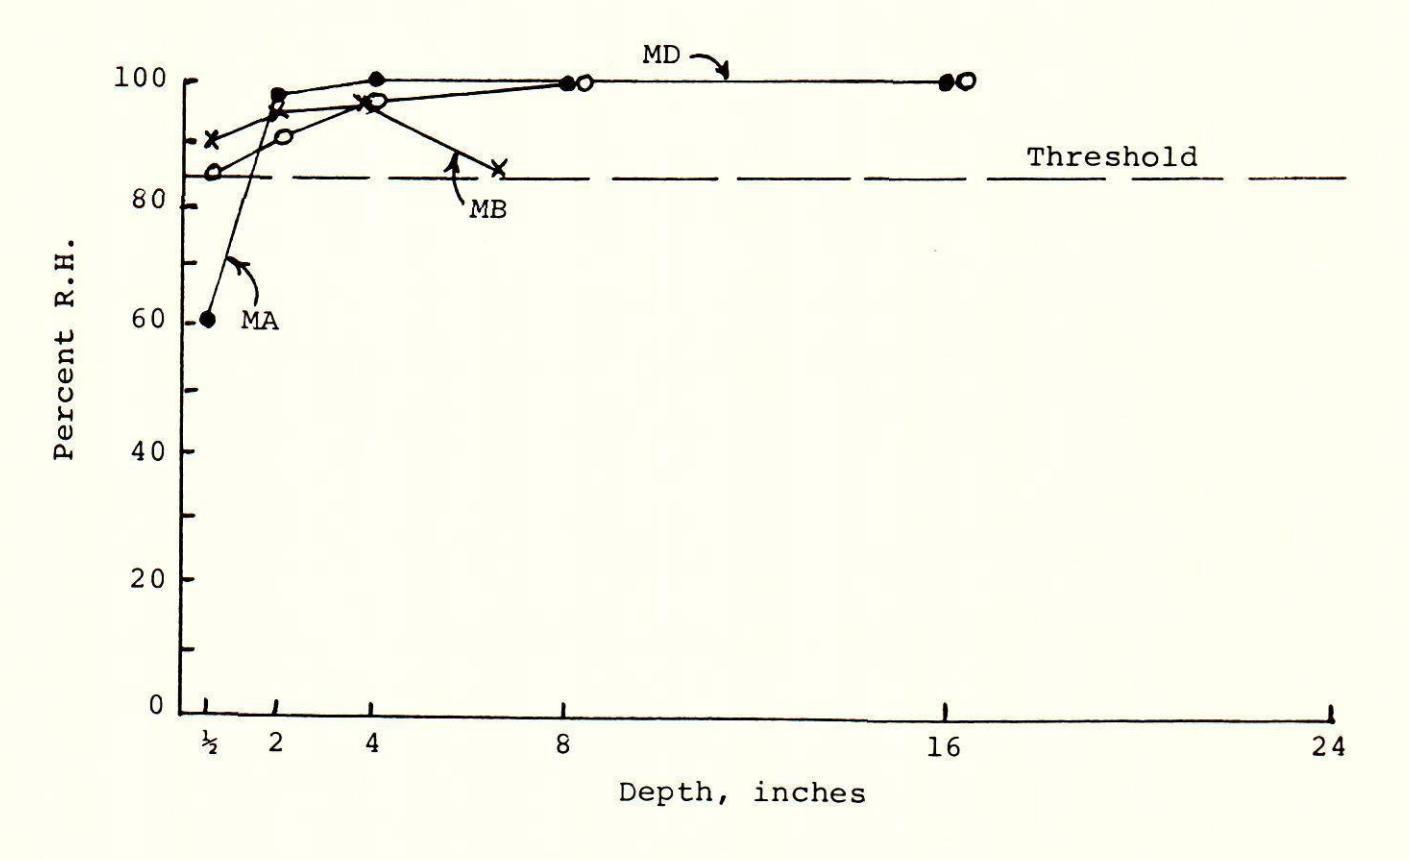
FIG. C1 - RELATIVE HUMIDITY DATA FOR MATILIJA DAM

Relative Humidity. – Results of RH measurements shown on figures C1 and C2 suggest that most concrete in the dam contains enough moisture to permit expansion from alkali-silica reactivity. The data show that atmospheric drying has had little or no effect on reducing relative humidities, even at depths as little as ½ to 1 inch from exposed surfaces. At four of the five locations sampled, RH values exceeded the 85 percent threshold level at this shallow depth. Only at location MA, which was in a massive retaining wall, was the RH less than 85 percent at the ½- to 1-inch depth.

The minimal effects of long-term atmospheric drying at the Matilija Dam site are readily seen in RH measurements at location MB, which was in an 8-inchthick concrete railing. The concrete, which was exposed to the atmosphere on both vertical surfaces, displayed evidence of reactivity. At the $\frac{1}{2}$ - to 1-inch depth from each exposed surface, RH values were 86 percent and 90 percent. At the 2- to $2\frac{1}{2}$ -inch and the 4- to $4\frac{1}{2}$ -inch depths, RH values were 95 percent. Thus, it is understandable that the higher RH values were found near the surface in the more massive units of the dam structure.

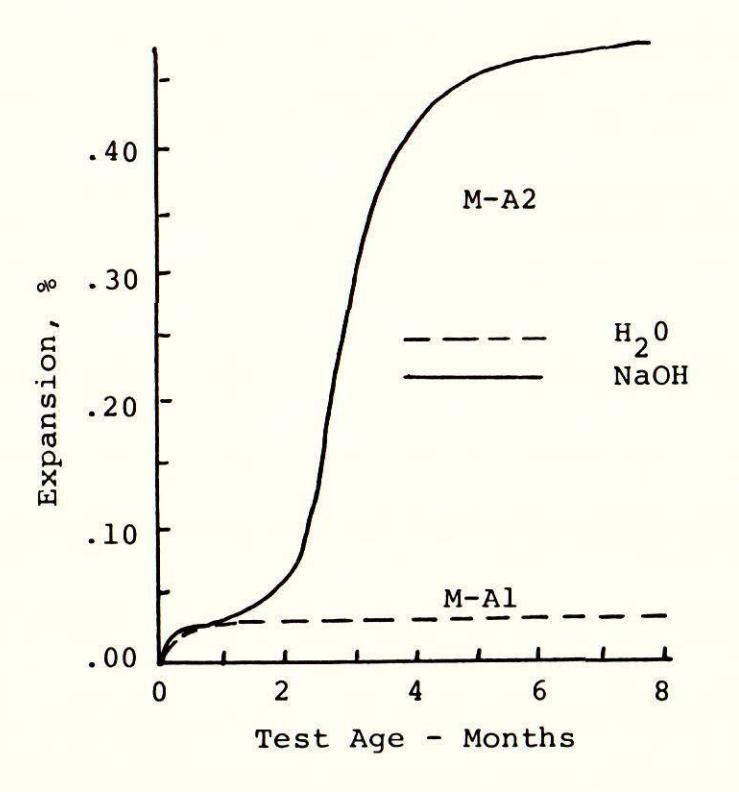
FIG. C4 - LENGTH CHANGE OF MATILIJA DAM CORES IMMERSED IN WATER OR 1N NAOH SOLUTION AT 100°F

Results shown on figure C4 indicate that potential exists for further reactivity and expansion only when additional alkali is present. This is shown by the 0.479 percent expansion for core M-A2. Core M-A1, which was immersed in water, showed only 0.030 percent expansion. This is in the range expected for dried concrete that has simply been rewet. These results suggest that a deficiency in available alkali, which had the effect of arresting expansive alkali-silica reactivity, developed in this concrete.

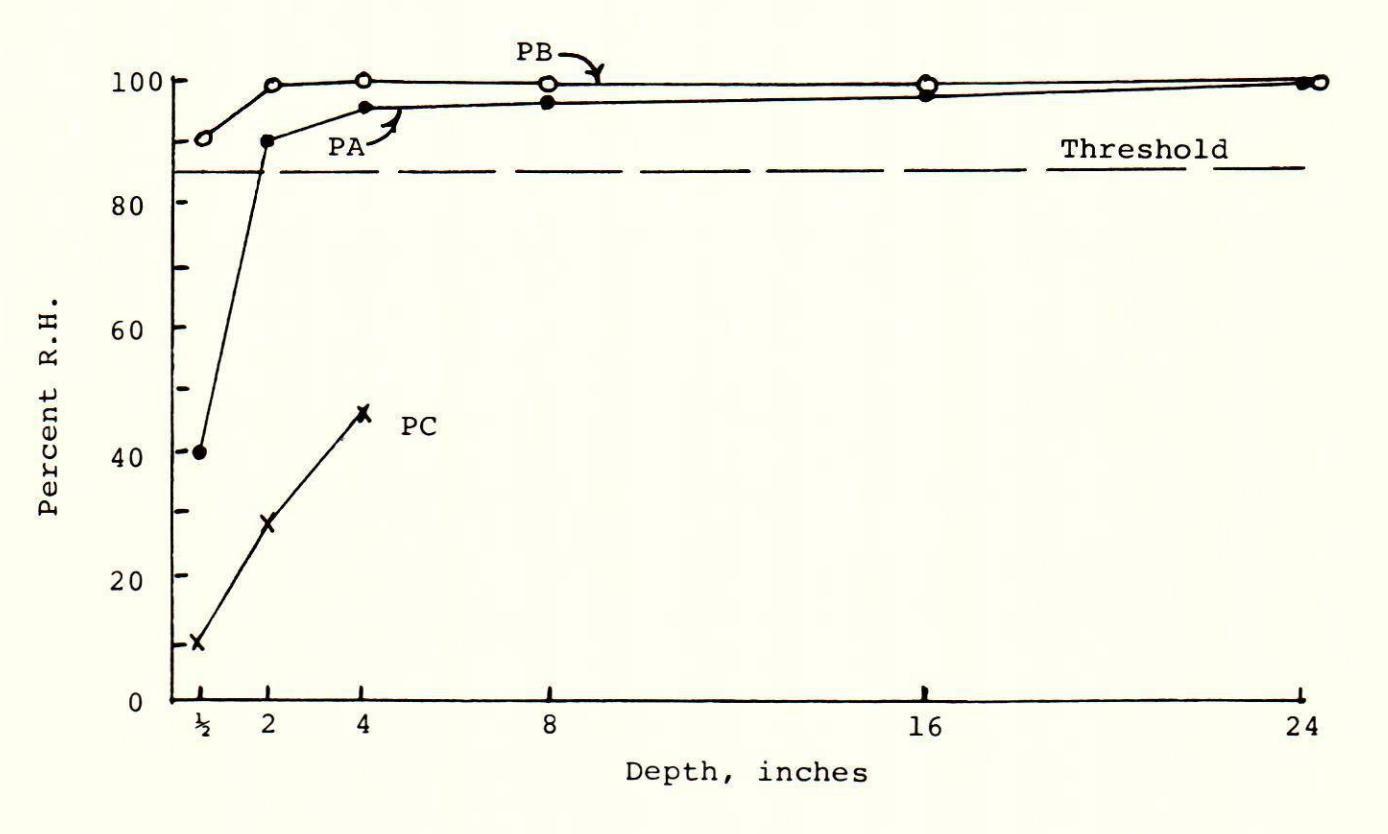
FIG. D1 - RELATIVE HUMIDITY DATA FOR PARKER DAM

Relative Humidity. – Results of measurements shown on figures D1 and D2, suggest that RH values are above the 85 percent threshold level for expansive reactivity in most concrete in the dam structure. Only at near-surface depths (generally less than about 2 inches) was concrete sufficiently dry to preclude expansion from reactivity. Similarly high RH levels were found in the 5-foot by 5-foot concrete block at the east end of the wall along the walkway on the dam. Thus, even in certain relatively small concrete members exposed to the atmosphere, RH values were sufficiently high to permit expansion to develop from alkali-silica reactivity.

Two of the five sample locations showed relatively low RH values at depths greater than 4 to 4½ inches. One was above the walkway on the dam in the east column of the west spillway. Here RH values ranged from 10 percent at the ½- to 1-inch depth to 47 percent at the 4- to 4½-inch depth. Reinforcing steel was encountered at the 6-inch depth; thus, no greater depths could be sampled. In this concrete, expansion from reactivity would not develop. However, cracking could develop if the concrete at greater depths contains enough moisture and expansive alkali-silica reactivity occurs.

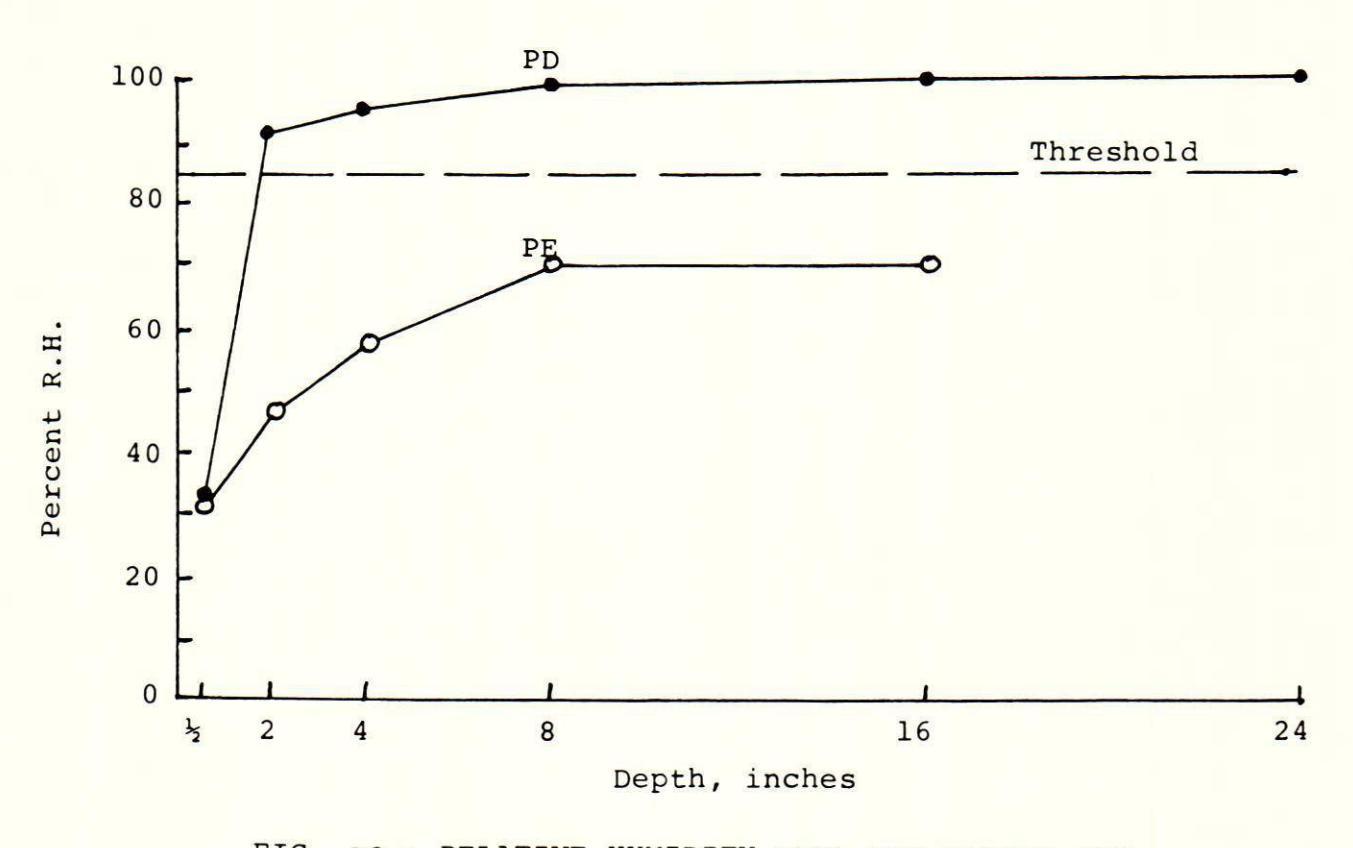
FIG. D2 - RELATIVE HUMIDITY DATA FOR PARKER DAM

The other location where comparatively low RH values were found was in the 24-inch-thick north wall of the powerhouse. This wall displayed faint mapcracking, which might represent only shrinkage. However, the border of each crack segment was discolored to dark gray by a colorless transparent deposit in the concrete, which was believed to be alkalisilica gel. The RH value at the 1/2- to 1-inch depth from the exterior surface was 32 percent, but it increased progressively with depth to 70 percent. This 70 percent RH value was found across the middle third of the wall. It may represent the highest RH level at this location because the room on the interior side of the wall is air-conditioned under intermediate to low (50 percent) relative humidity. Thus, it is believed that alkali-silica reactivity had developed earlier in the wall concrete, causing the observed map-cracking. Gradually, the RH decreased to below the 85 percent threshold level, arresting further expansive reactivity. Accordingly, expansion from reactivity in this wall is not expected to develop in the future.

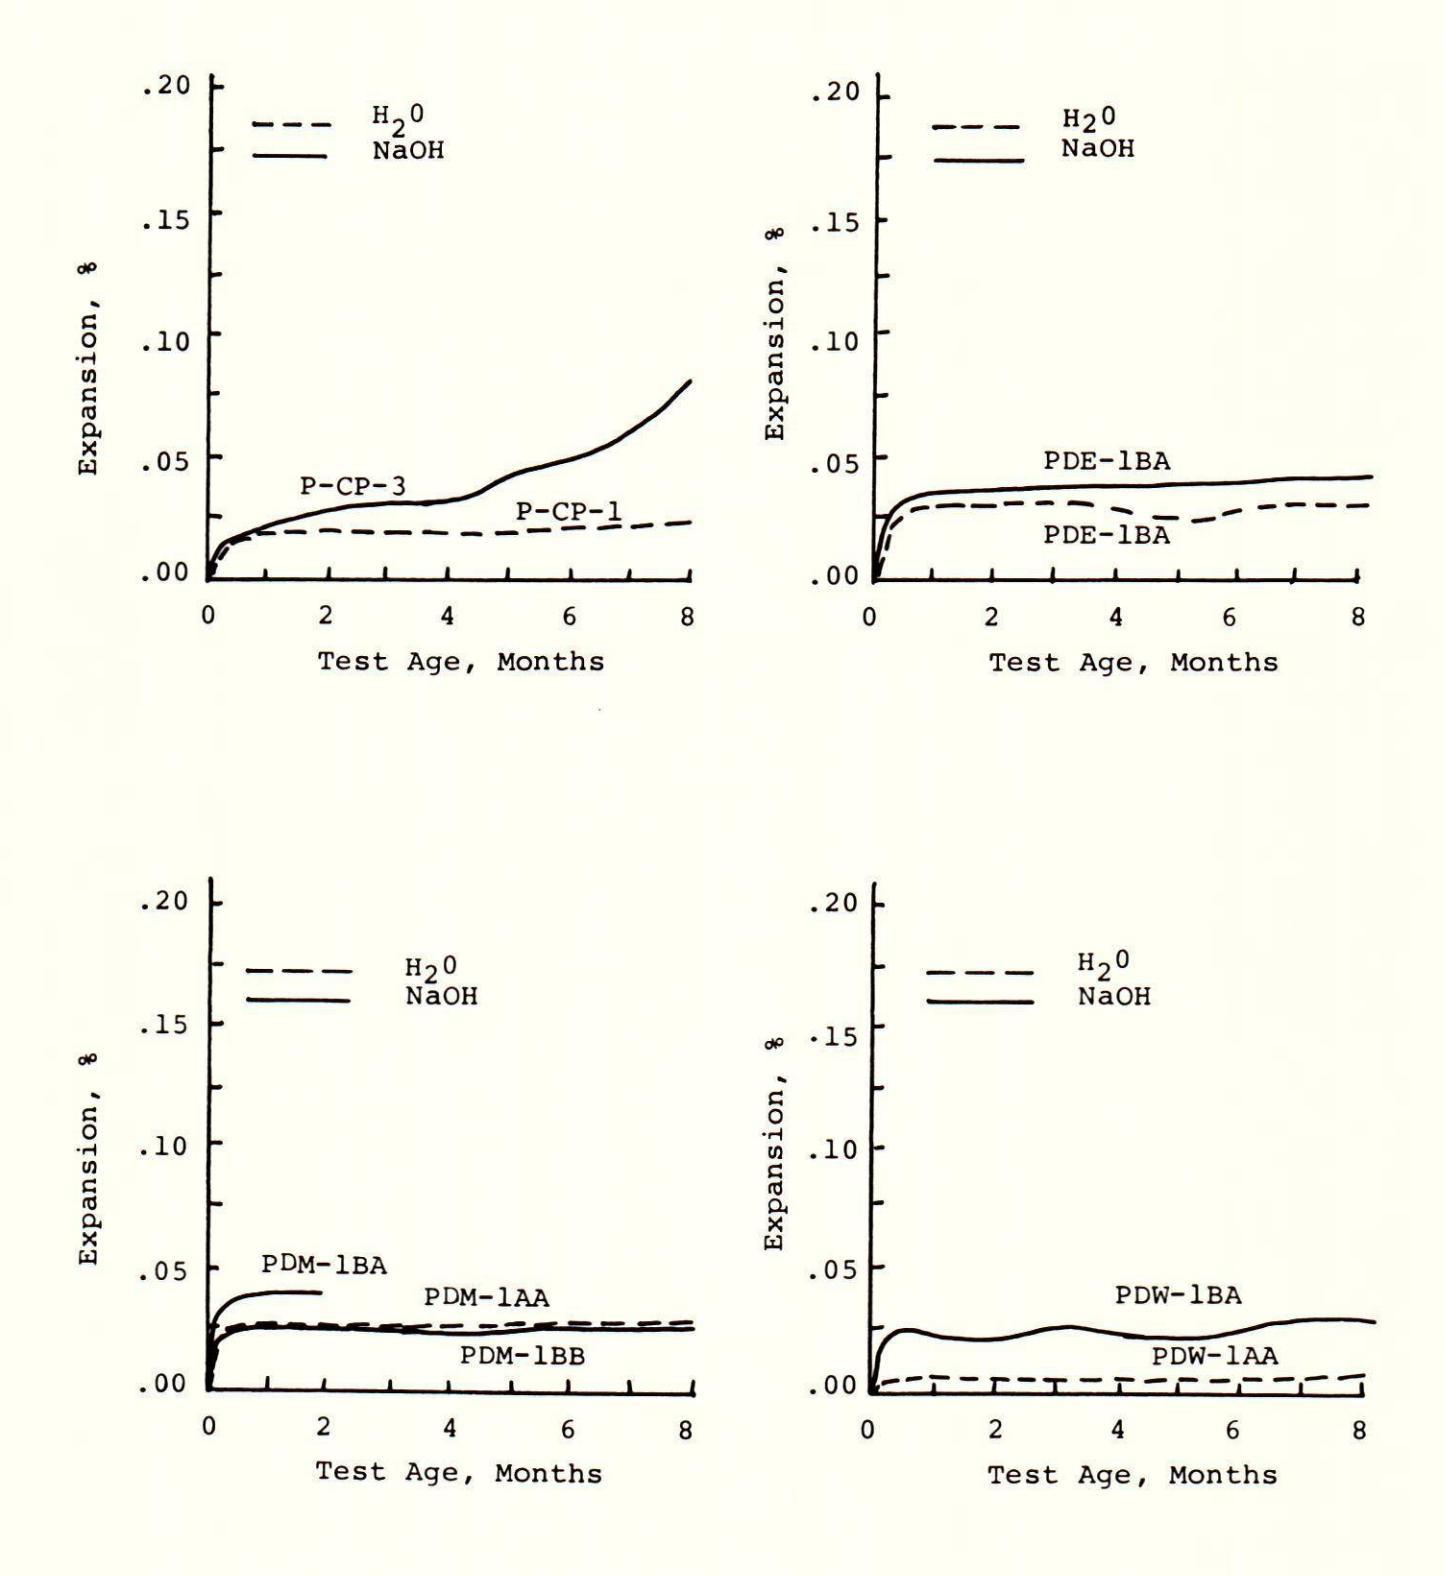
FIG. D5 - LENGTH CHANGES OF PARKER DAM CORES IMMERSED IN WATER OR 1N NAOH SOLUTION AT 100°F

Those cores immersed in 1N NaOH solution showed slightly greater expansions than companion cores immersed in water. The maximum difference found was 0.023 percentage point for companion cores PDW-1AA and PDW-1BA. This is approximately the lower limit considered to indicate additional expansive reactivity. However, this difference was established within one to two weeks after testing and remained constant for the duration of the test period. This suggests swelling of existing alkali-silica gel rather than additional expansive reactivity or rewetting of concretes from different moisture conditions. The potential for expansive reactivity no longer exists in this concrete.

The two cores from the concrete block at the end of the retaining wall produced results similar to those noted above.

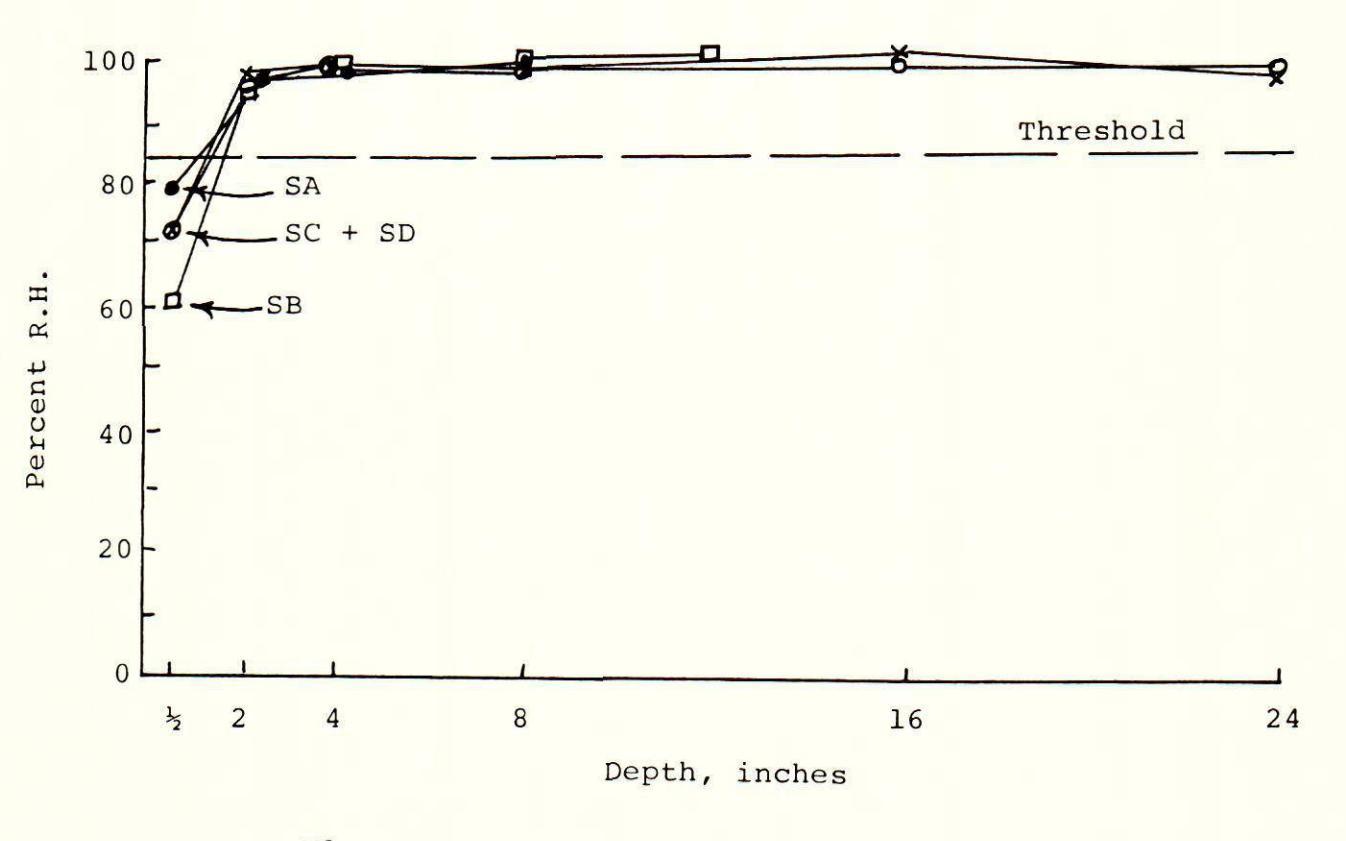
FIG. E1 - RELATIVE HUMIDITY DATA FOR STEWART MOUNTAIN DAM

Relative Humidity. – The results of measurements at six locations in the dam are shown on figures E1 and E2. They indicate that the 85 percent threshold RH value required for development of expansive reactivity was reached at depths ranging from 2 to 16¹/₂ inches from exposed surfaces.
