GEOTECHNICAL INVESTIGATION

Yerba Buena Road Distress Ventura County Public Works Agency Ventura County, California

April 2025

SUBJECT:Geotechnical InvestigationRE:Yerba Buena Road DistressVentura County, California

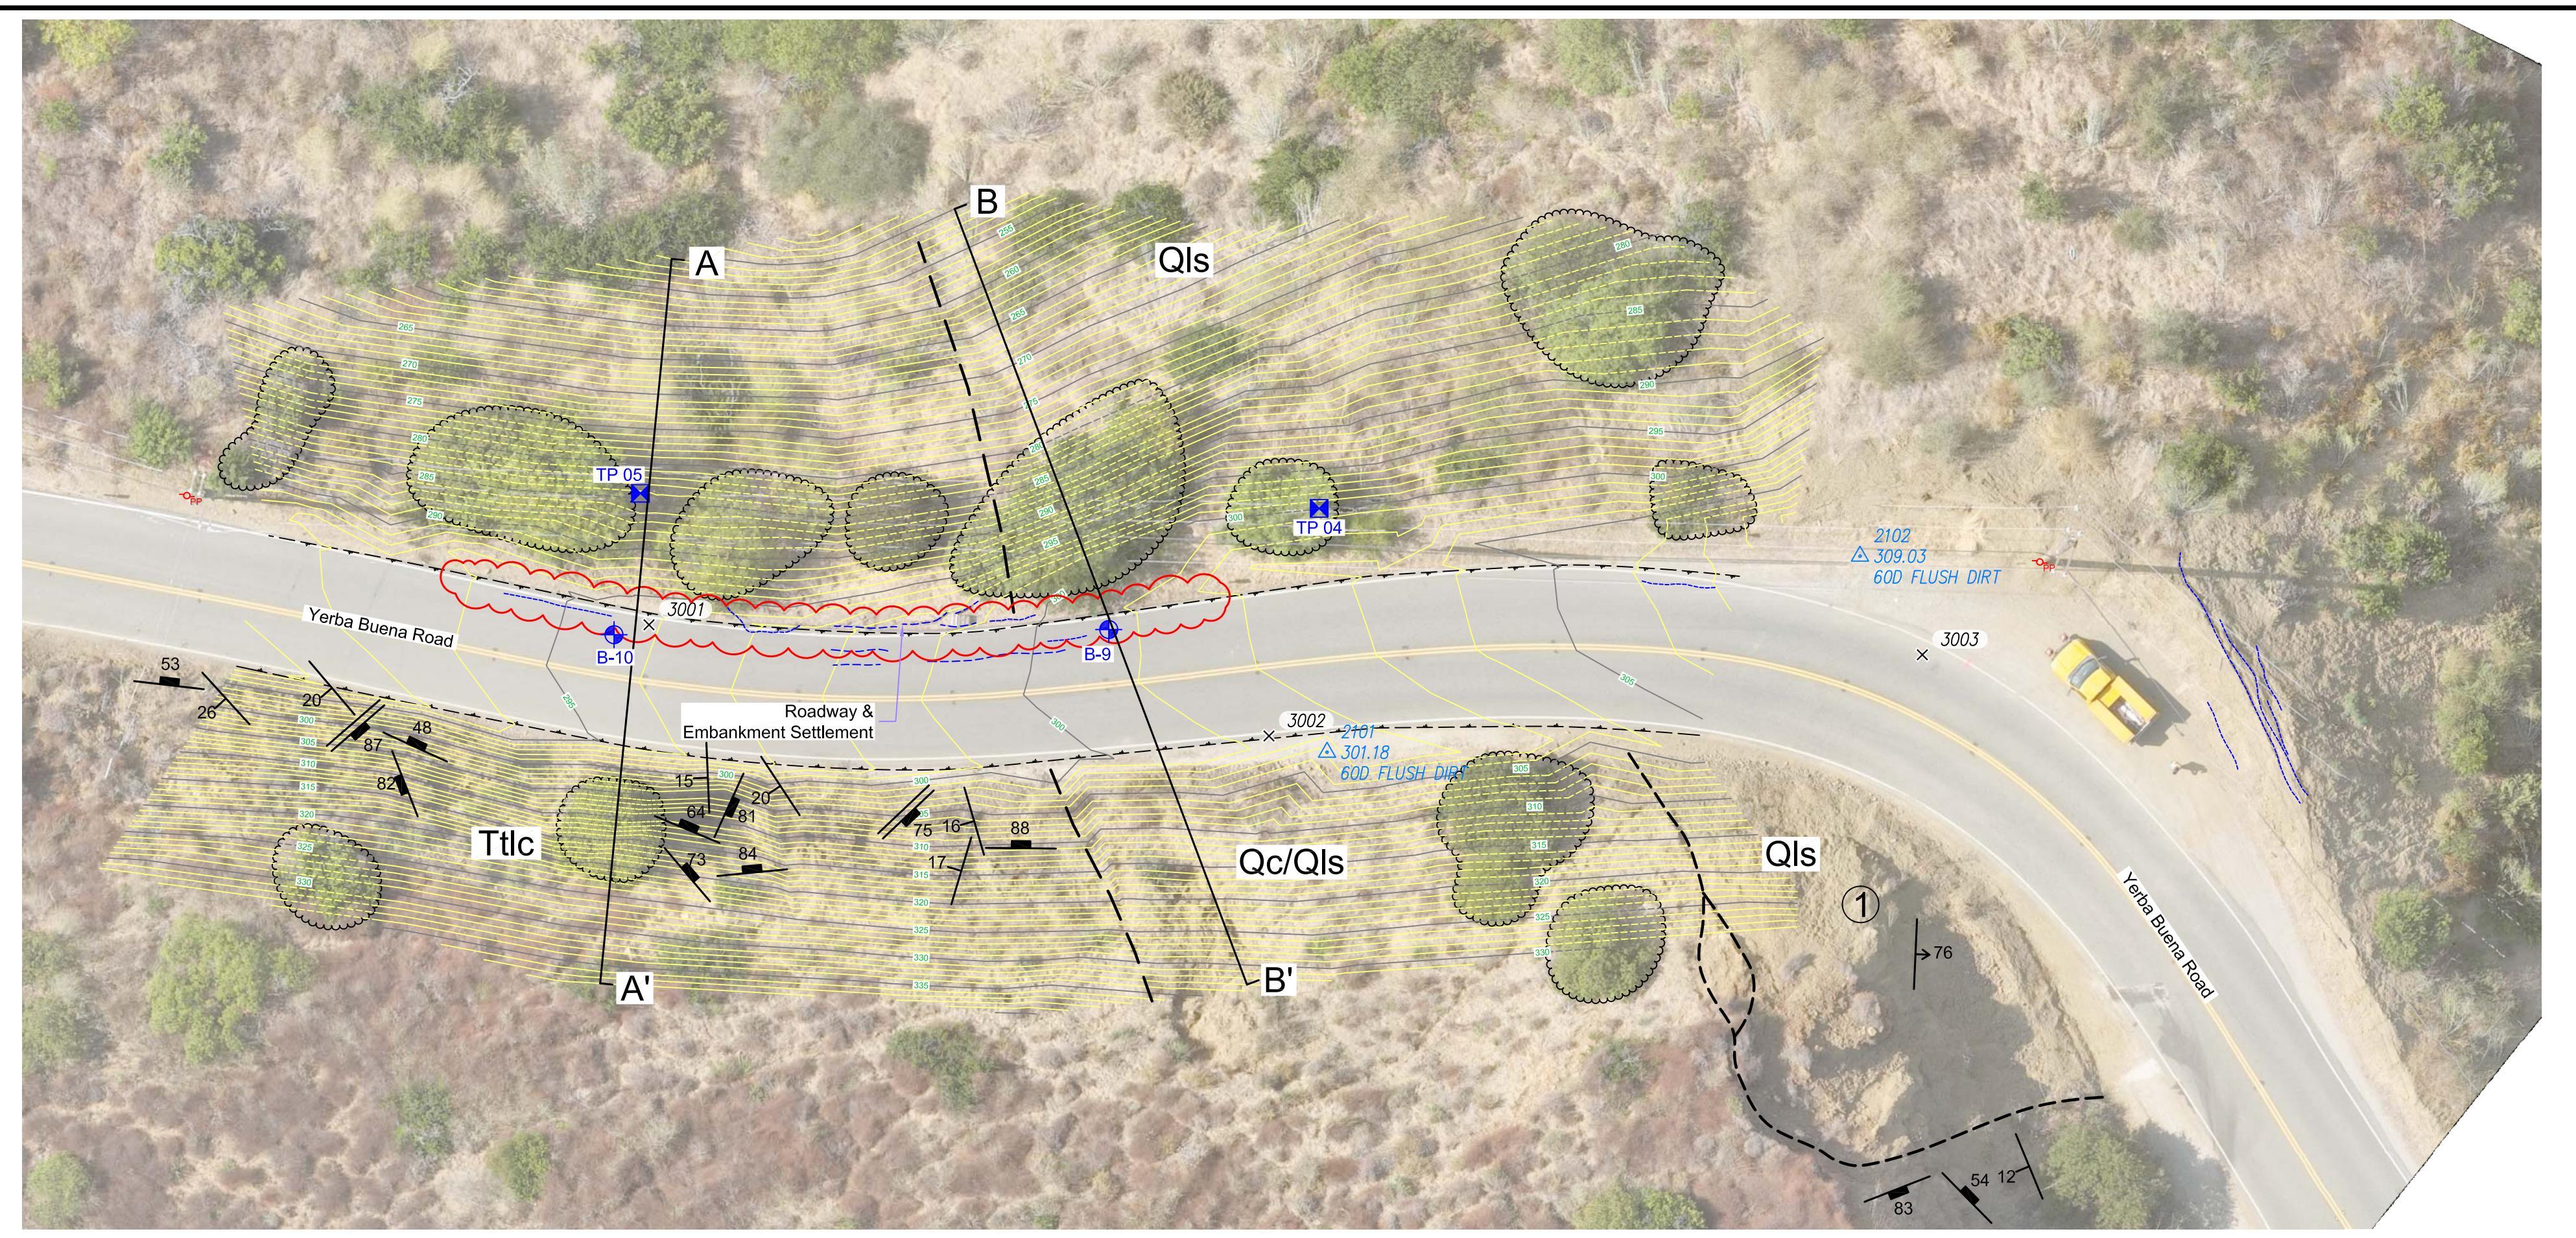
GEOLOGIC MAP Yerba Buena Road Distress - Mile Post (MP) 0.93 VENTURA COUNTY, CALIFORNIA

- Discontinuous, sub-linear to arcuate cracking along the graded dirt shoulder and western portion of the southbound travel lane, with the majority of this distress occurring between borings B-9 and B-10 (see Figure 4a). Roughly located in the center of the distressed area is a section of pavement, shoulder and embankment that has broken and vertically dropped approximately six to twelve inches (6"-12"), as measured along the top-of-slope.

- Evidence of relatively recent, relatively thin and localized slope failures was observed in the ascending slopes along the east side of the roadway. This includes instability in colluvium at the northern end of the County-provided mapping, where field mapping and logging of boring B-9 (Figure 4a) indicate the presence of an inactive, deeper landslide feature.

- Also observed just north of topographic mapping is pronounced, discontinuous and relatively linear cracks along the top of the descending roadway embankment. These cracks have occurred in what appears to be recent spill fill along the top of the roadway embankment.
