CALLEGUAS CREEK

WATERSHED FEASIBILITY STUDY

HYDROLOGY APPENDIX

February 2003

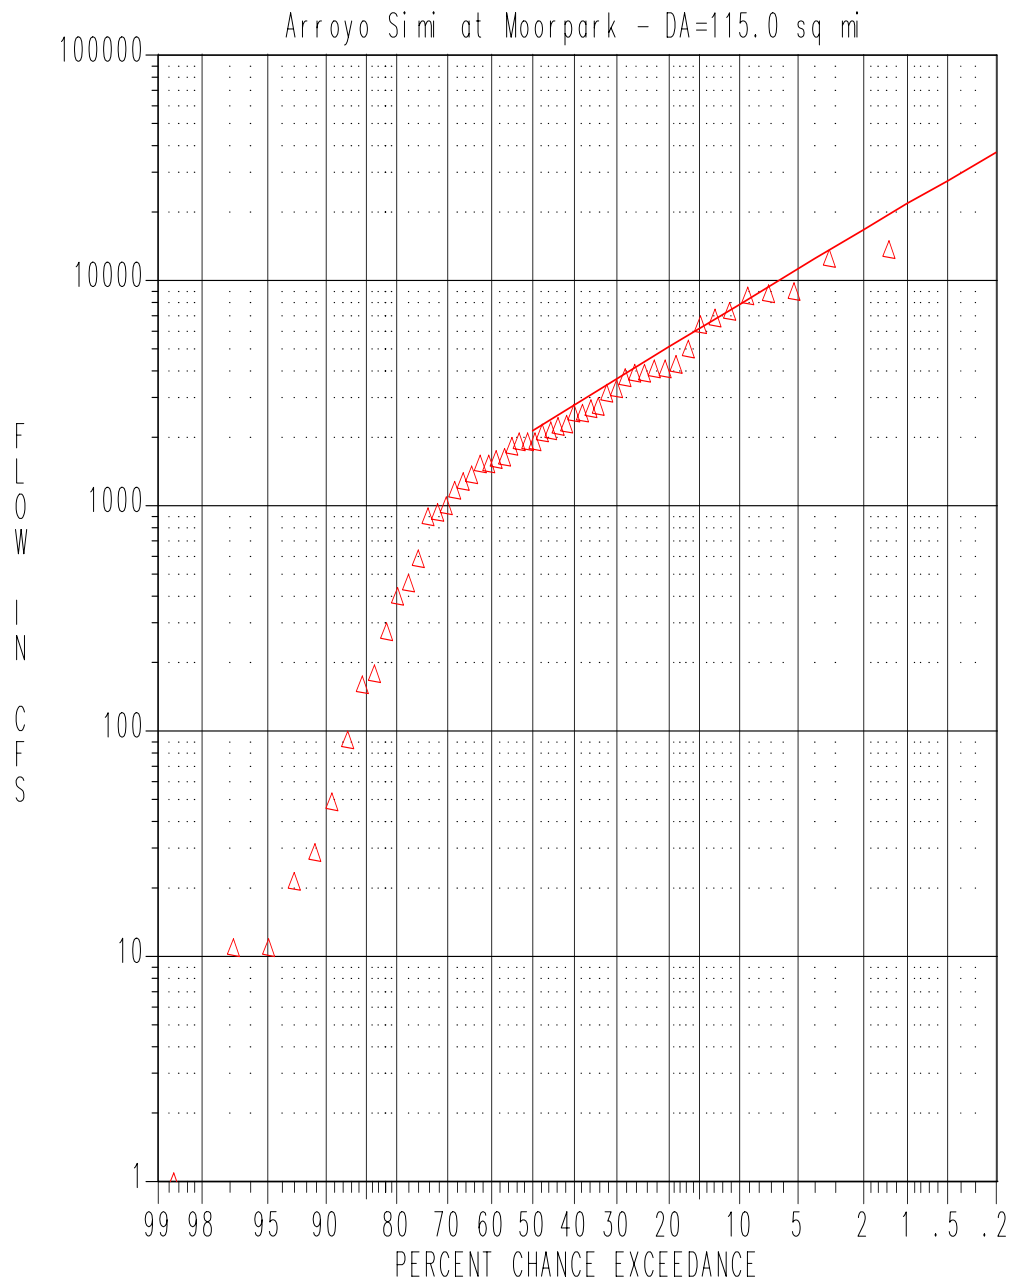
Figure 10: Discharge-Frequency Curve – Arroyo Simi at Moorpark
 Gage No. 801 - Drainage Area 115.0 mi²

— Frequency Curve
 △ Annual Max. Flows (Median P.P.)

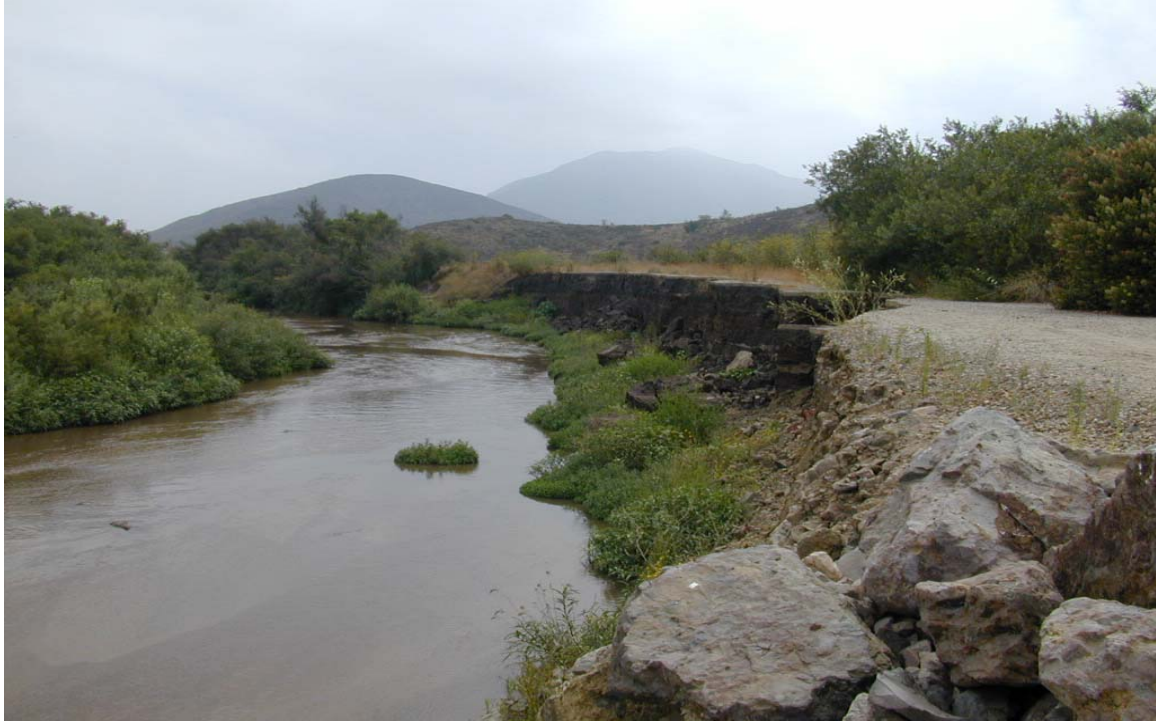
Calleguas Creek at Old Dairy Rd. (Erosion), near CSUCI, looking upstream

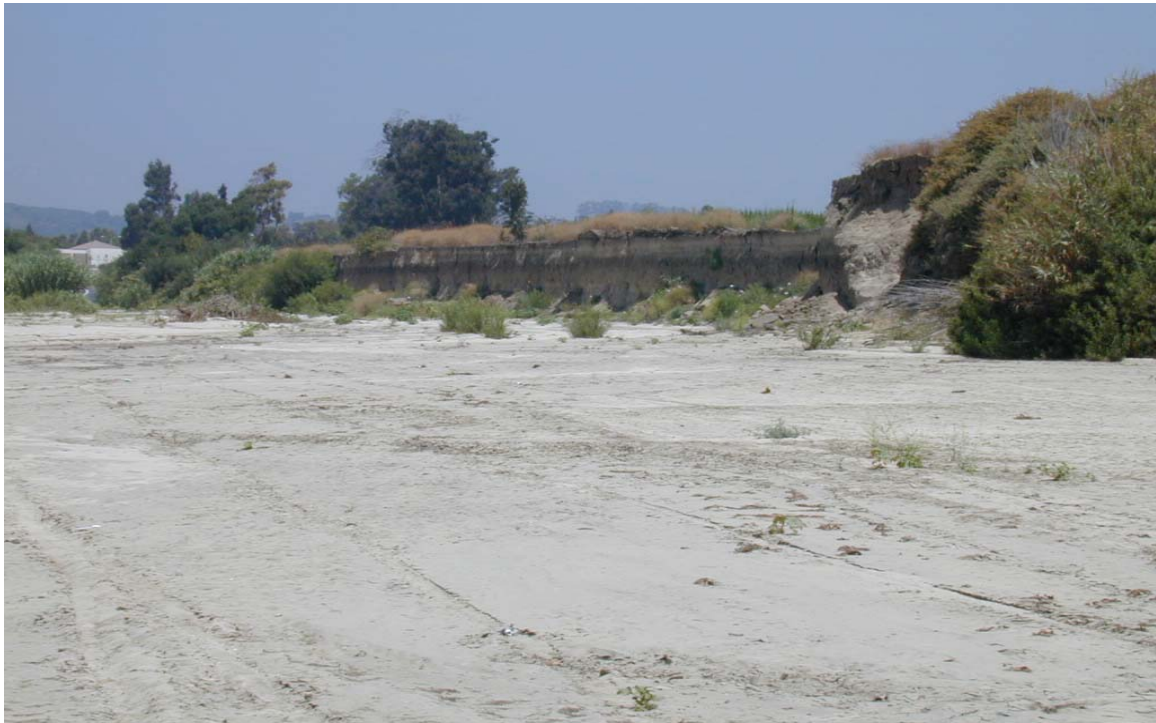
Calleguas Creek at Mission Oaks Blvd. (Bank Erosion), looking upstream
