SANTA ROSA ROAD DEBRIS BASIN No. 2
DEBRIS BASIN MODIFICATION
PRELIMINARY DESIGN STUDY
JUNE 2016

Santa Rosa Road Debris Basin No. 2

Debris Basin Modification

Preliminary Design Study

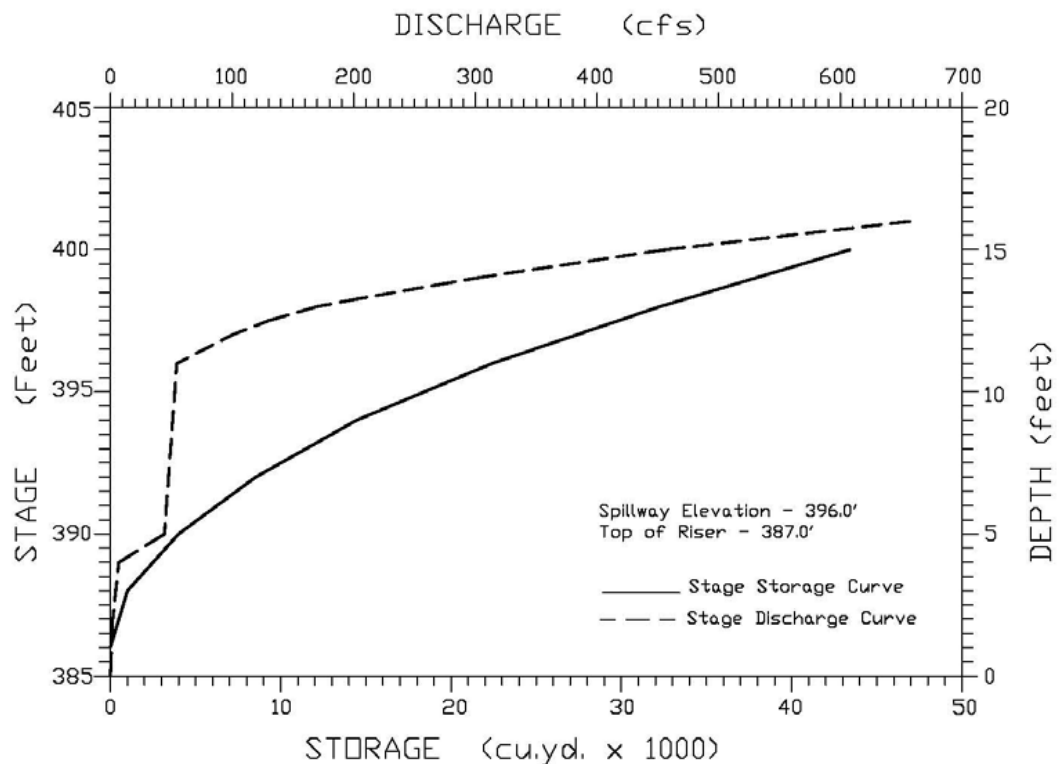
Figure 2-1. Stage-Discharge and Stage-Storage Curve (VCWPD, 2005)

In Figure 2-1, "Spillway Elevation - 396.0'" refers to the emergency spillway (Figure 2-3) crest elevation. "Top of Riser - 387.0'" refers to the primary spillway and debris bleeder elevations (all elevations are NGVD29). The spillway and bleeder are shown in Figure 2-4 and Figure 2-5. Discharge is given in cubic feet per second (cfs). The spillway and riser elevations differ by 9 feet in the stage-storage and debris-storage curves. The "as-built" drawings indicate the emergency spillway elevation is 126.0 feet and the spillway and riser elevations are 116.0 feet (local benchmark elevation values), a difference of 10.0 feet. The spillway and riser elevations of 396.0 and 387.0 (NGVD29) from stage-storage and debris-storage curves were used for the hydraulic modeling.

Stage-discharge and stage-storage curves for flood storage and a debris stage-storage curve are located in *Debris and Detention Basins* (VCWPD, 2005) and presented here as Figure 2-1 and Figure 2-2.

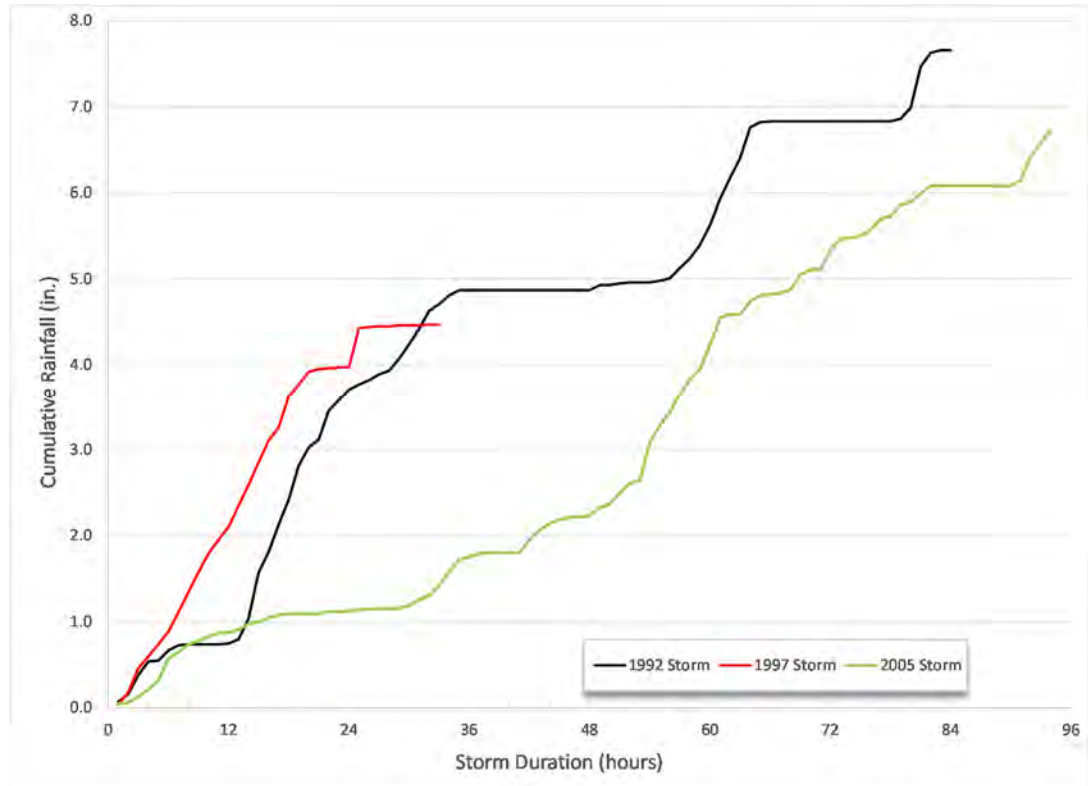
Figure 2-7. Cumulative Hourly Rainfall Totals, Lake Bard Rainfall Gage

Hourly rainfall measurements are not recorded at the Moorpark County Fire Station gage. The nearest hourly rainfall data is the Lake Bard gage located approximately 3 miles from the debris basin. The highest three 24-hour rainfall event records were evaluated by VCWPD for cumulative rainfall totals and peak rainfall intensity using the Lake Bard hourly rainfall gage data. Cumulative hourly rainfall totals for the three events are presented in Figure 2-7.

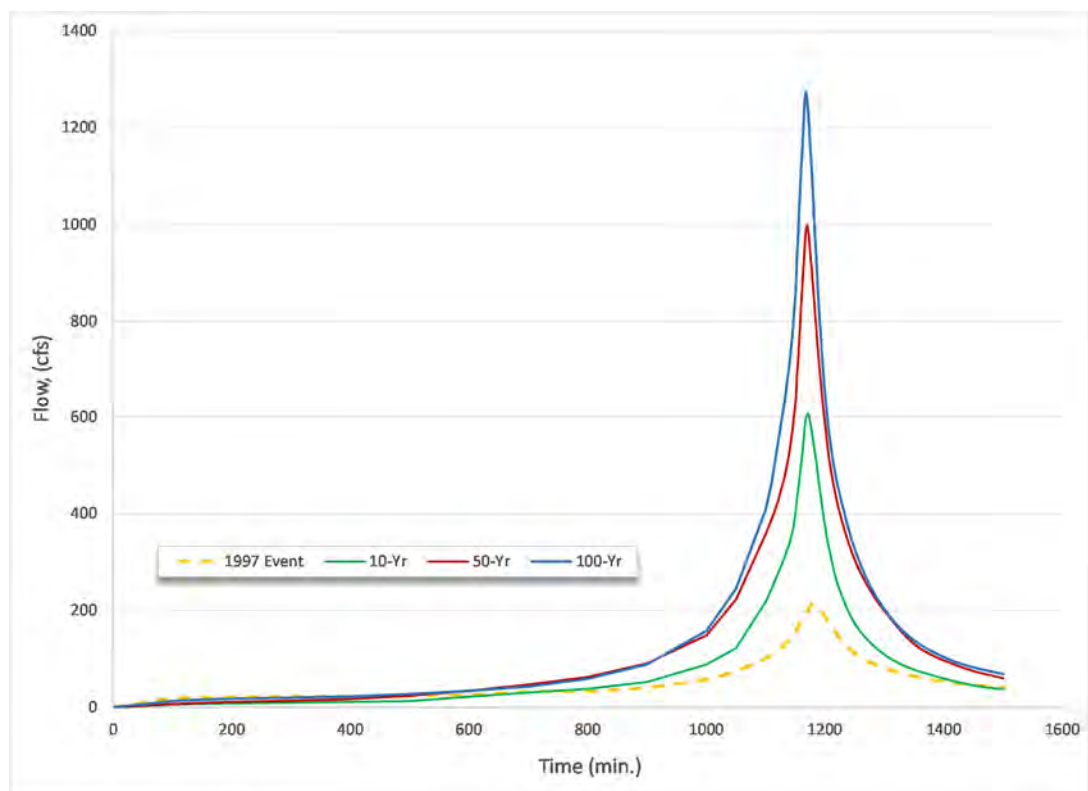
Figure 3-1. Event Hydrographs

Design Event			
	1997	10-year	50-year	100-year
Peak Flow (cfs)	213	607	1,000	1,274
Time to Peak (min.)	1,178	1,171	1,170	1,168
Flood Volume (ac-ft)	102	151	248	283

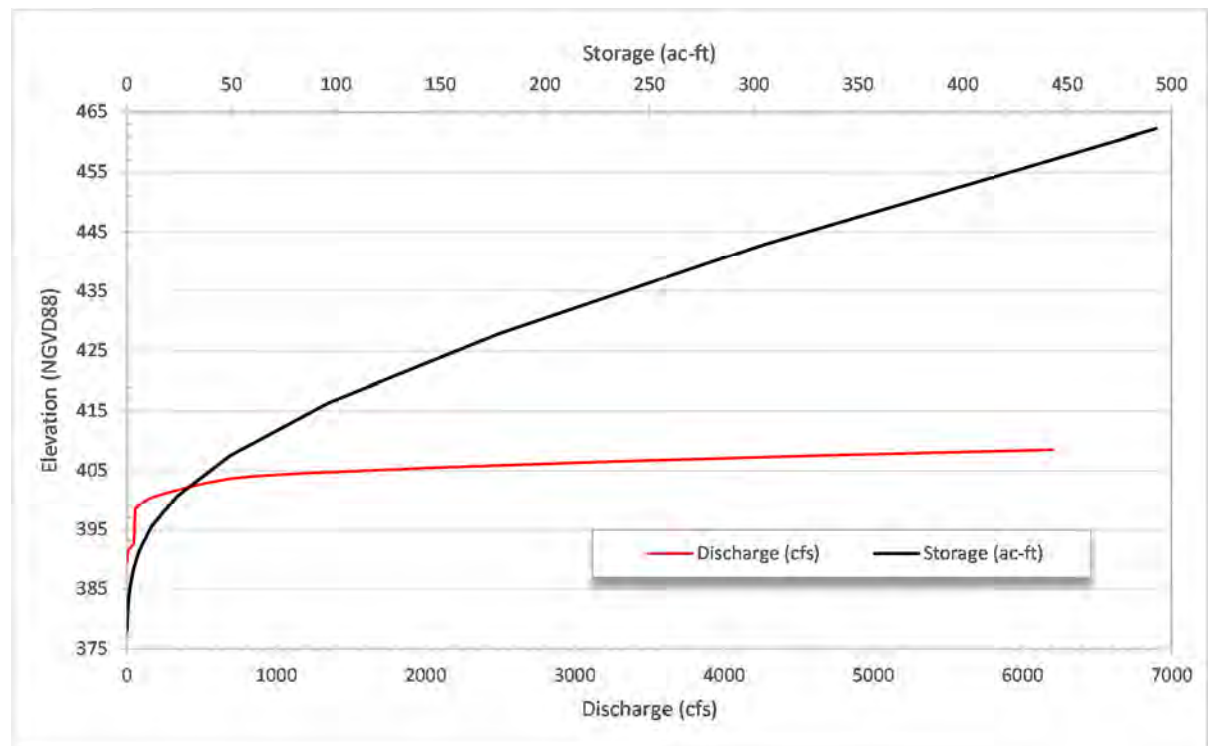
Figure 3-2. Stage-Storage-Discharge Curves

Basin routing and dam break discharges were evaluated in HEC-HMS version 4.0 (USACE 2013). A stage-storage curve was generated from LiDAR data provided by VCWPD. A stage-discharge curve for existing conditions was generated from the scanned stage-discharge curve in *Debris and Detention Basins* (VCWPD 2005) and extrapolated for dam crest

overtopping using the broad-crested weir equation. The resulting stage-storage-discharge curves are presented in Figure 3-2.

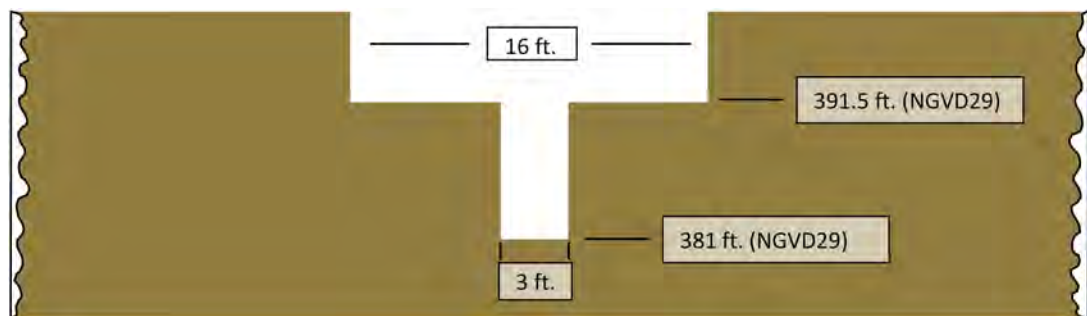
Figure 4-2. Lowered and Widened Spillway Alternative with Slot

Another similar alternative was considered which replaces the low flow spillway, bleeder and culvert with a 3-foot wide slot to provide open channel flow from the clean out elevation upstream of the embankment to the downstream toe of the embankment (see Figure 4-2). The intent of this “slot” option is to allow sediment to flow through the structure while still trapping larger debris. The slot width cannot be “calculated” and would be somewhat experimental in nature (WEST has assumed the slot width equal to 3 feet). The elevation and width of the spillway above the slot is recommended to have the same dimensions as previously calculated (width of 16 feet at elevation 391.5 (NGVD29)) to provide adequate freeboard for the 100-year event. A rating curve for the slot option was not explicitly calculated because the slot would likely provide more conveyance than the current low flow outlet and the dimensions of the emergency spillway are identical to the previous alternative.

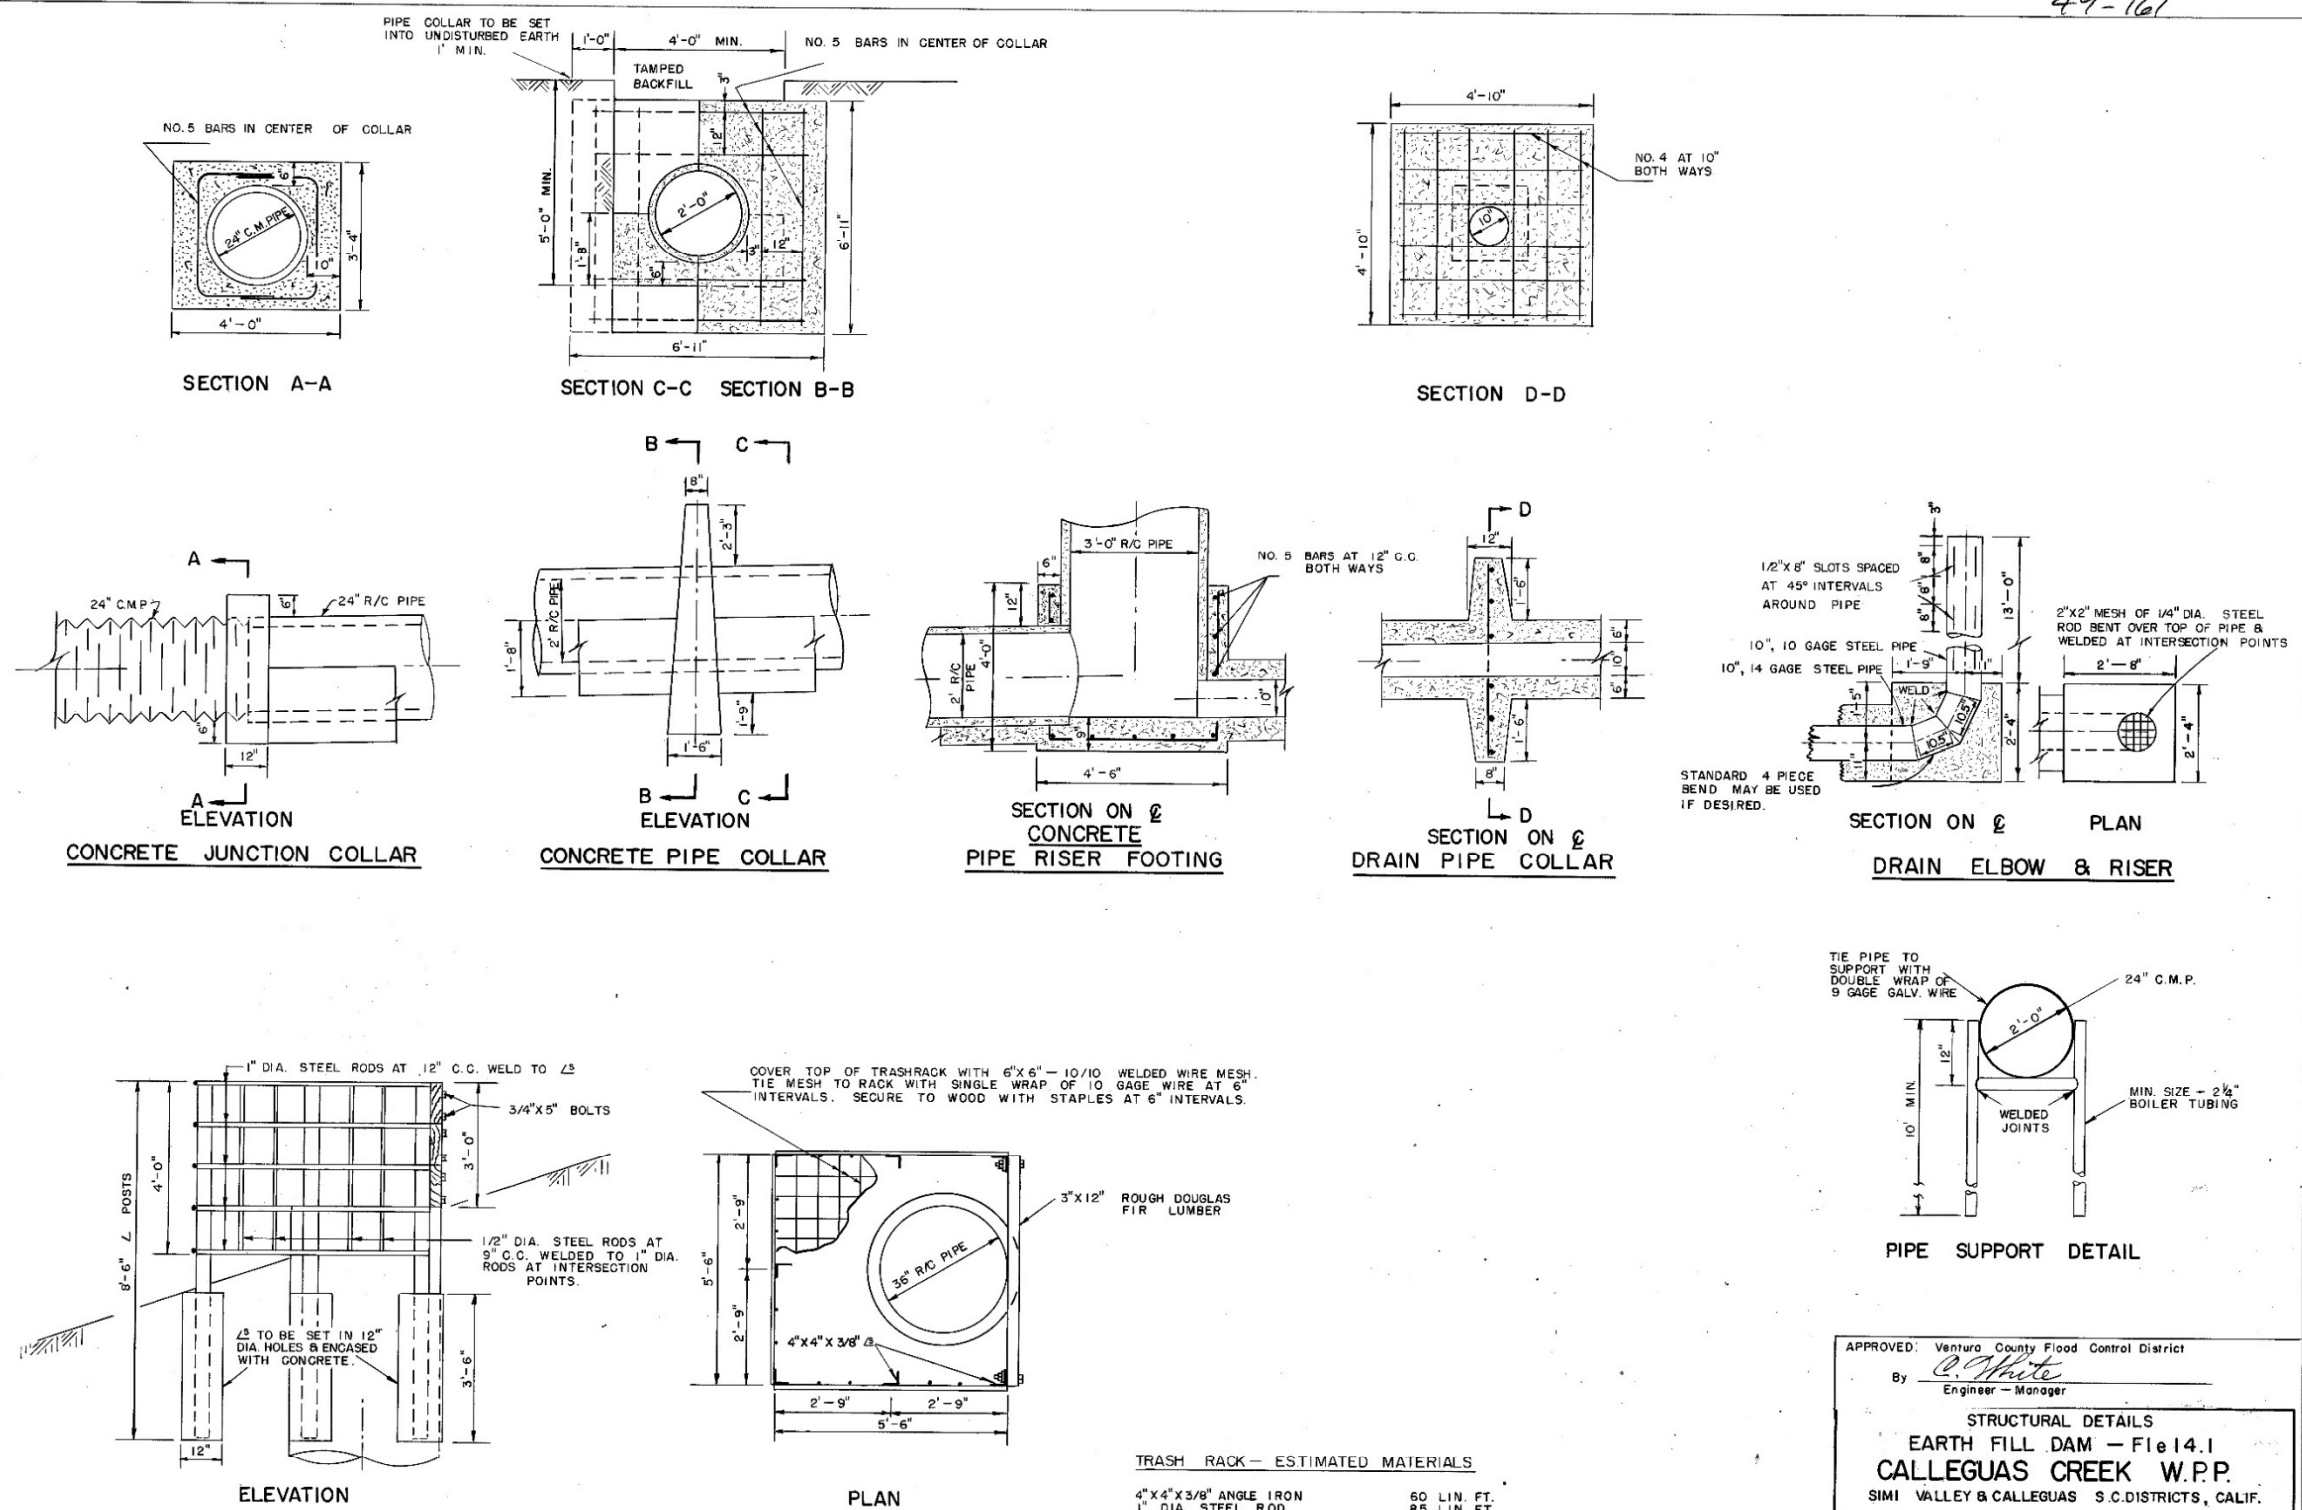
TRASH RACK - ESTIMATED MATERIALS

4" X 4" X 3/8" ANGLE IRON	60 LIN. FT.
1" DIA. STEEL ROD	85 LIN. FT.
1/2" DIA. STEEL ROD	48 LIN. FT.
3/4" X 5" BOLTS WITH WASHERS	12 EACH
3" X 12" D.F. LUMBER	50 BD. FT.
CONCRETE	10 CU. YD.
6" X 6" - 10/10 WELDED WIRE MESH	36 SQ. FT.

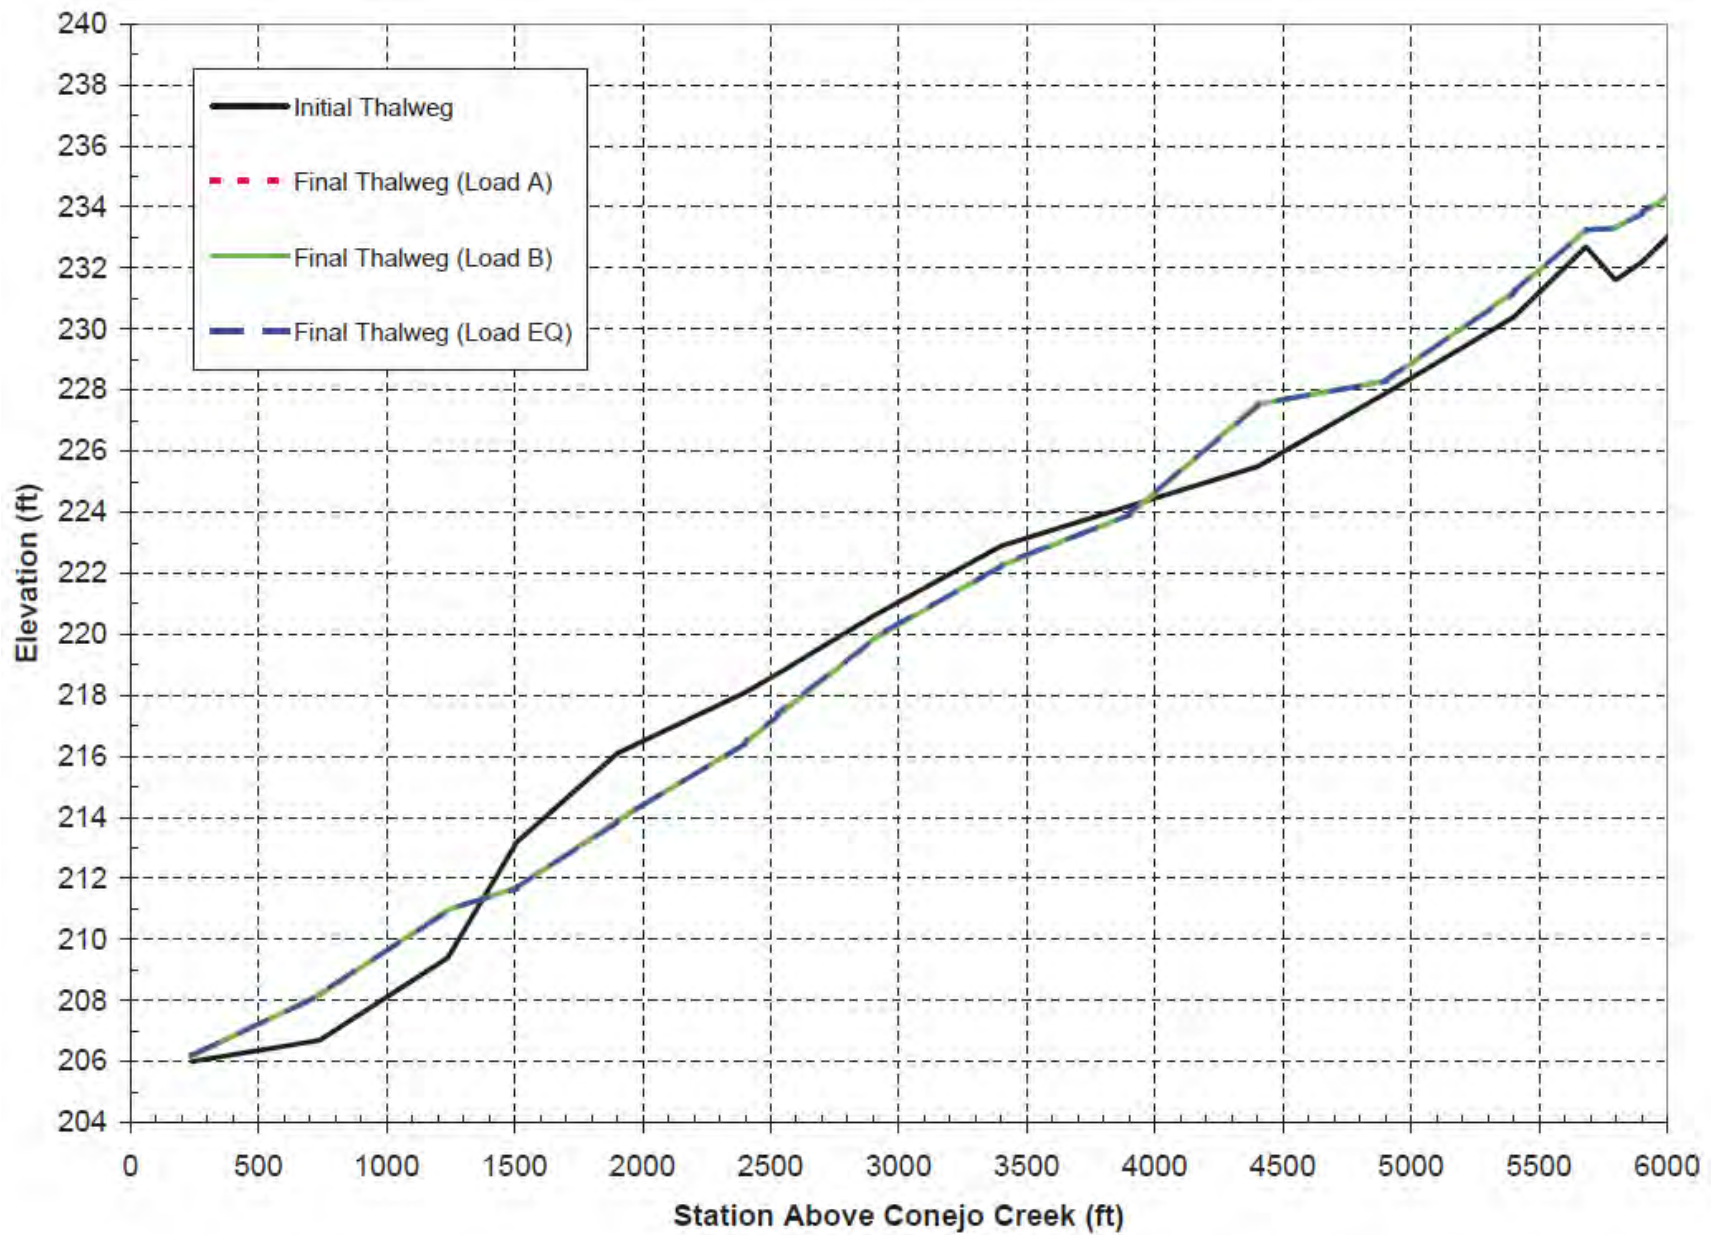
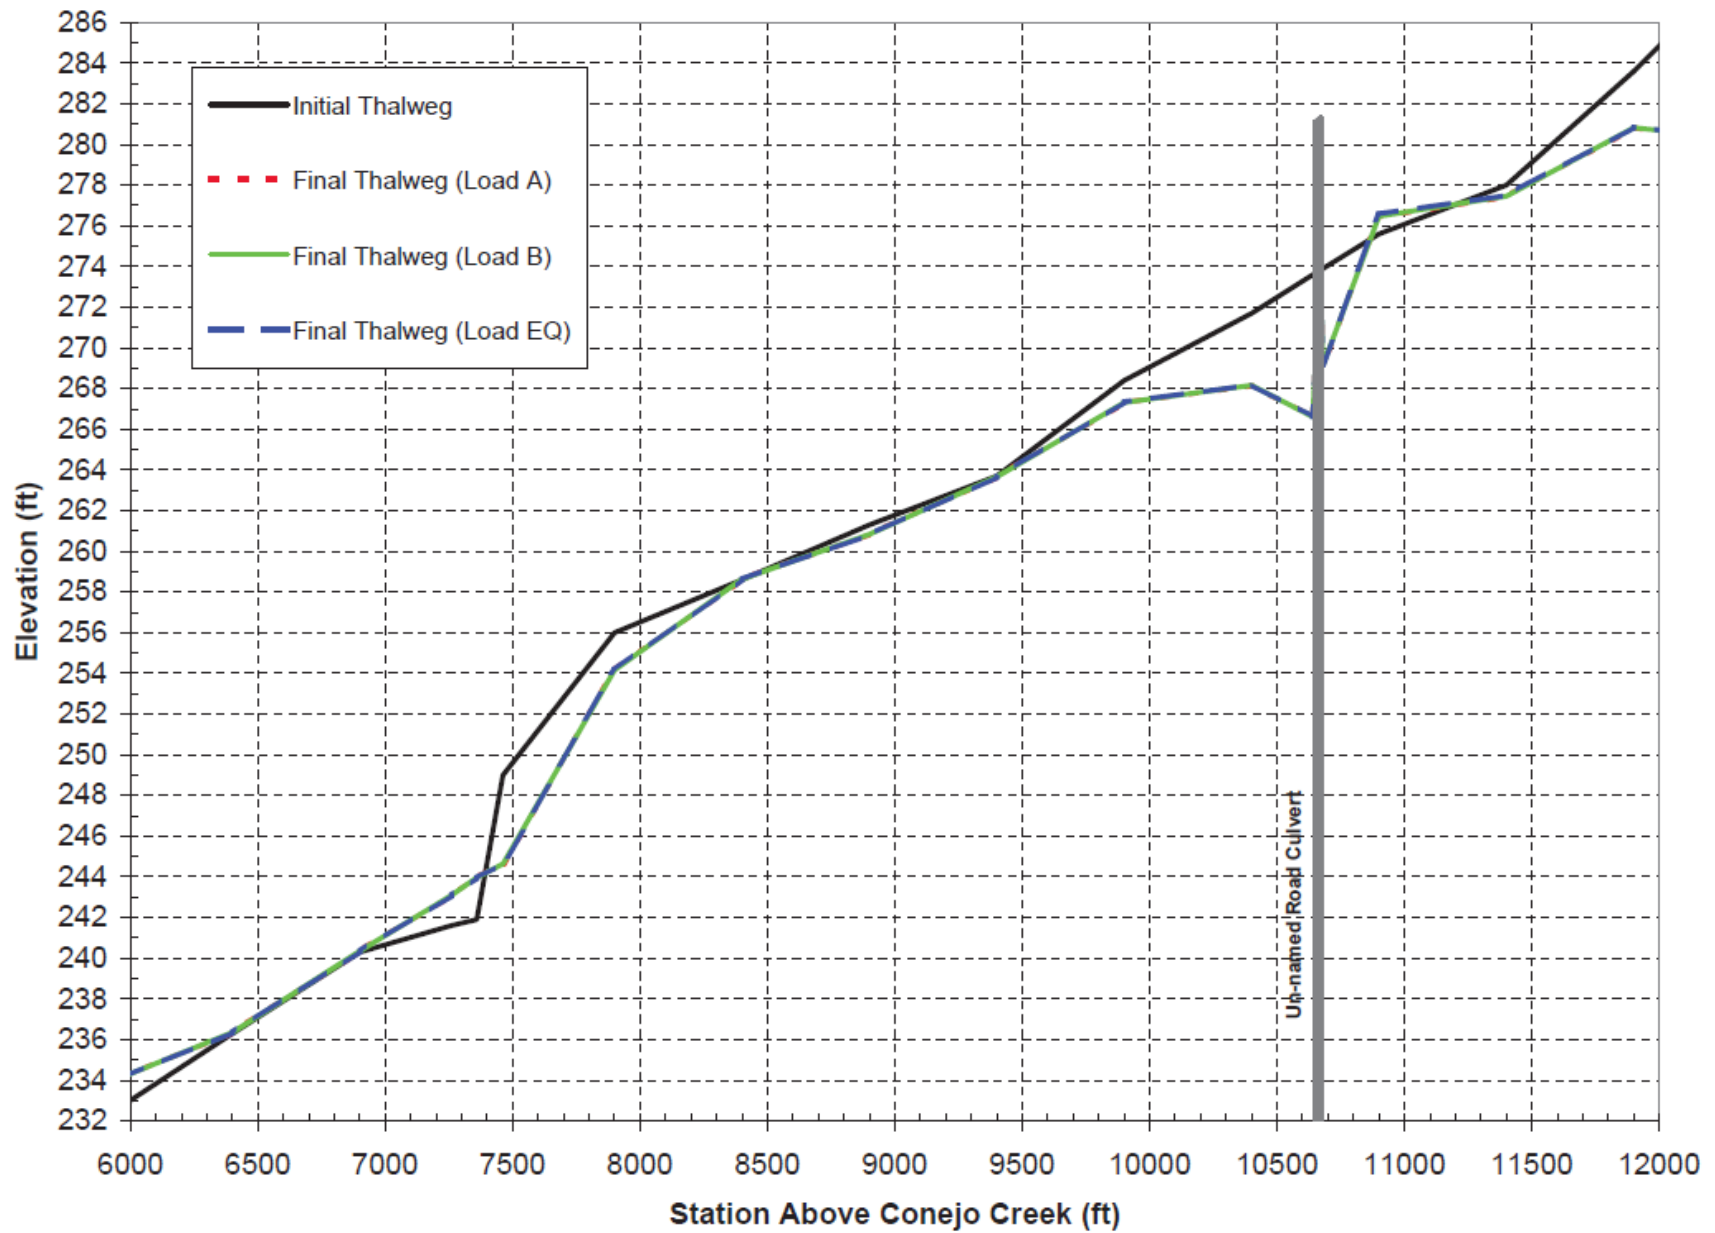
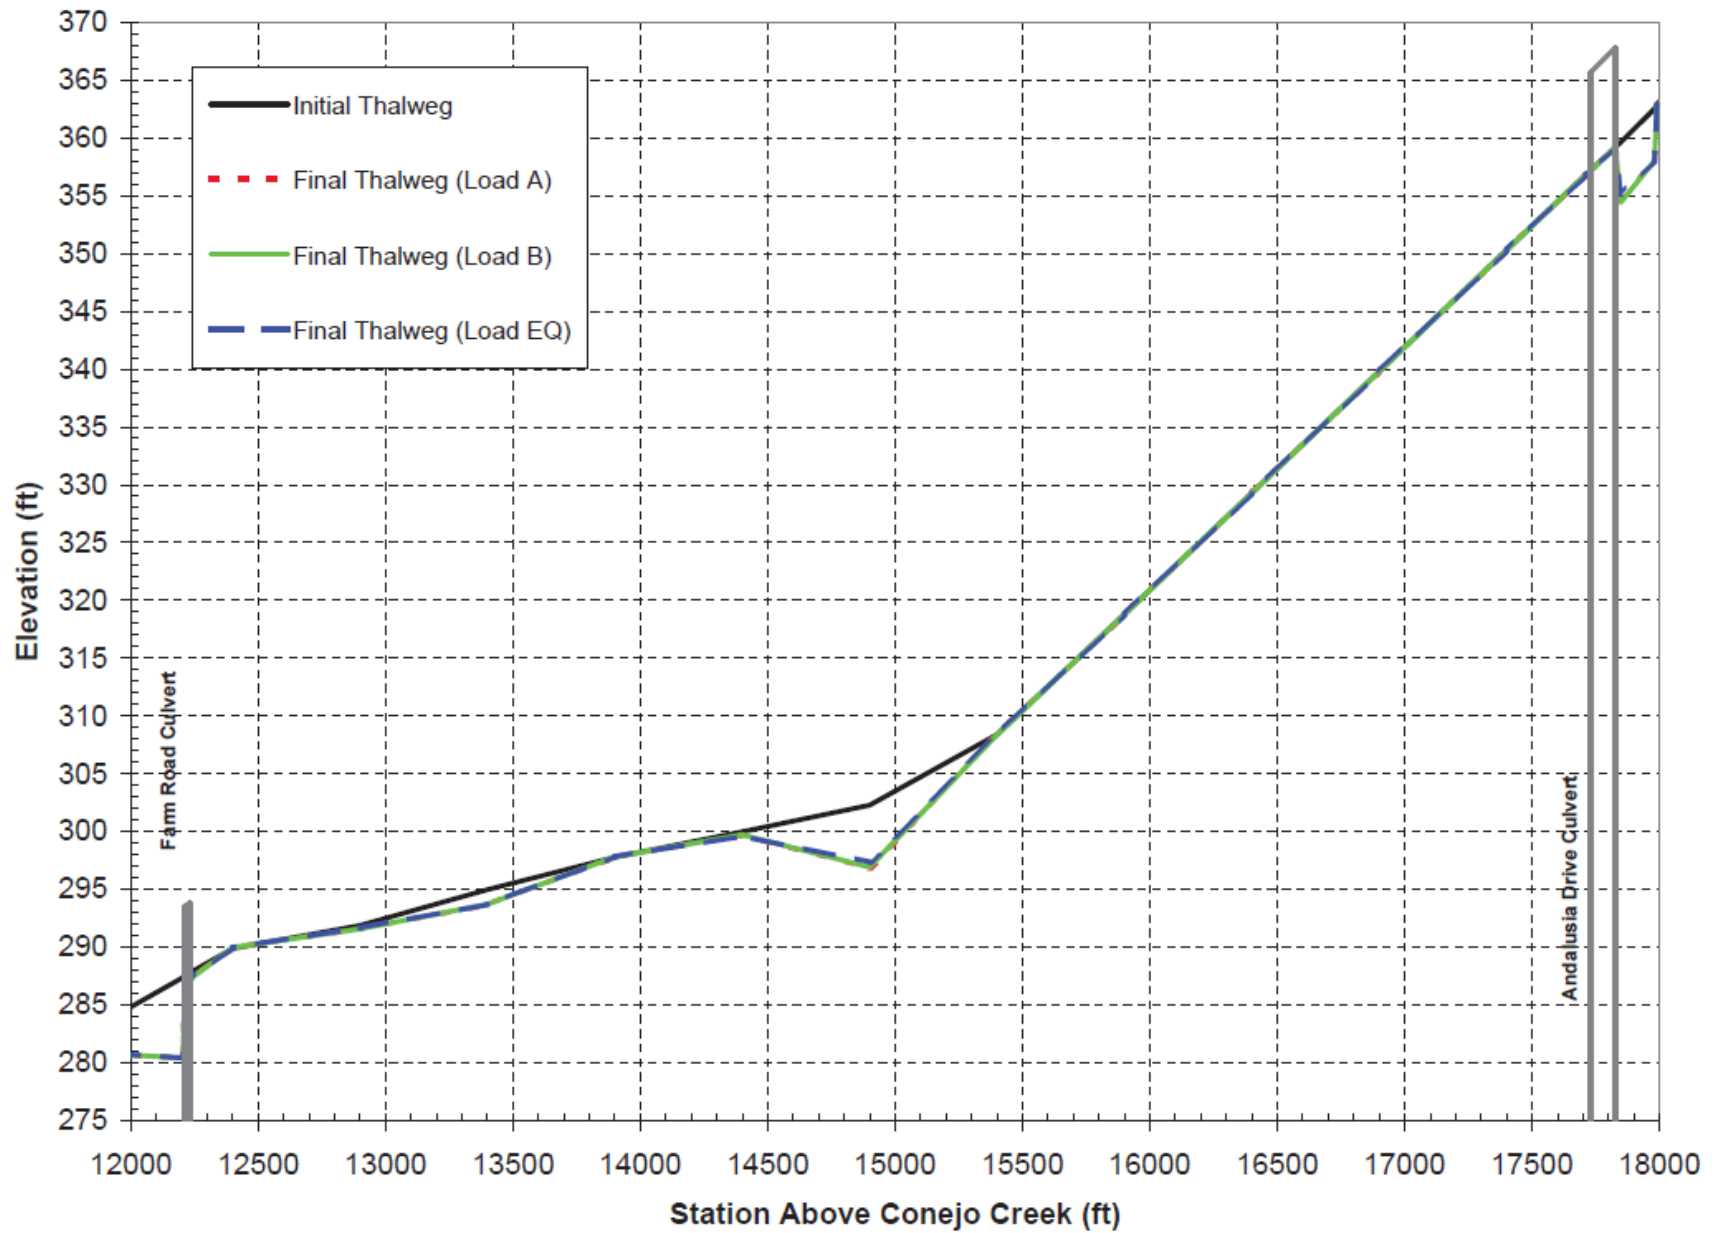
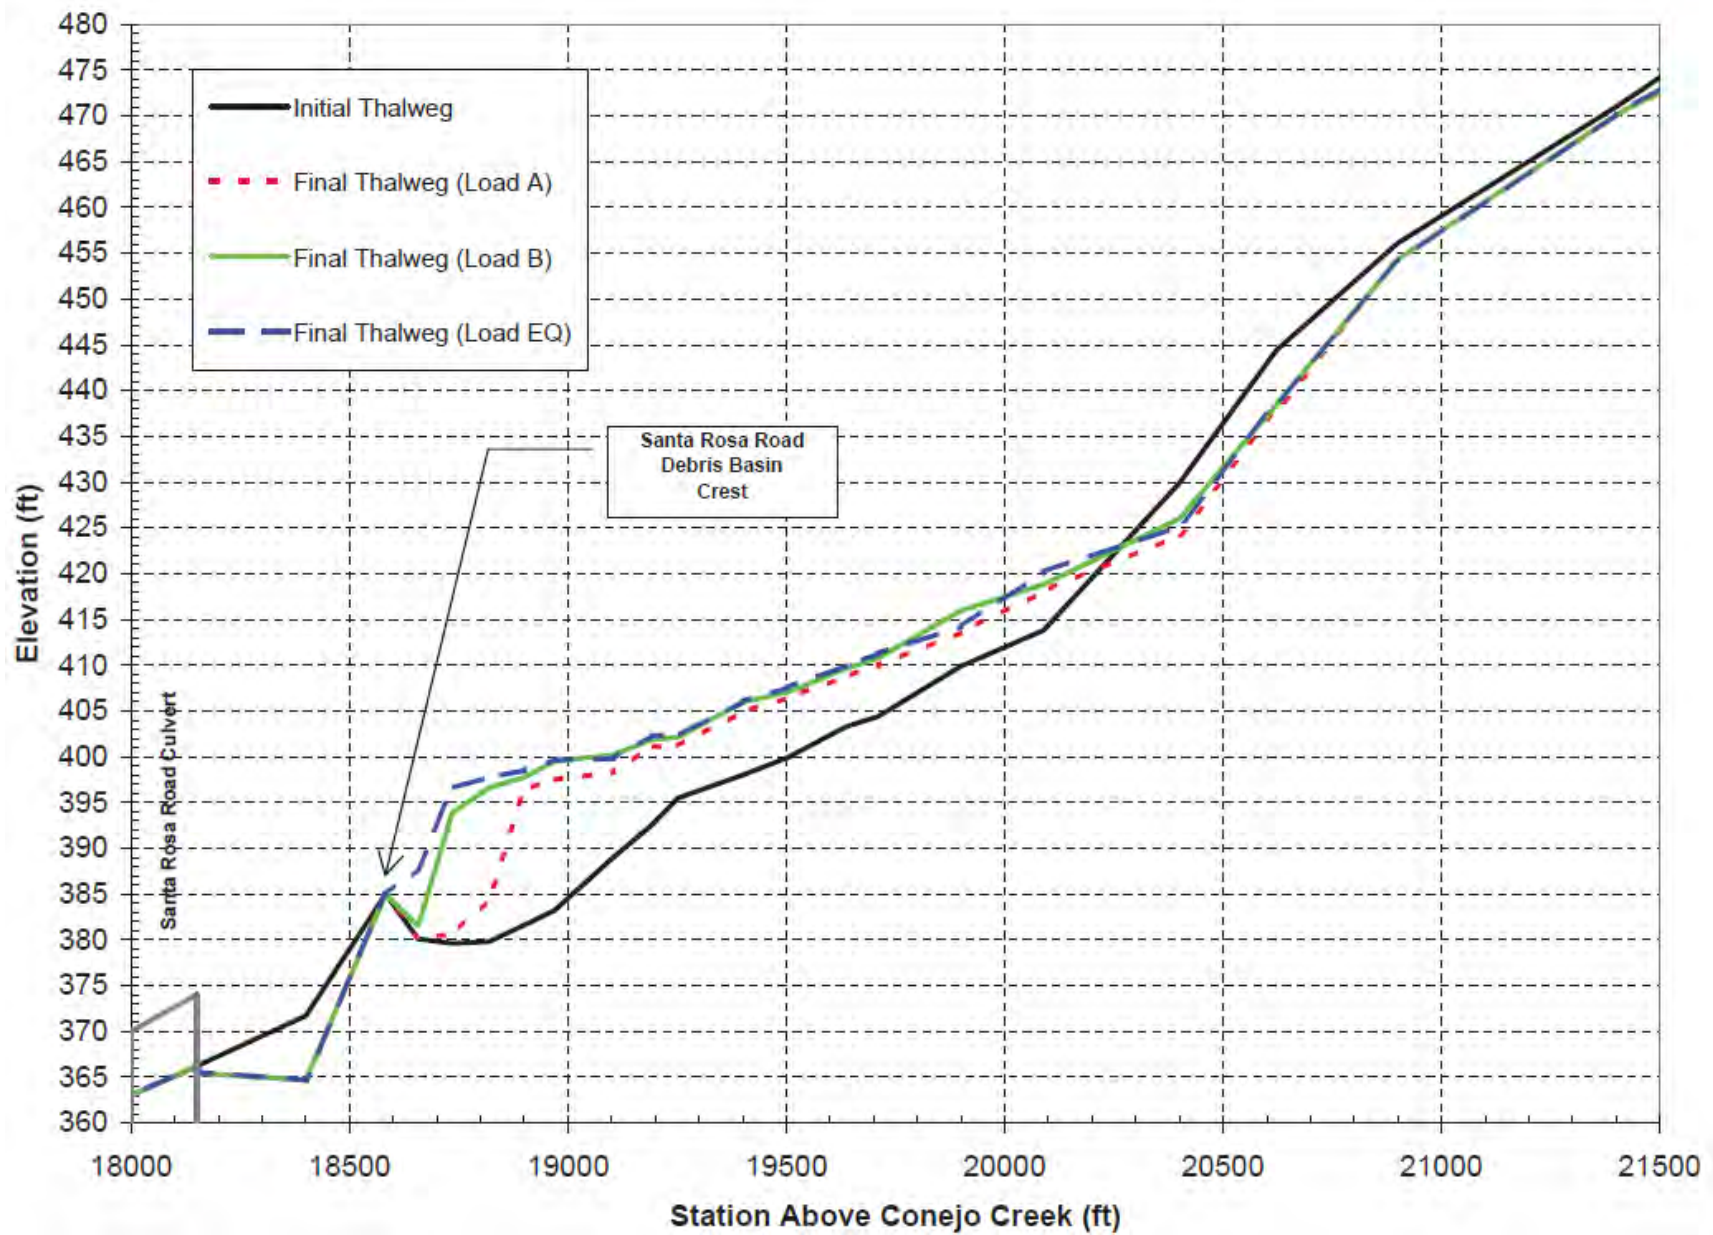
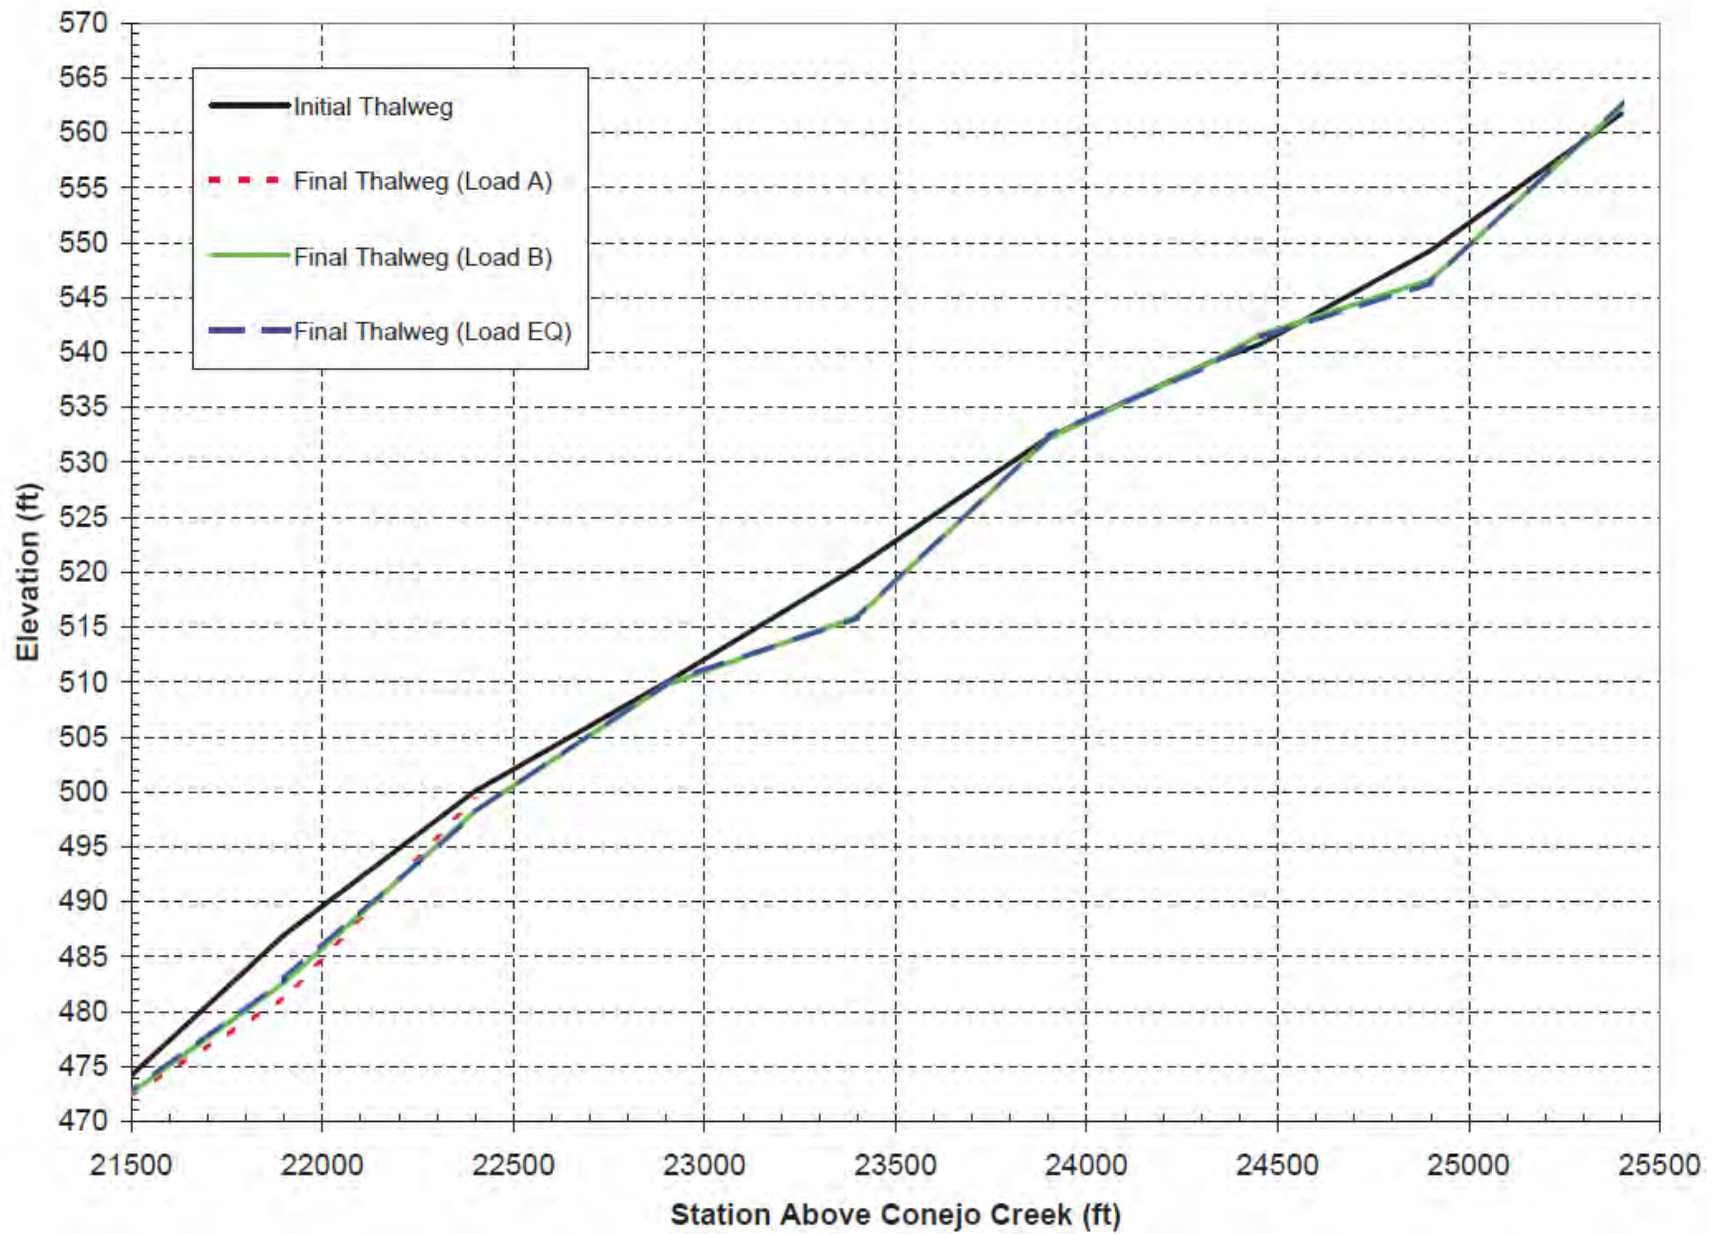
Figure E-1A. Santa Rosa Basin Existing Conditions Invert Profile – Initial and Final Conditions.

The WEST Consultants (2007) study included a sediment transport analysis downstream of the basin. There were three assumed sediment loads under existing conditions and under a proposed “Basin Removal” condition. Results indicated basin removal could be beneficial as minor erosion immediately downstream of the basin had been observed. In addition, the downstream receiving stream, Conejo Creek, is erosive downstream of its confluence with Santa Rosa Creek and could benefit from an increased sediment supply. Sediment modeling result profiles are located in Appendix E.
