SANTA ROSA ROAD DEBRIS BASIN No. 2
DEBRIS BASIN MODIFICATION
PRELIMINARY DESIGN STUDY
JUNE 2016

Santa Rosa Road Debris Basin No. 2

Debris Basin Modification

Preliminary Design Study

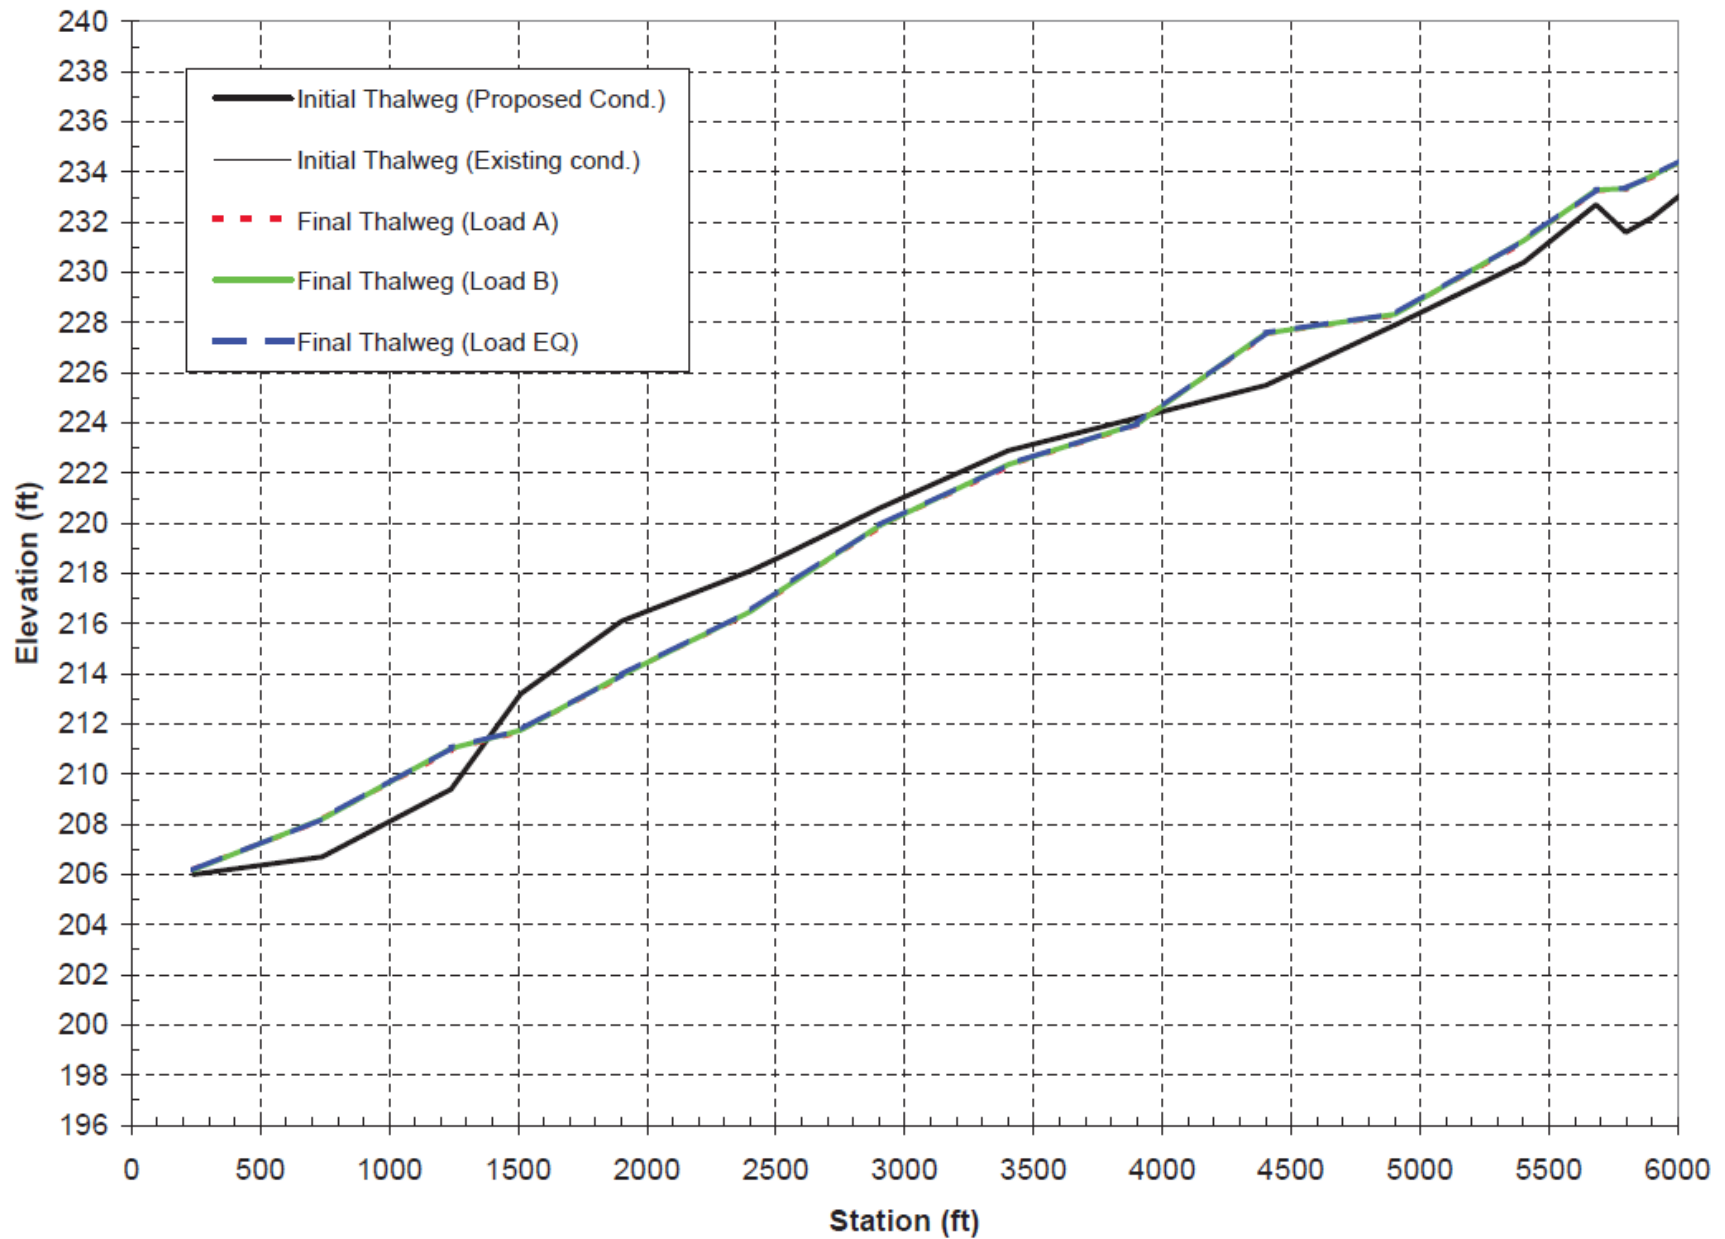
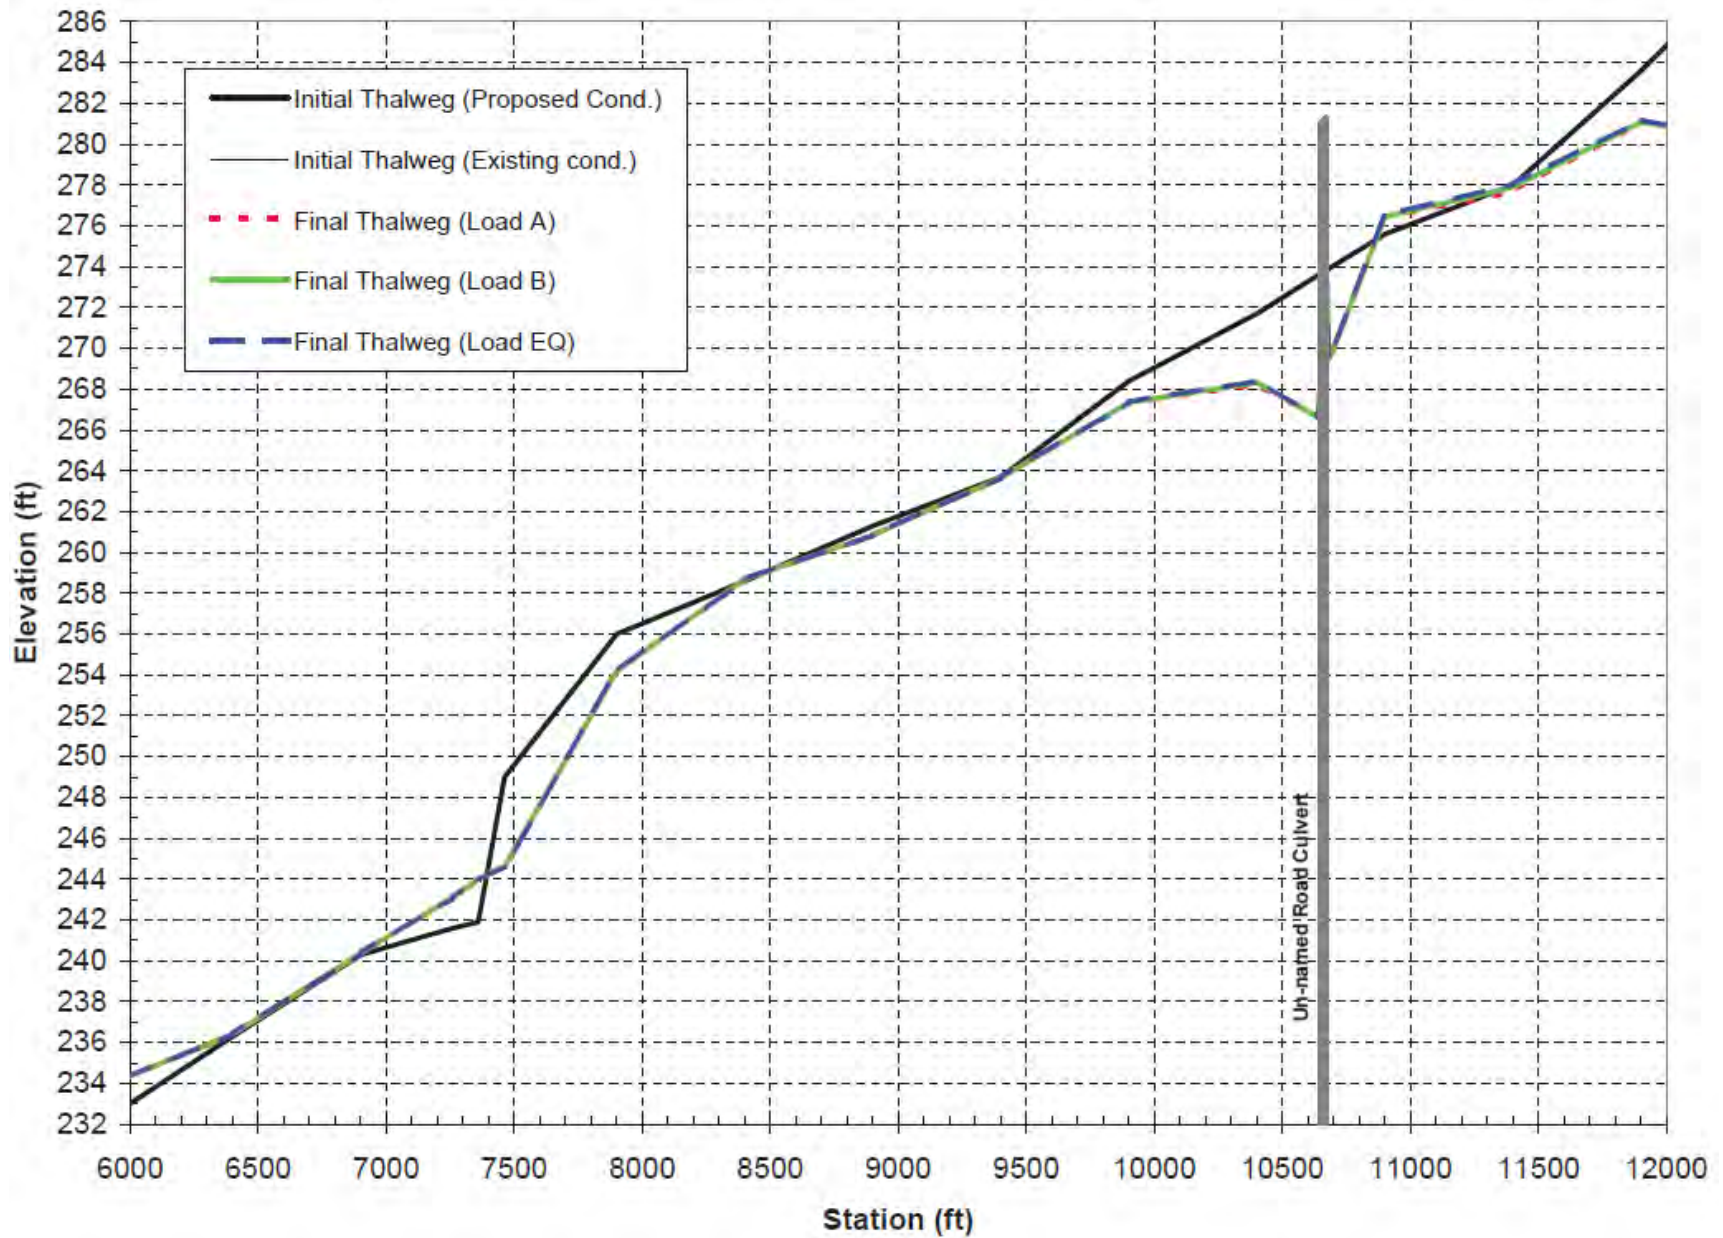
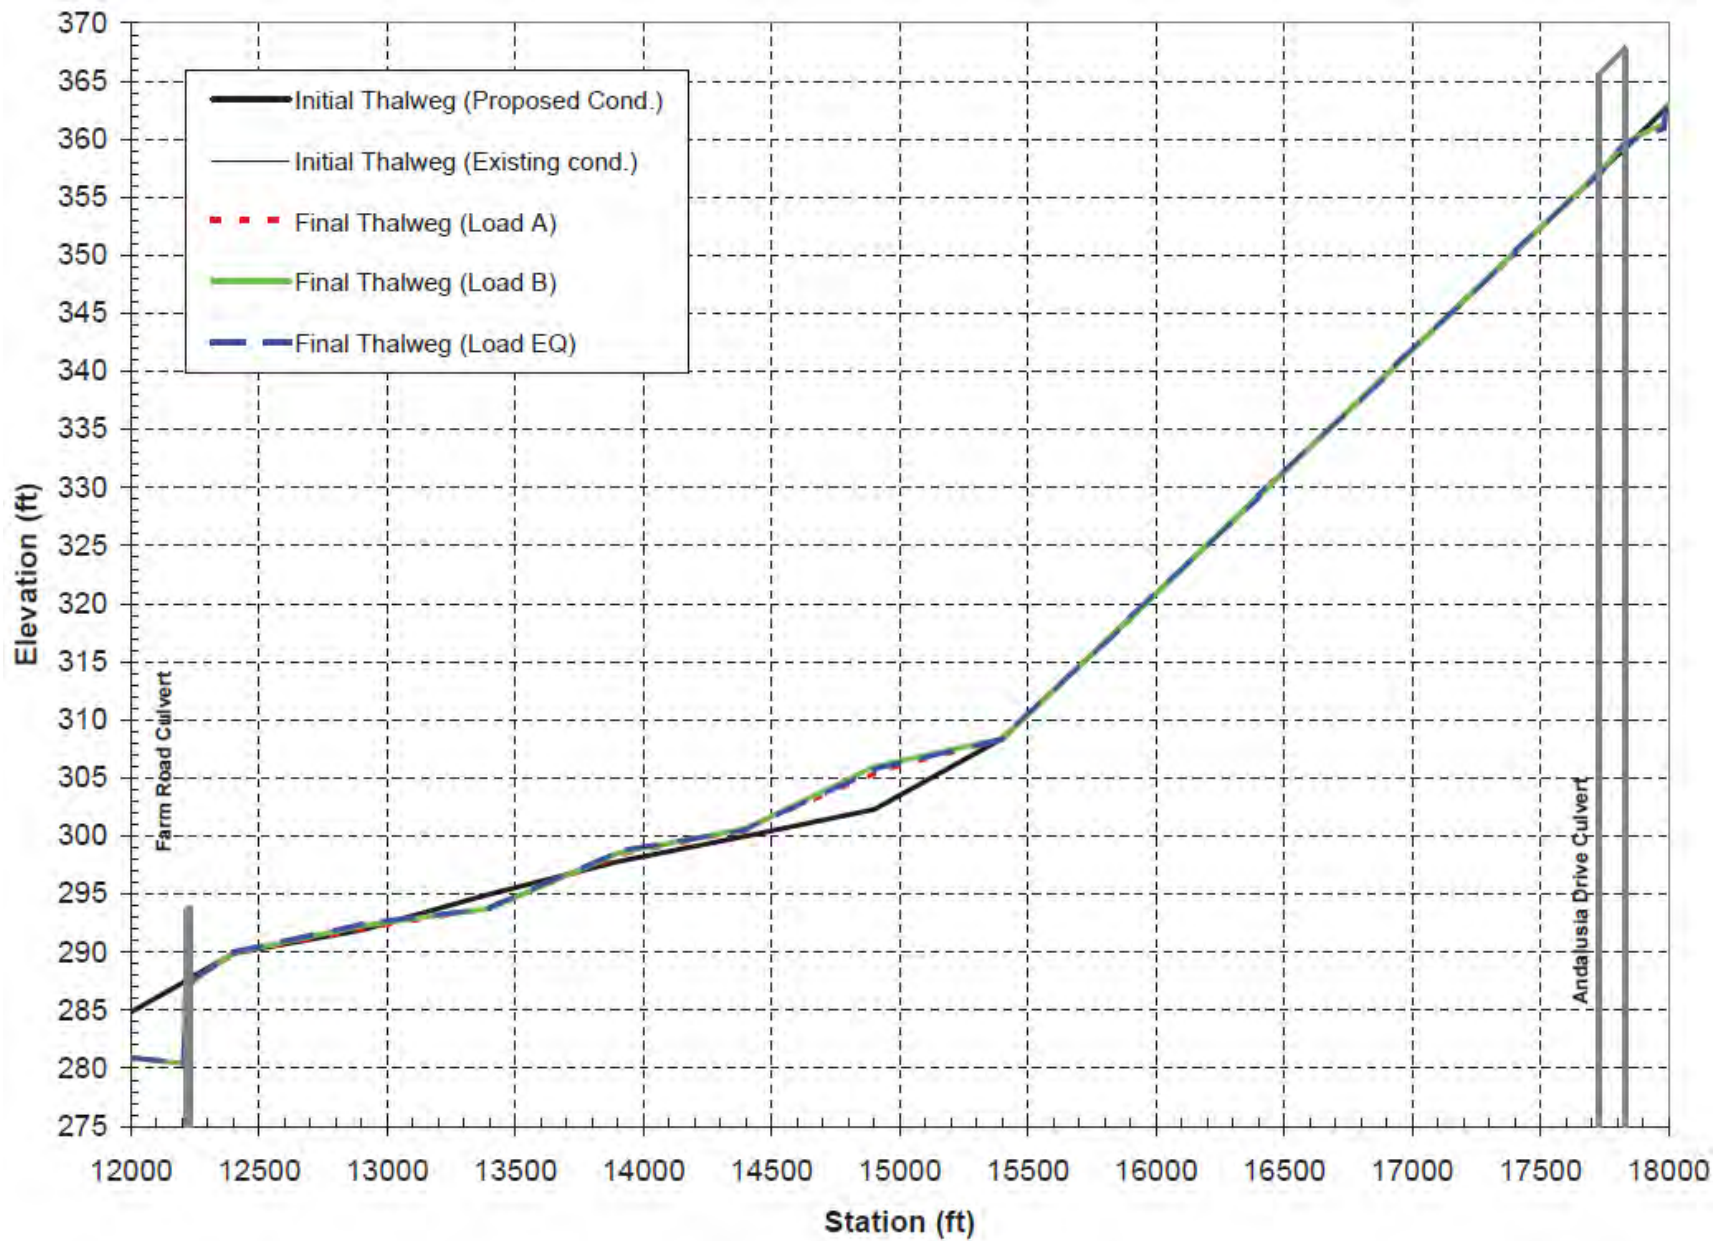
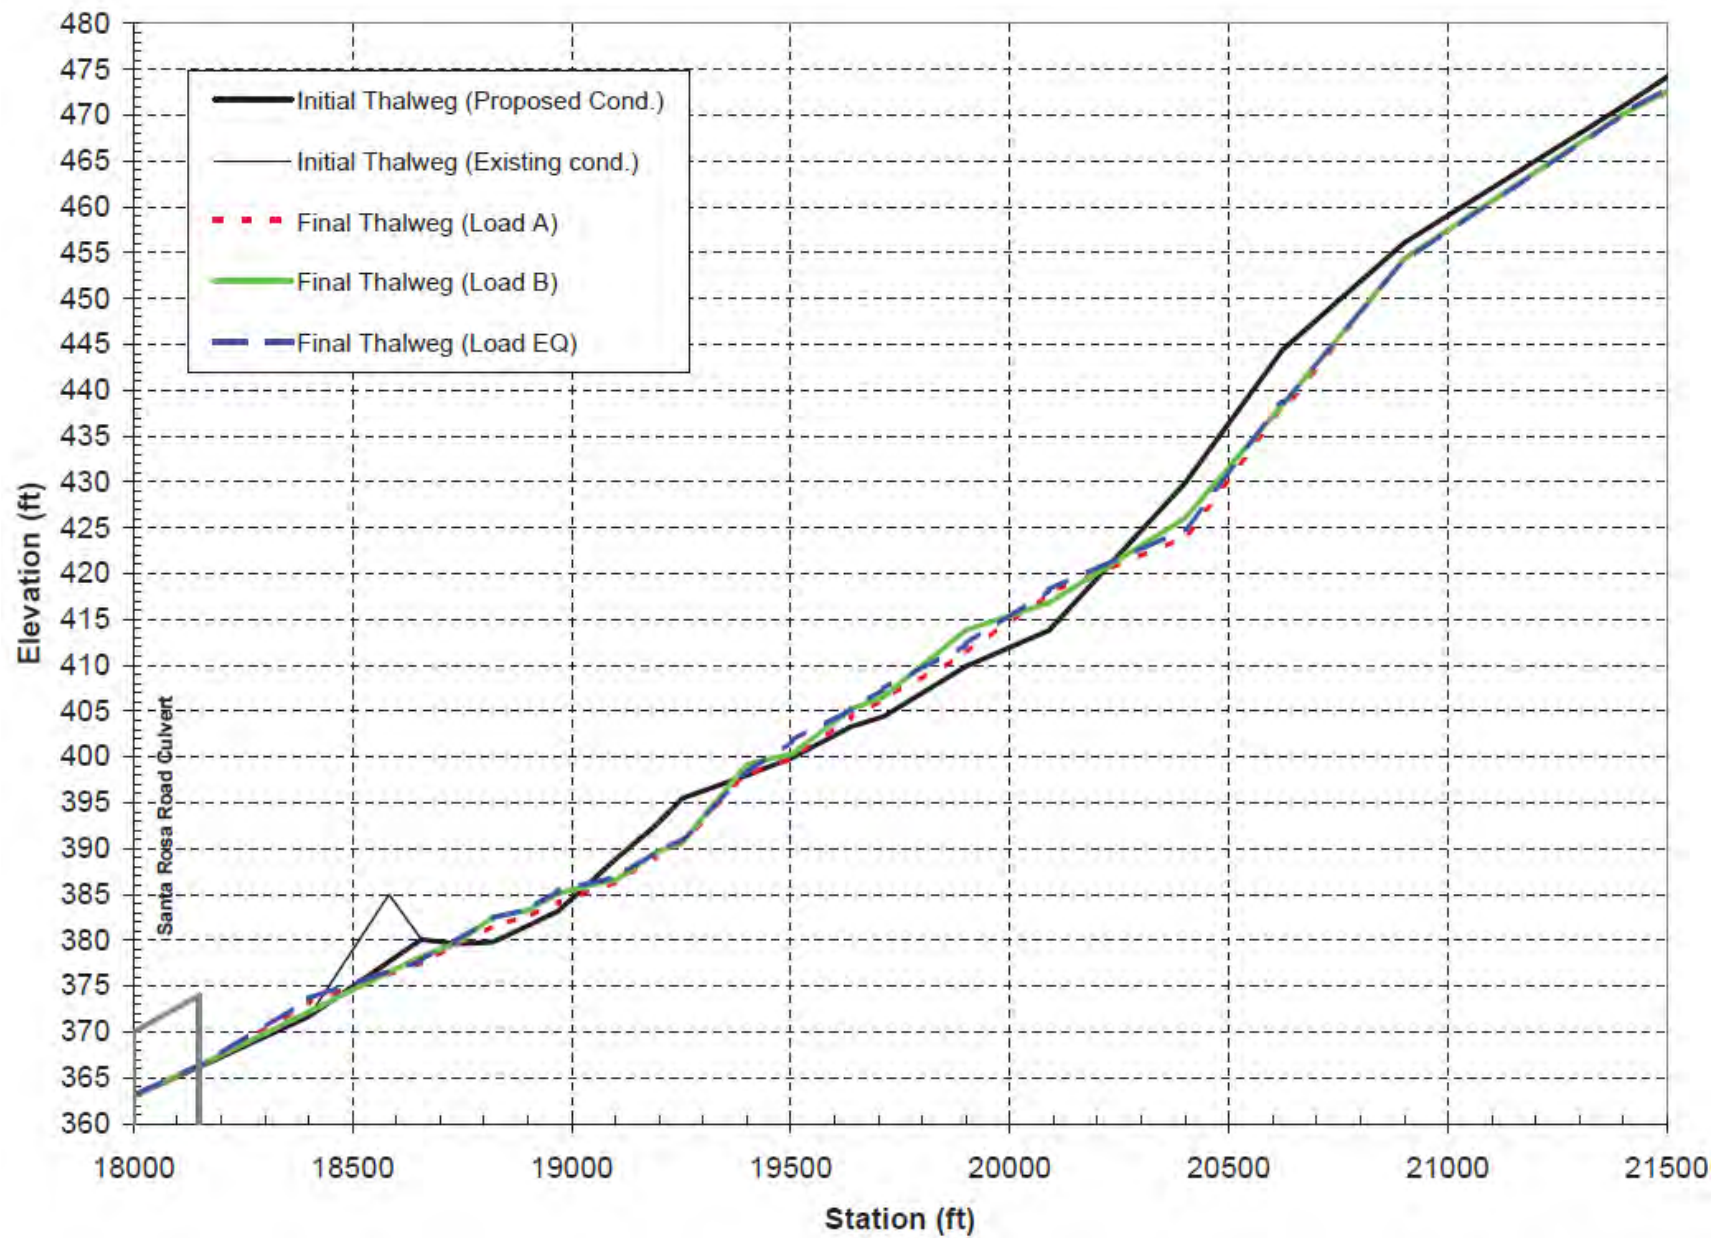
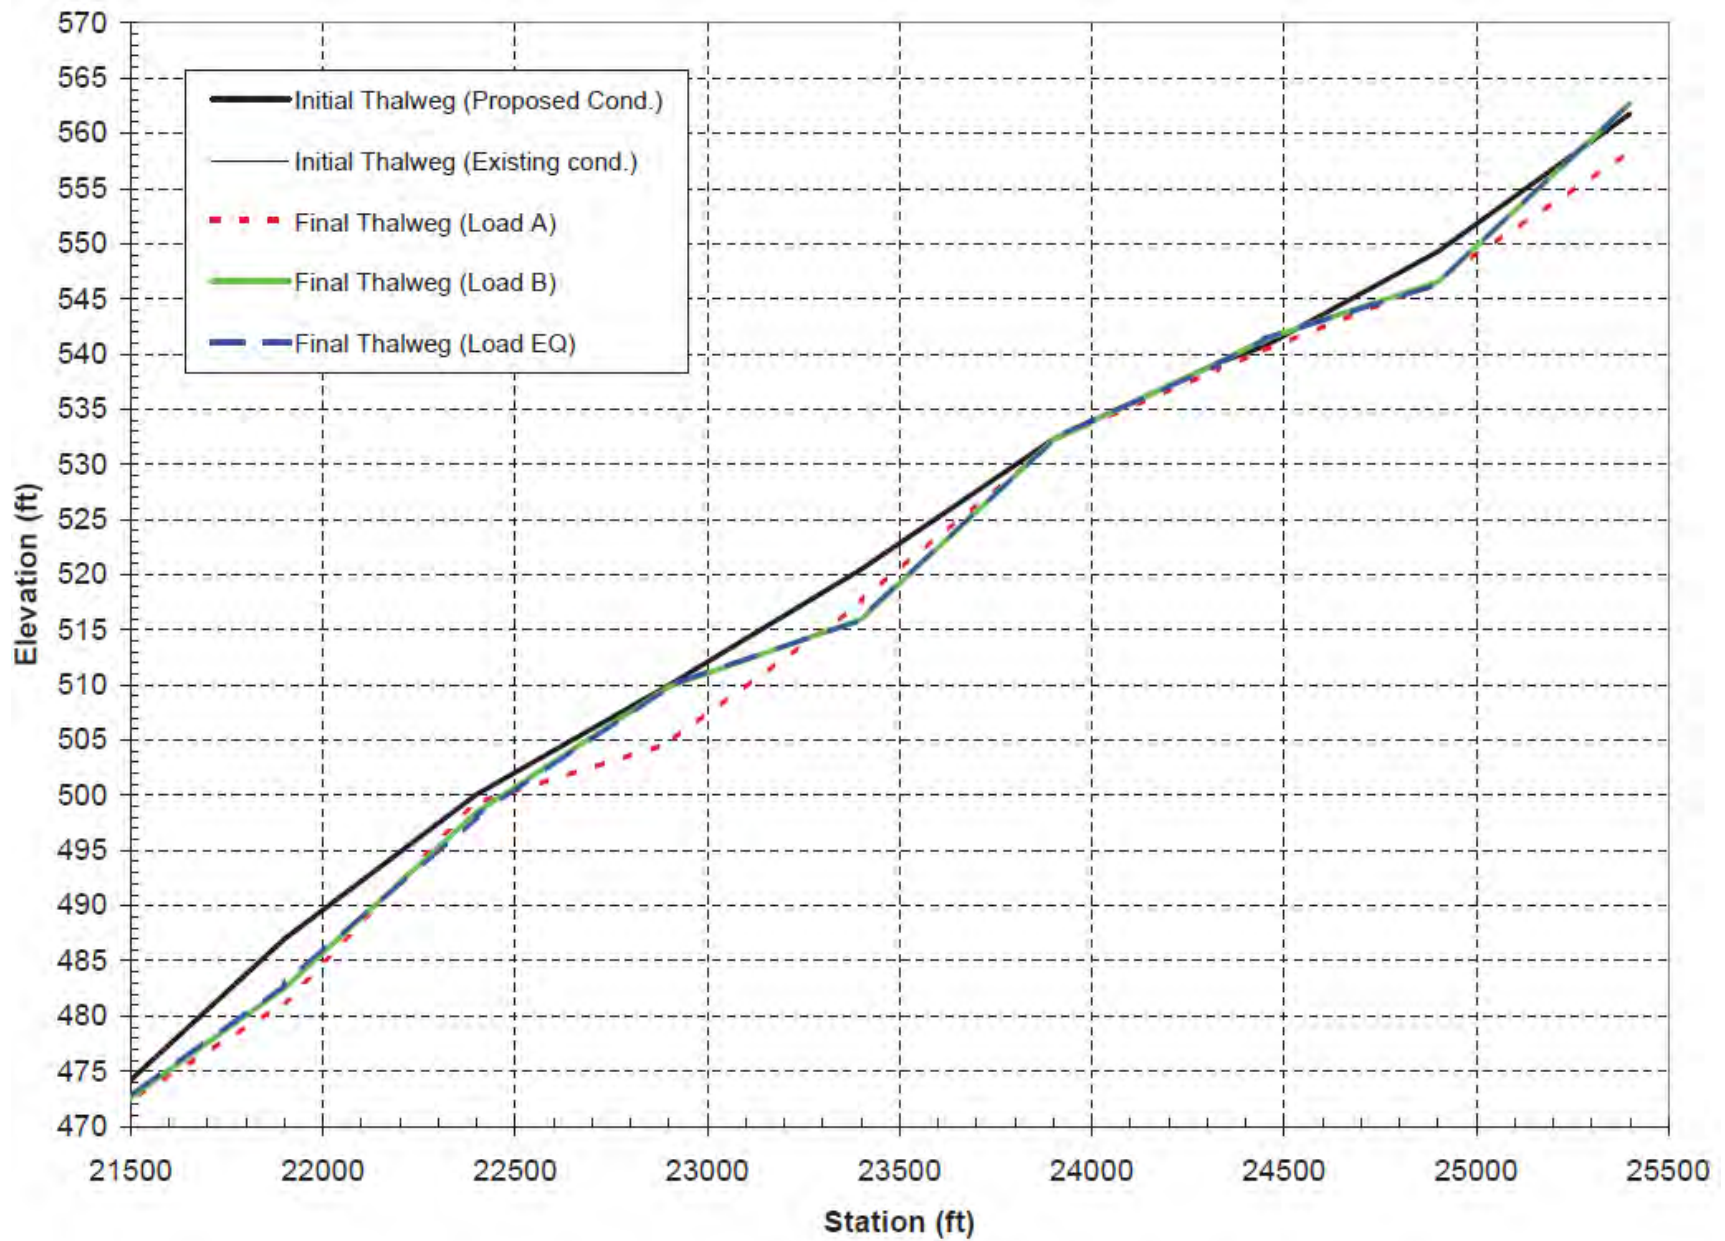
Figure E-2A. Santa Rosa Basin Proposed Conditions (Removal) Invert Profile – Initial and Final Conditions.

The WEST Consultants (2007) study included a sediment transport analysis downstream of the basin. There were three assumed sediment loads under existing conditions and under a proposed “Basin Removal” condition. Results indicated basin removal could be beneficial as minor erosion immediately downstream of the basin had been observed. In addition, the downstream receiving stream, Conejo Creek, is erosive downstream of its confluence with Santa Rosa Creek and could benefit from an increased sediment supply. Sediment modeling result profiles are located in Appendix E.

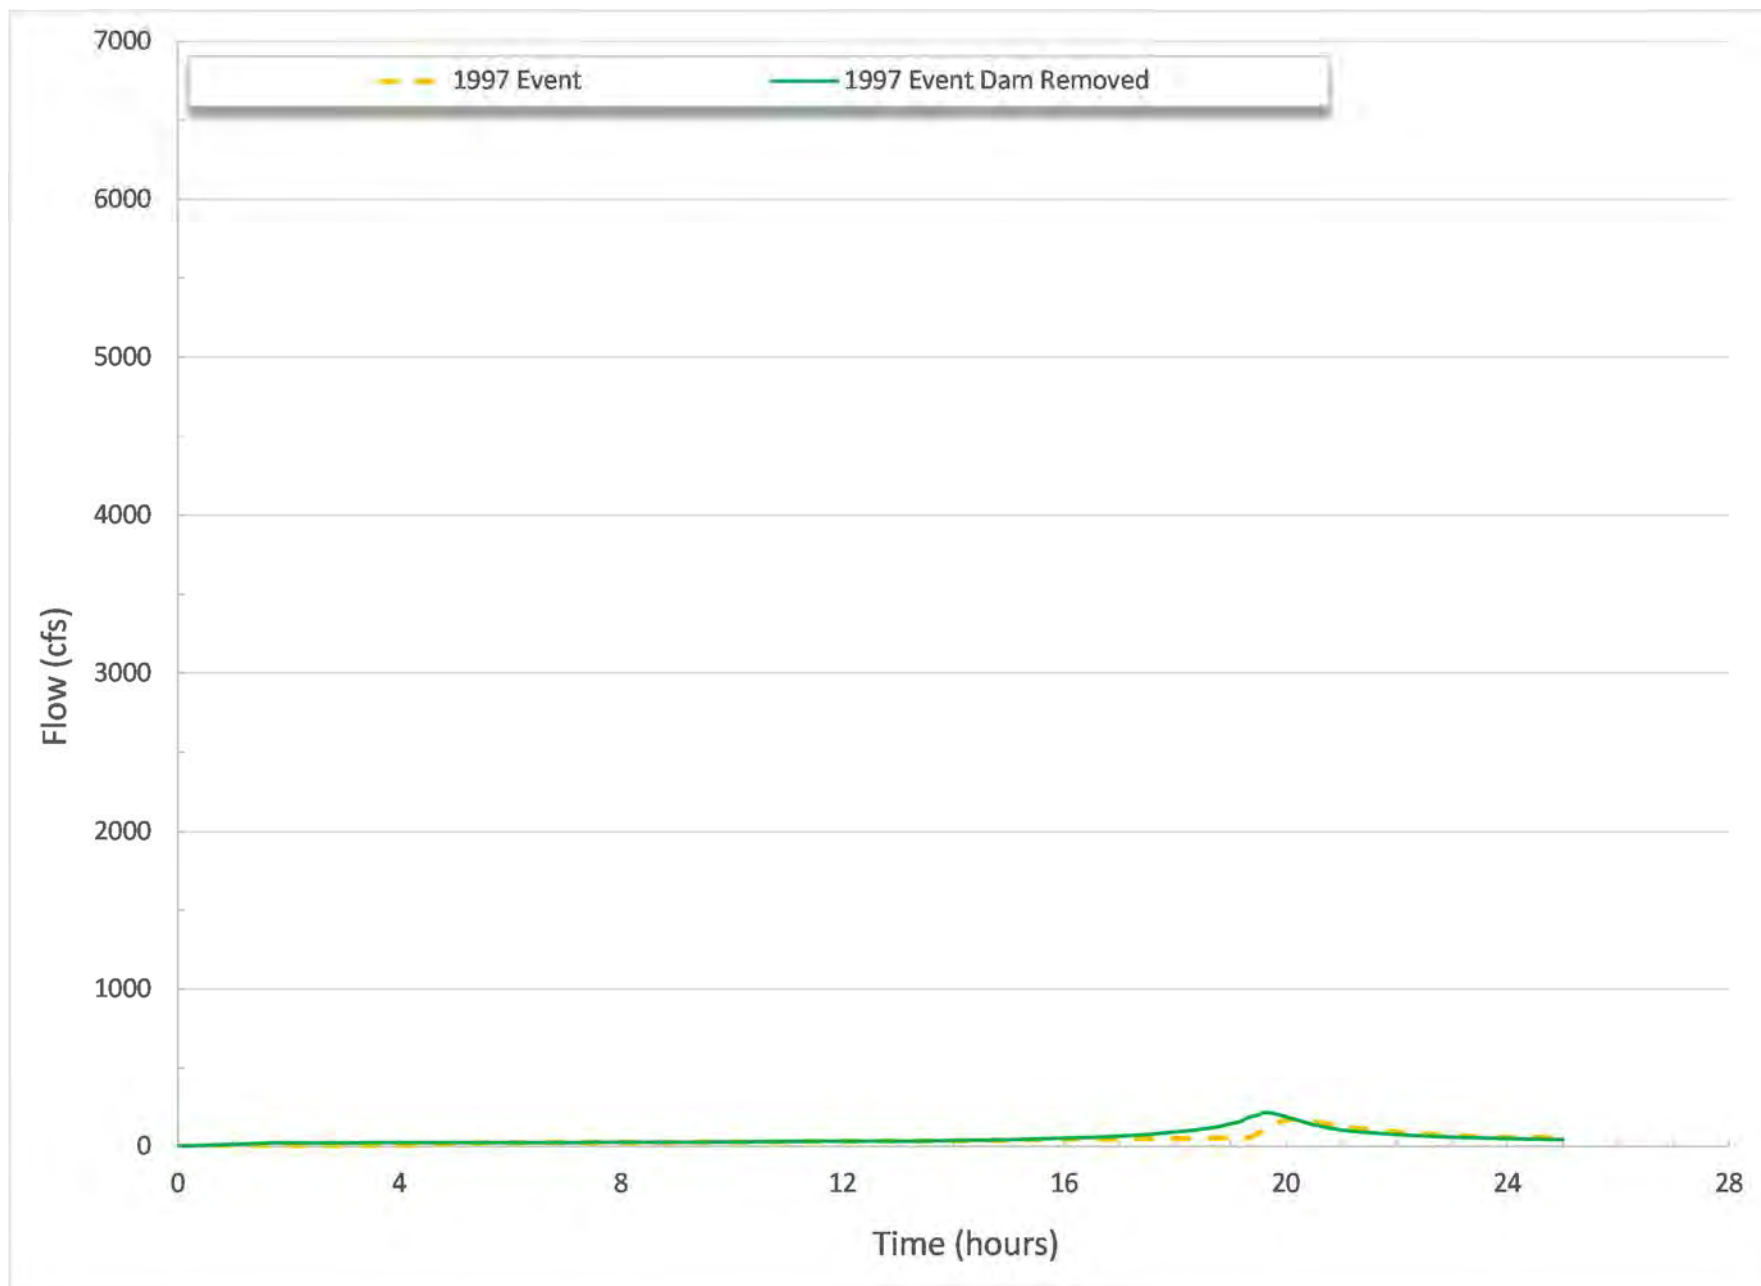
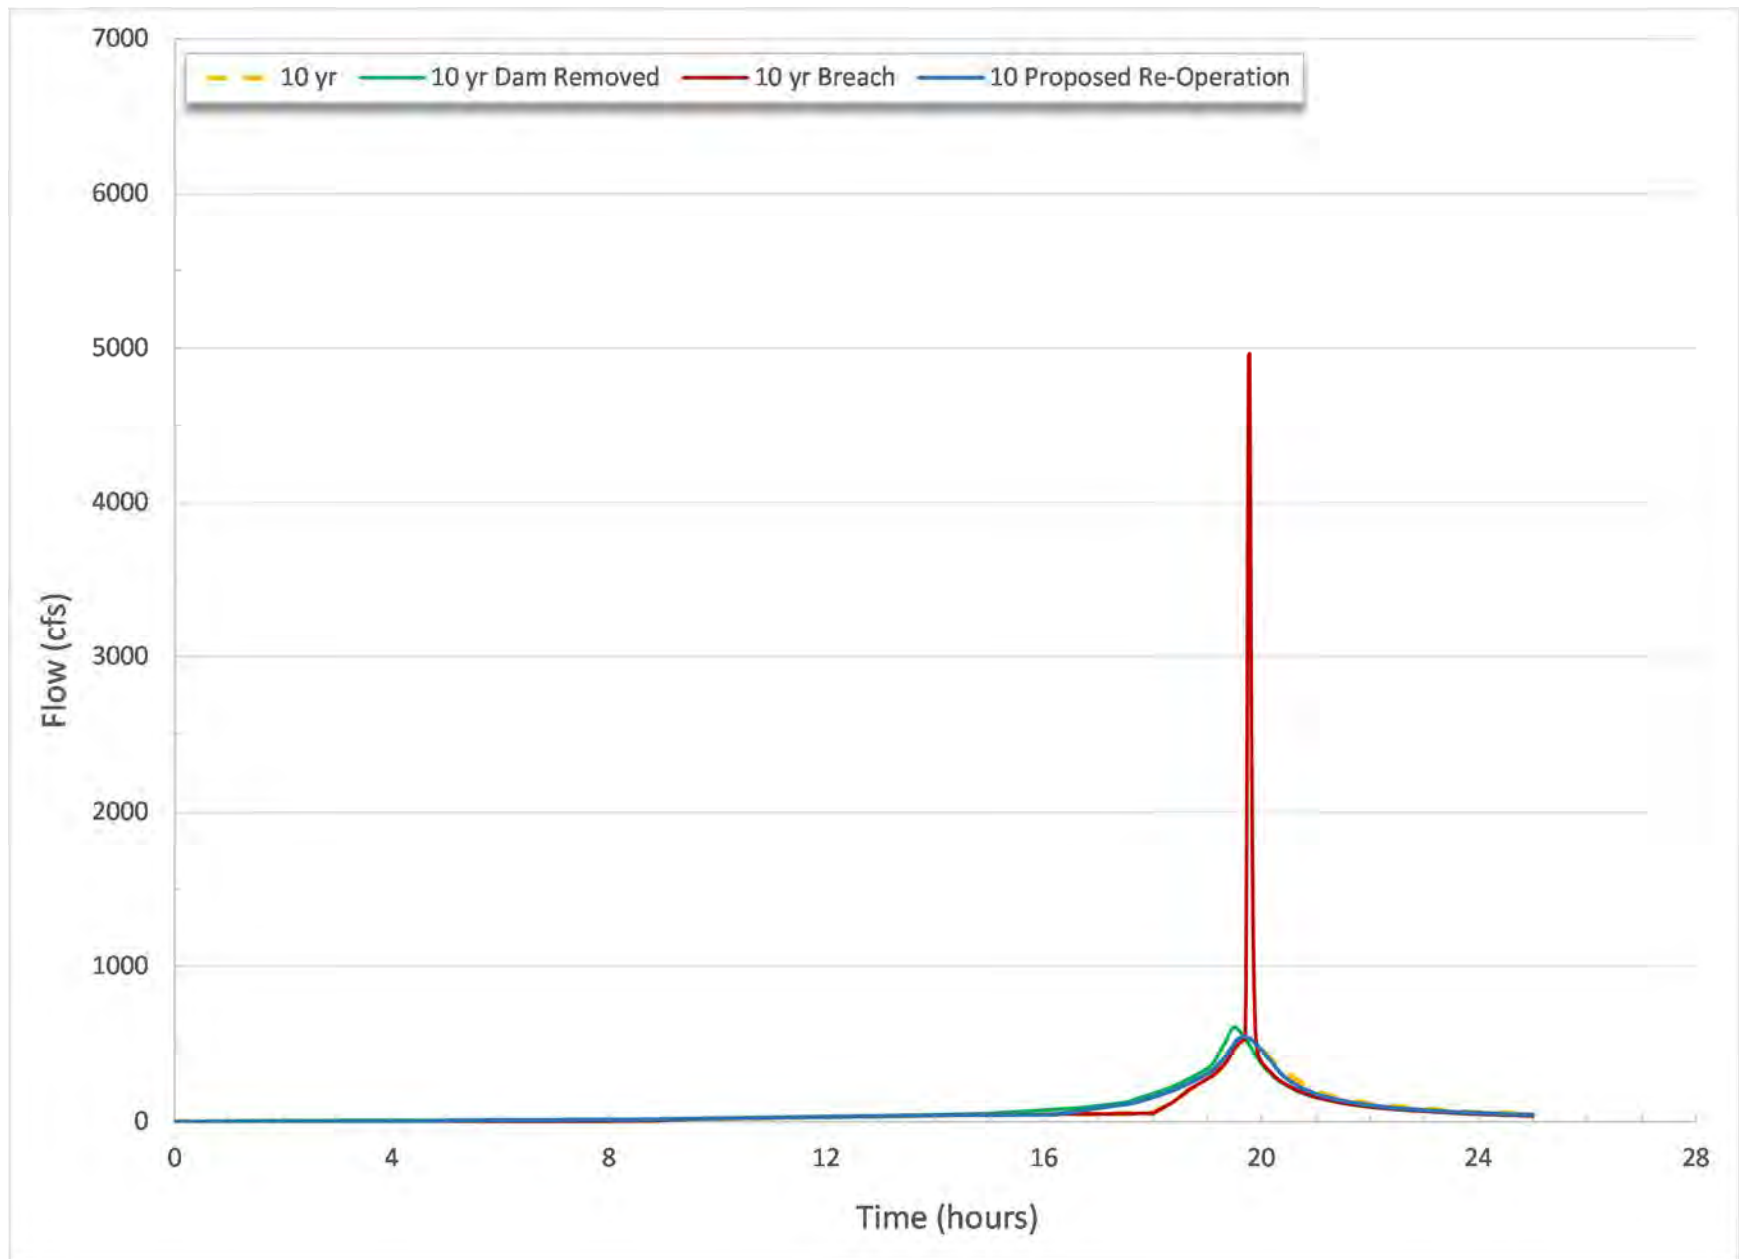
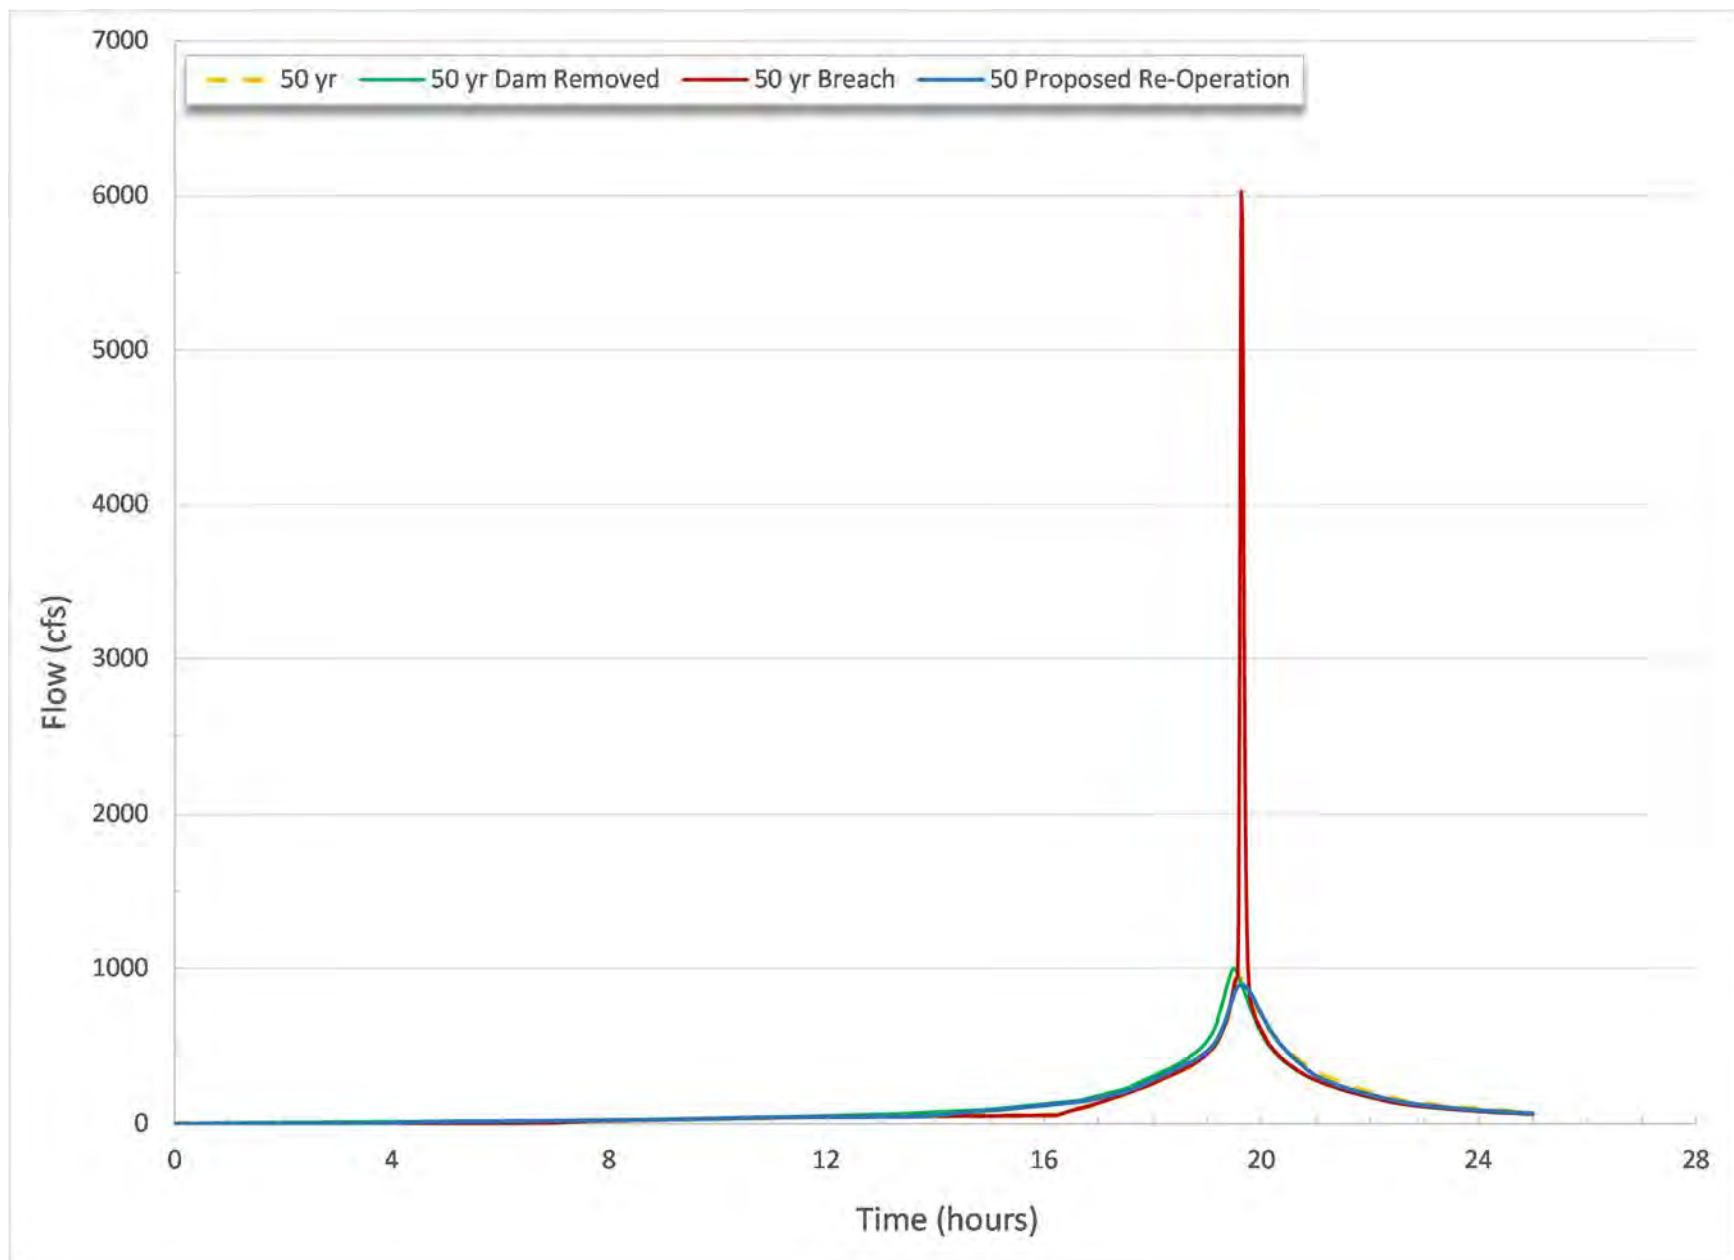
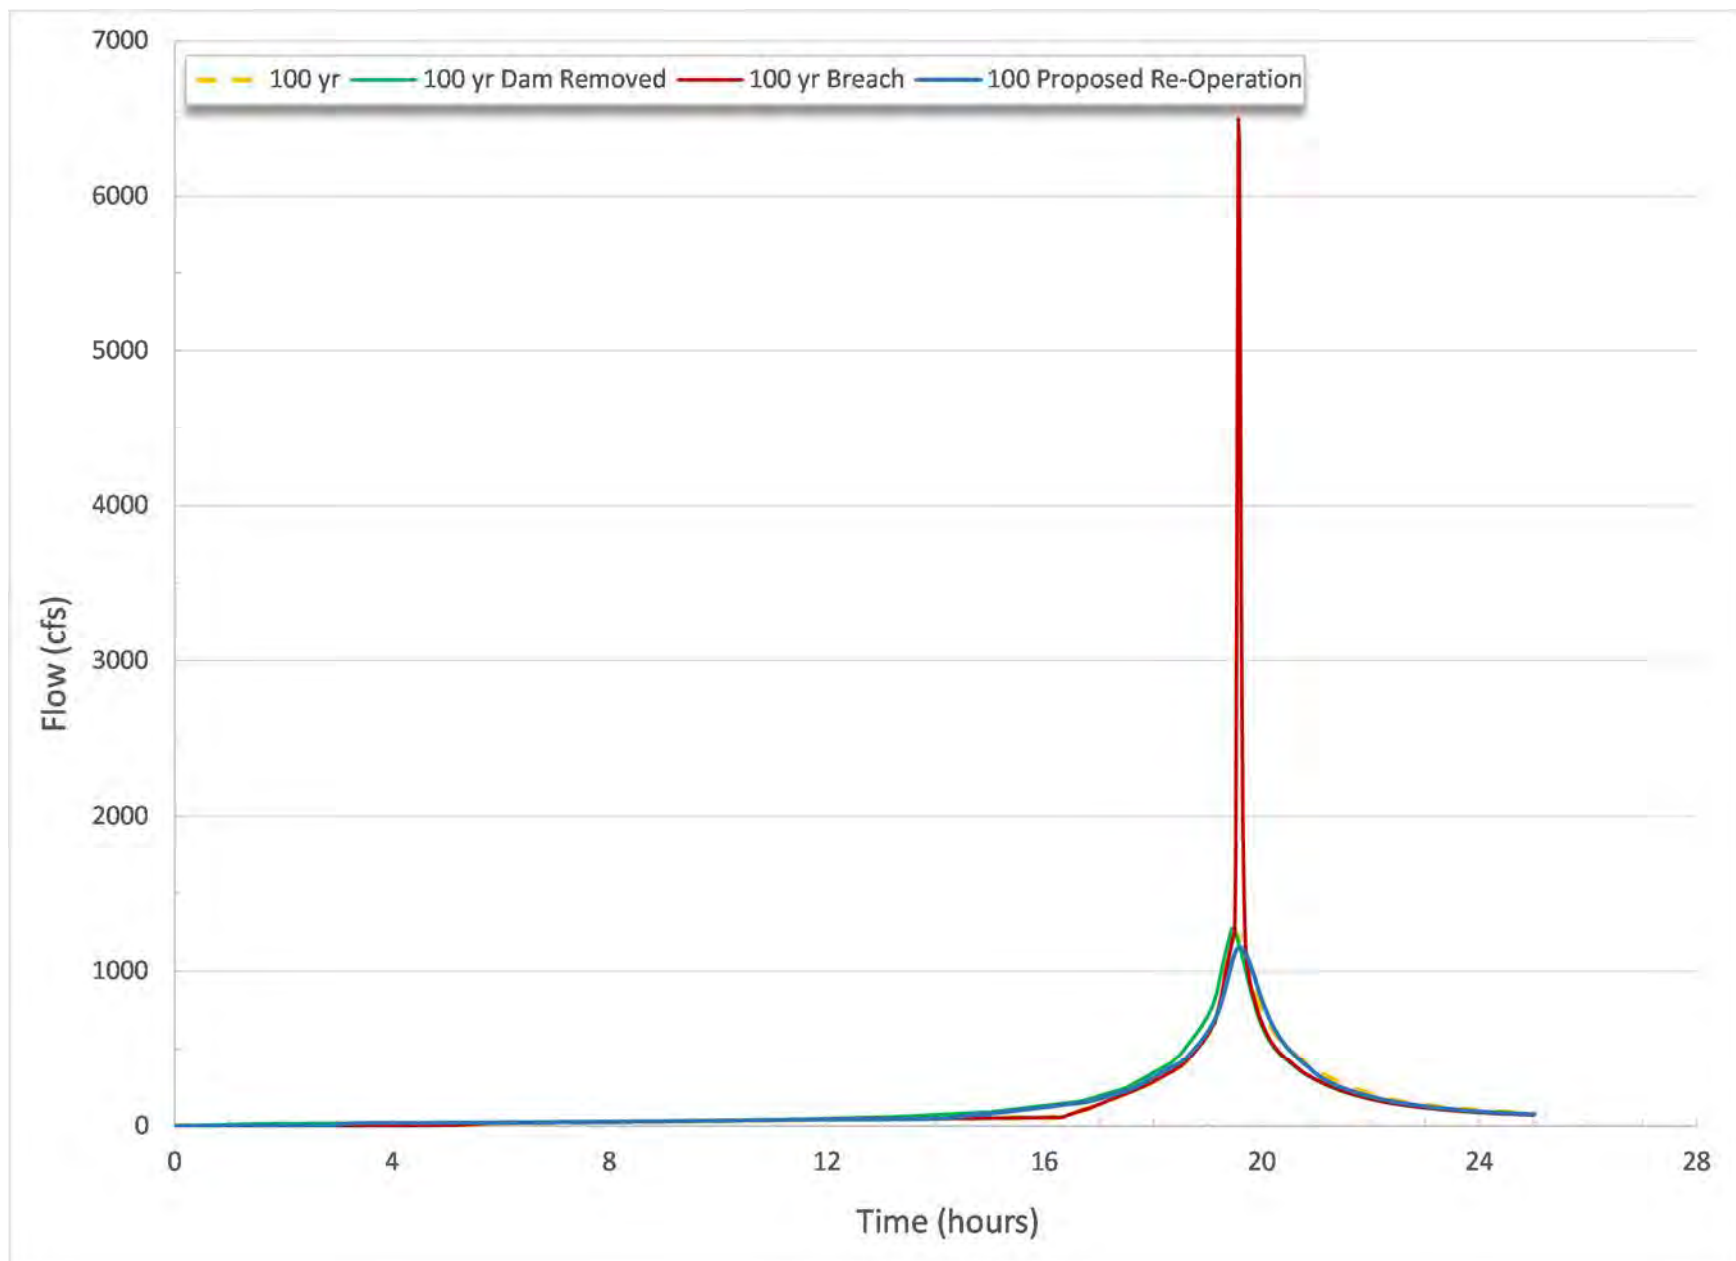
Figure F-1. 1997 Event HEC-HMS Output Hydrographs

HEC-HMS was used to route event hydrographs through the basin. The resulting outflow hydrographs were input to the HEC-RAS hydraulic model (see Appendix F). All elevations in HEC-HMS are NAVD 88.
