SANTA ROSA ROAD DEBRIS BASIN No. 2
DEBRIS BASIN MODIFICATION
PRELIMINARY DESIGN STUDY
JUNE 2016

Santa Rosa Road Debris Basin No. 2

Debris Basin Modification

Preliminary Design Study

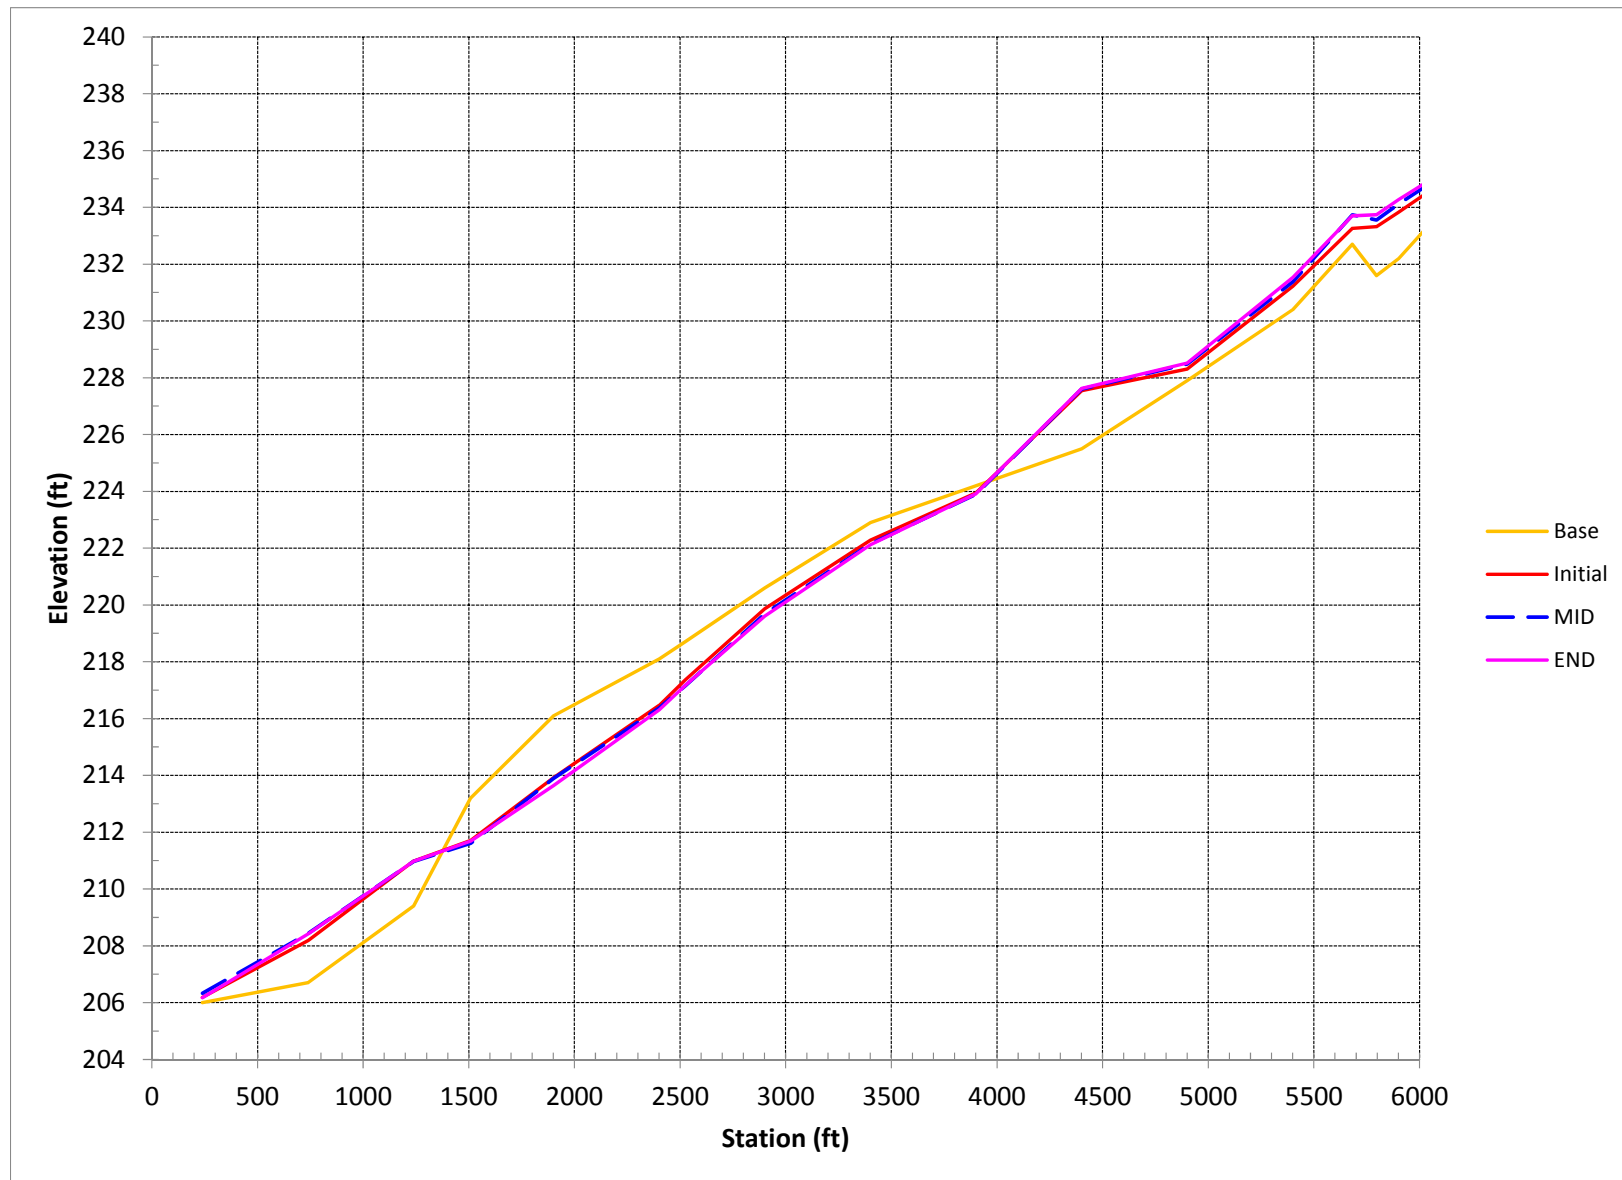
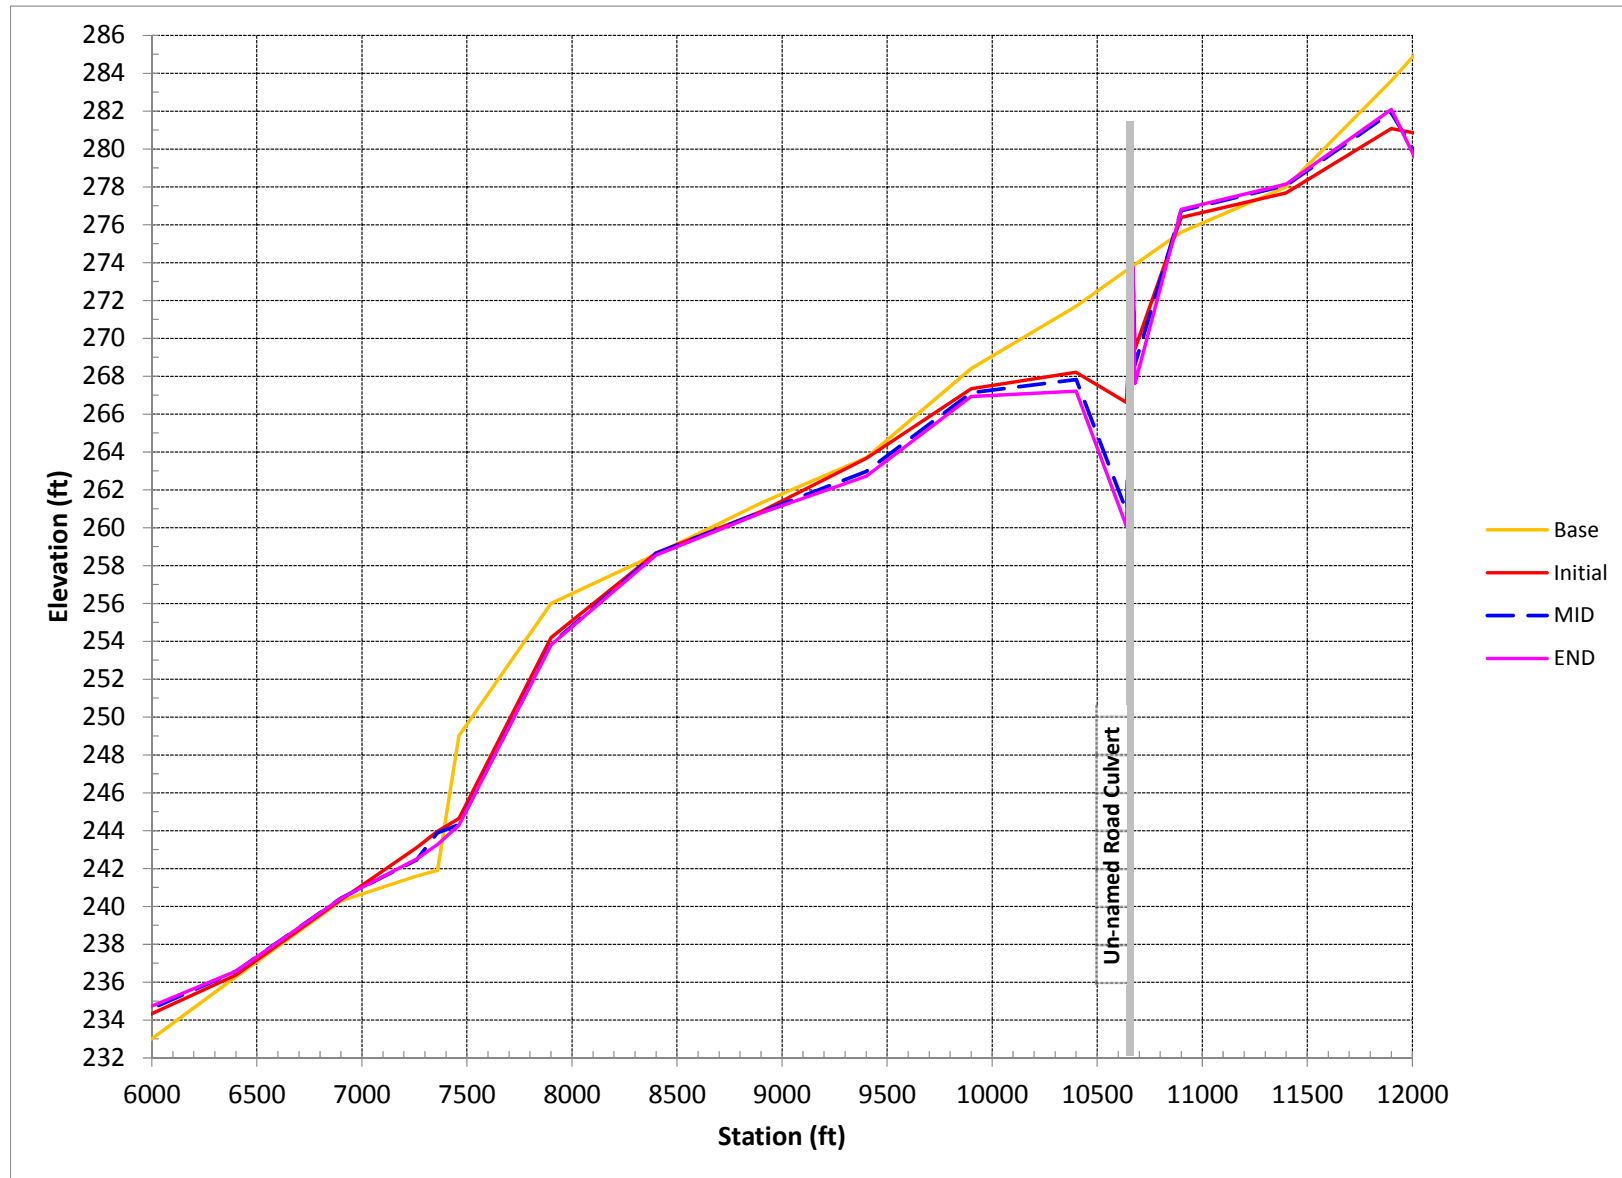
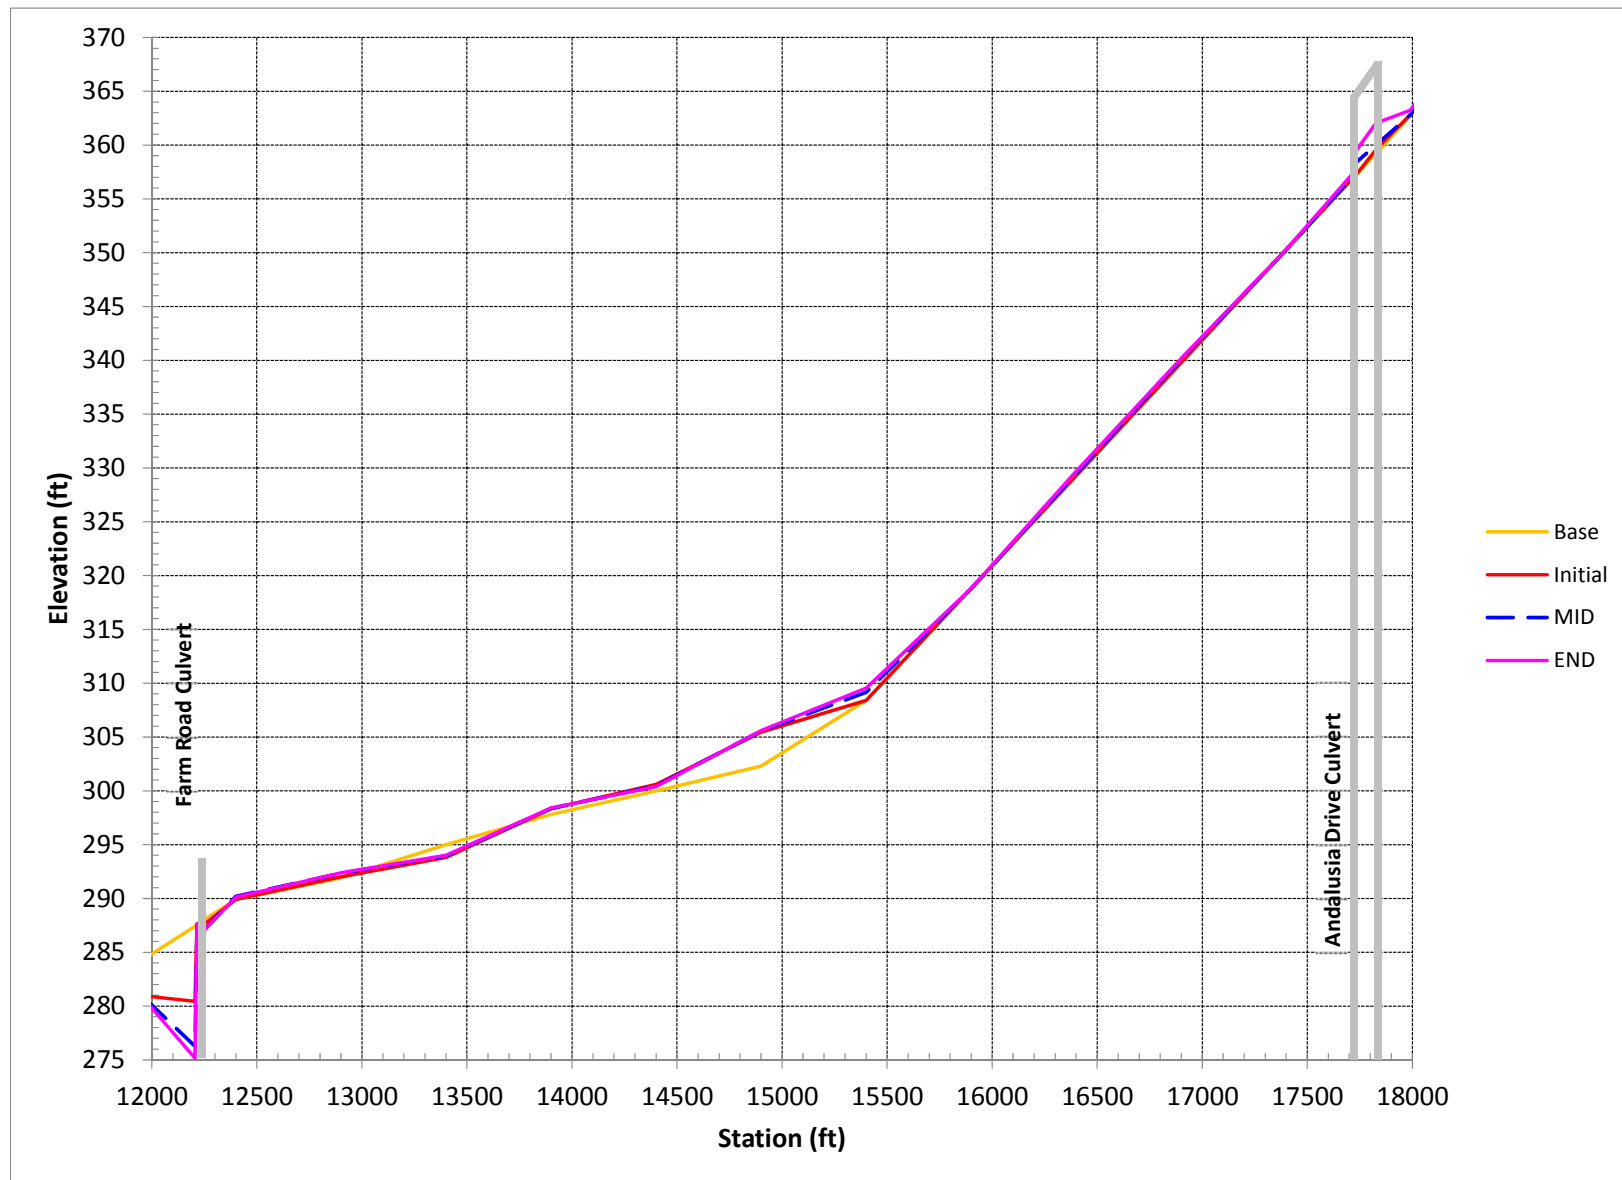
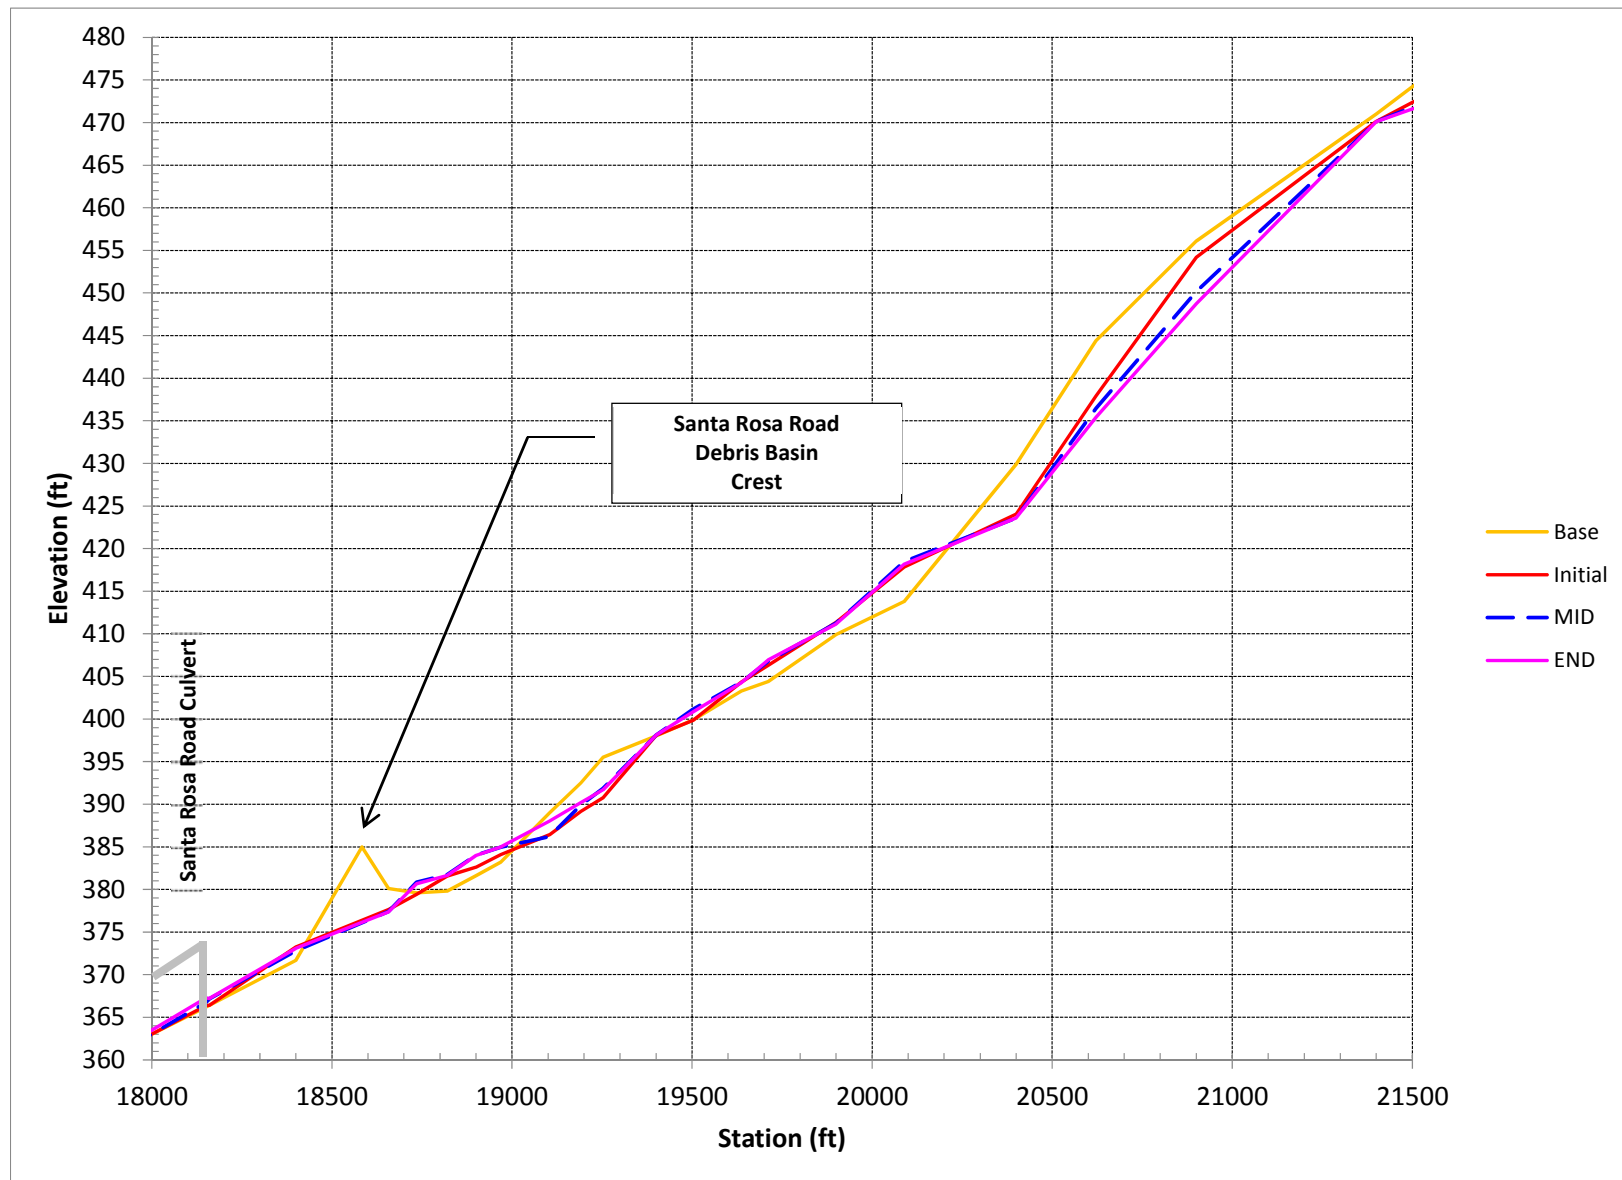
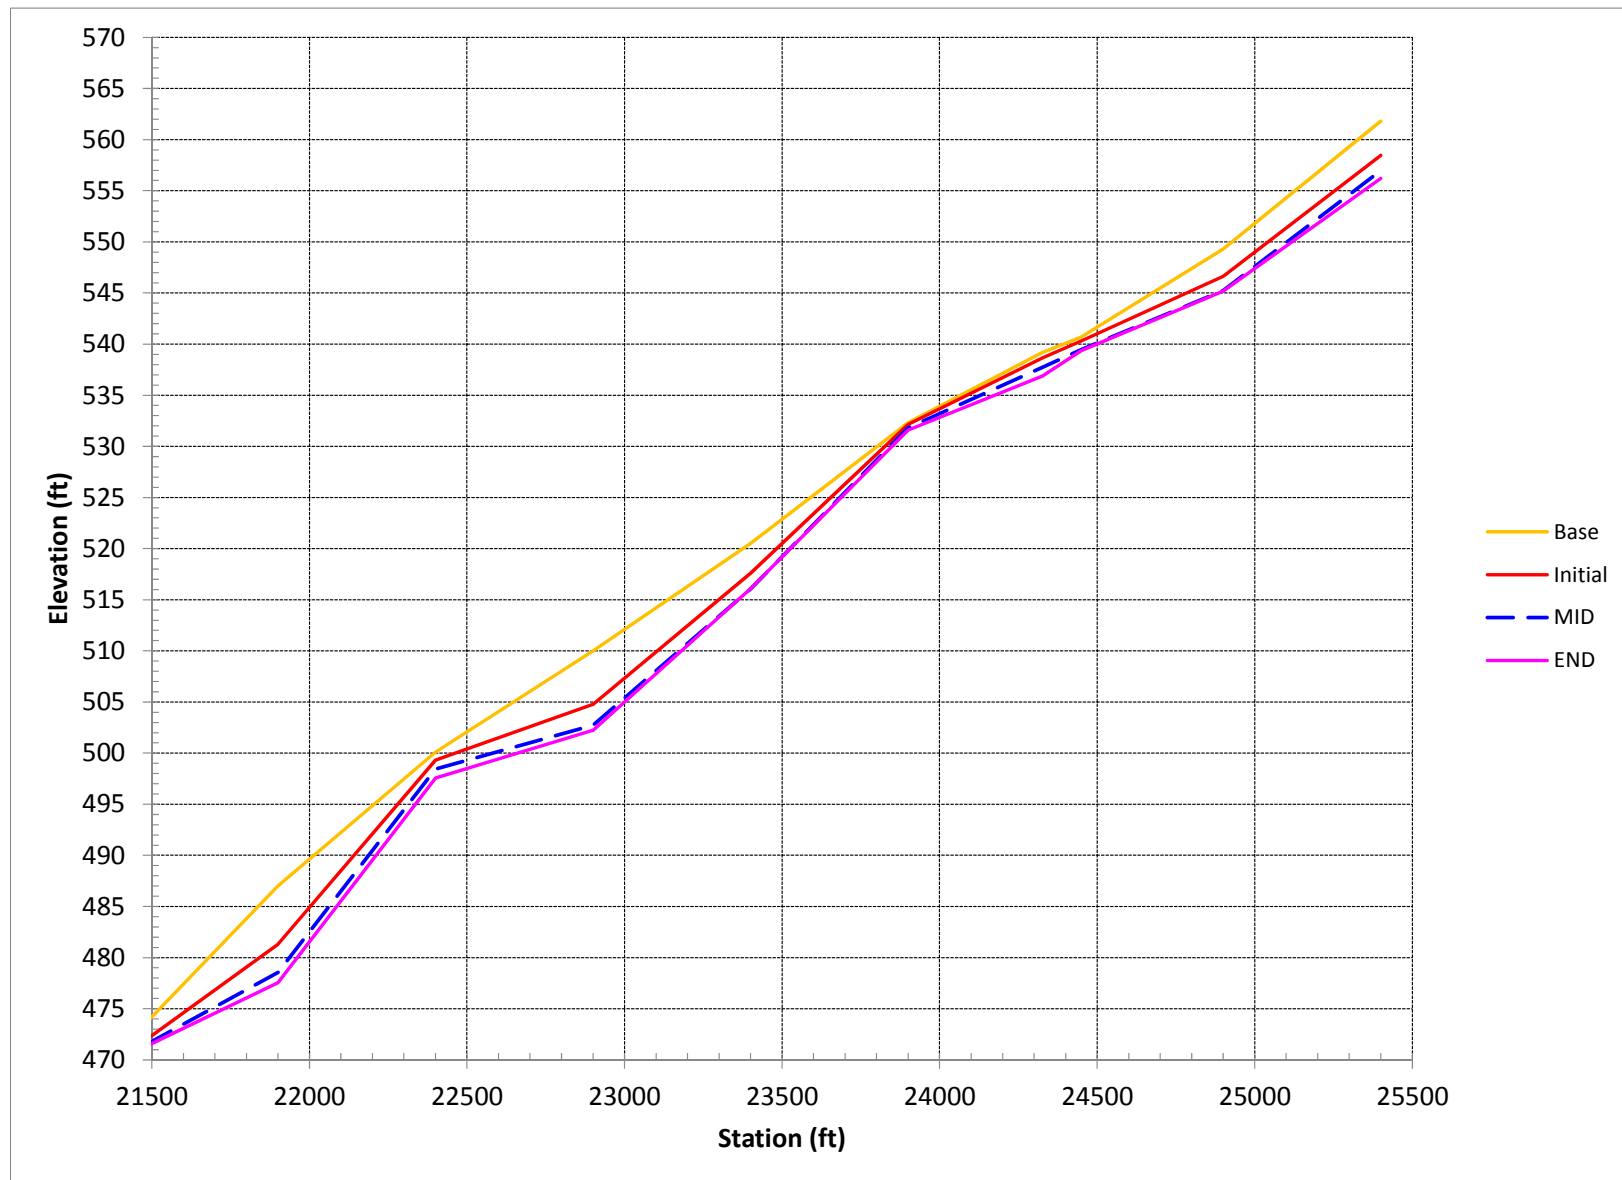
Santa Rosa Basin Proposed Conditions (Removal) Invert Profile for "Load A" – Base (before long-term simulation), Initial (after long-term simulation), Mid (peak of 100-year event), and Final Conditions.

- The inflowing sediment load was updated for Load A (Scott Method sediment yield, unburned condition minus wash load) and Load B (Scott Method sediment yield, burned condition 4.5 years after a fire minus wash load)
- The initial cross section geometry data were updated to reflect the final geometry results for the long term simulation.

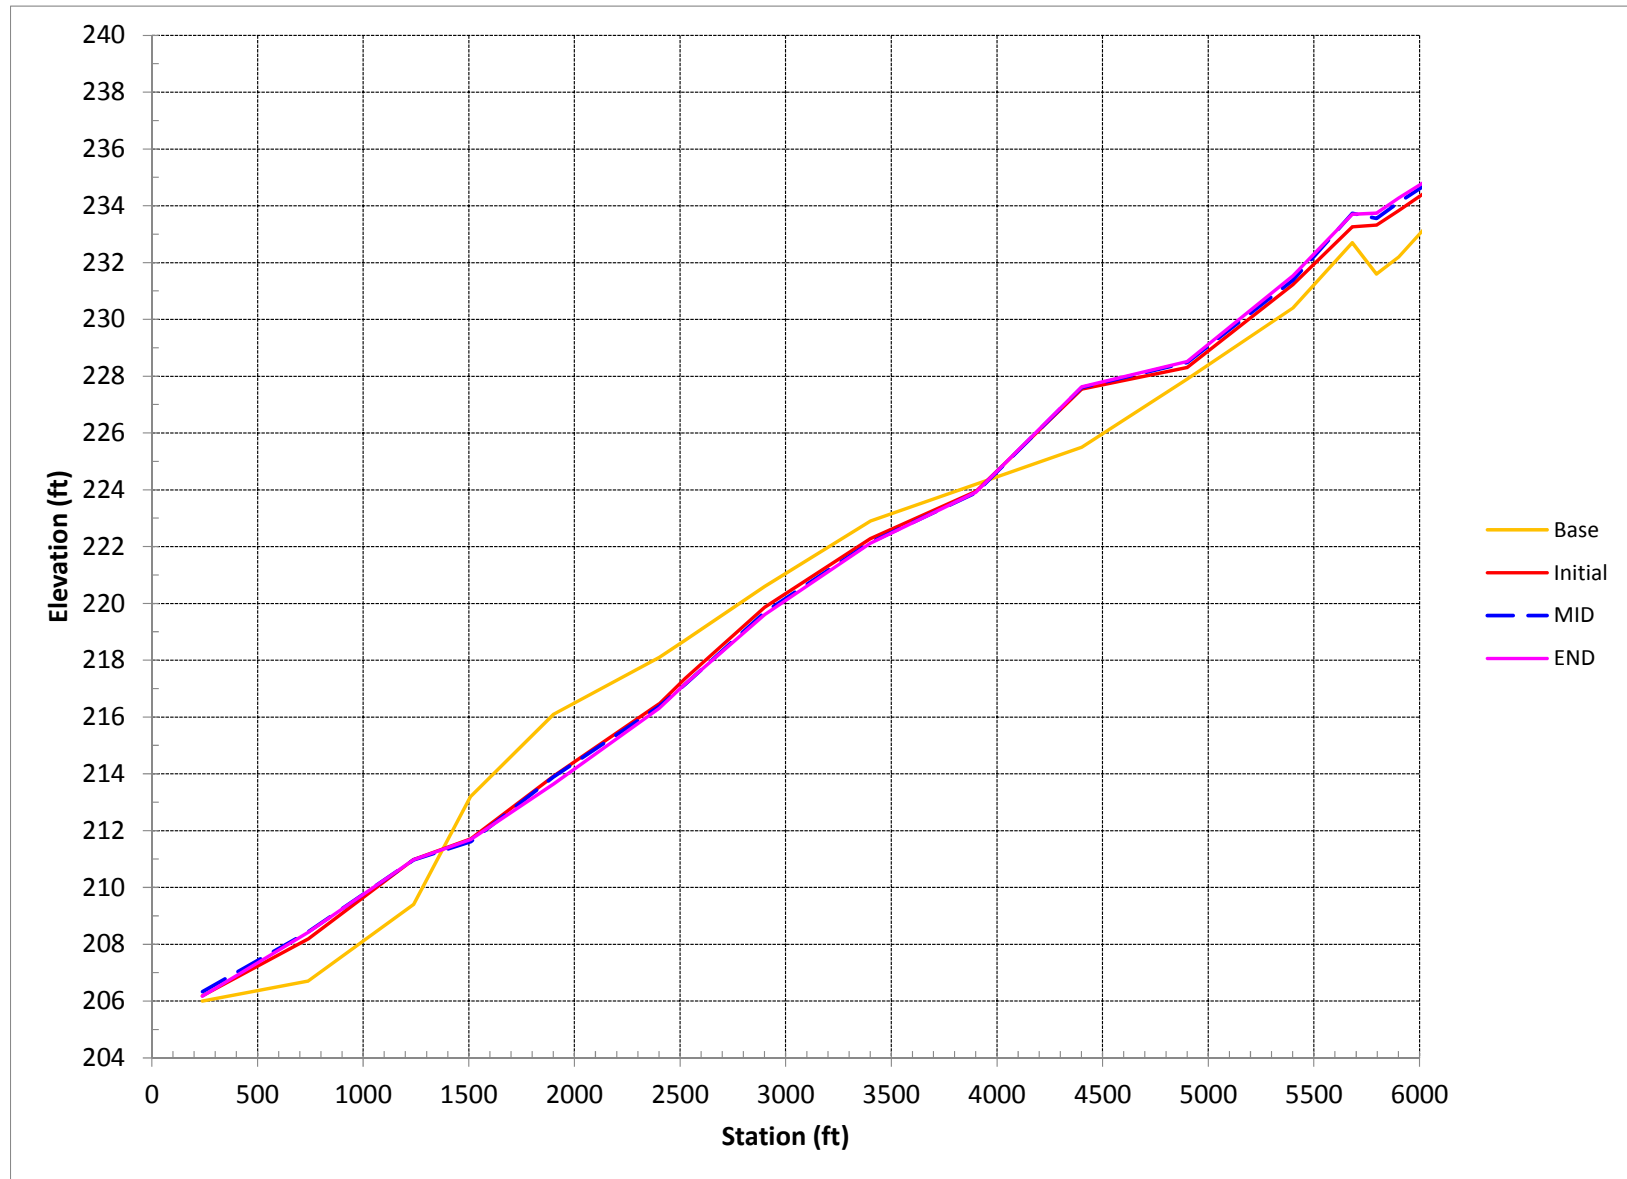
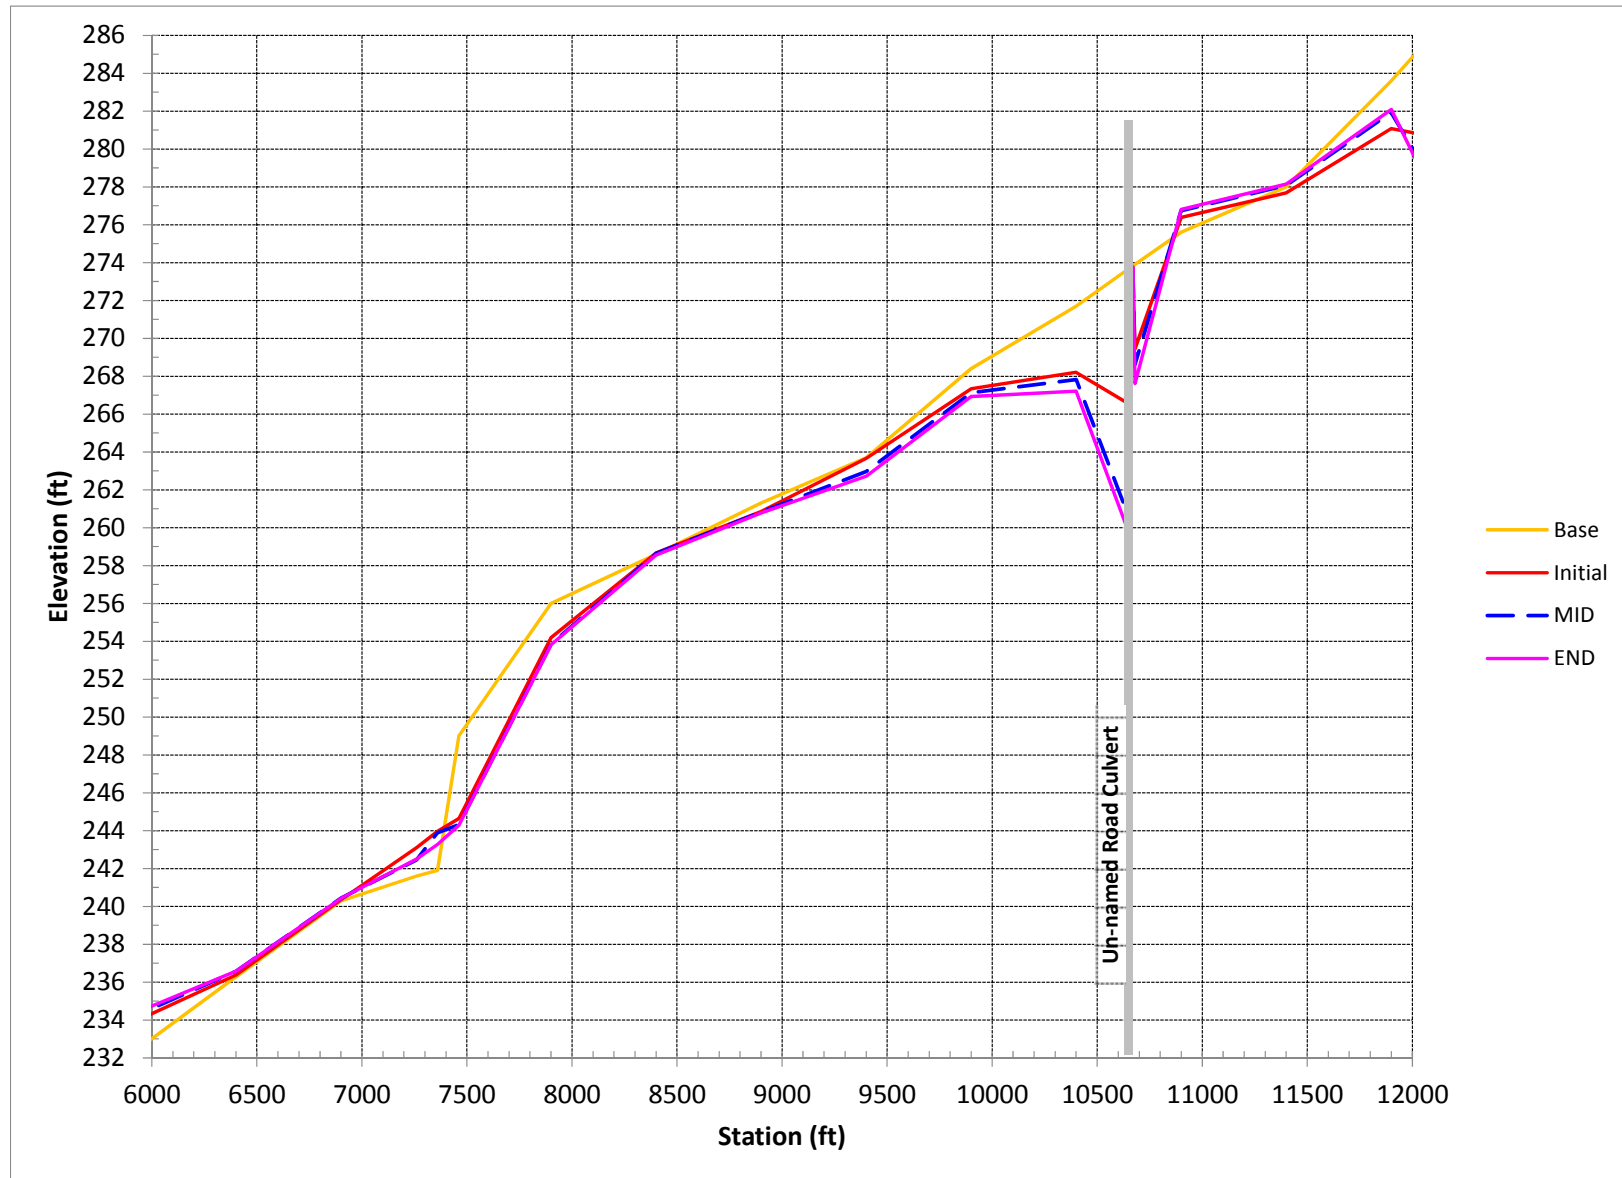
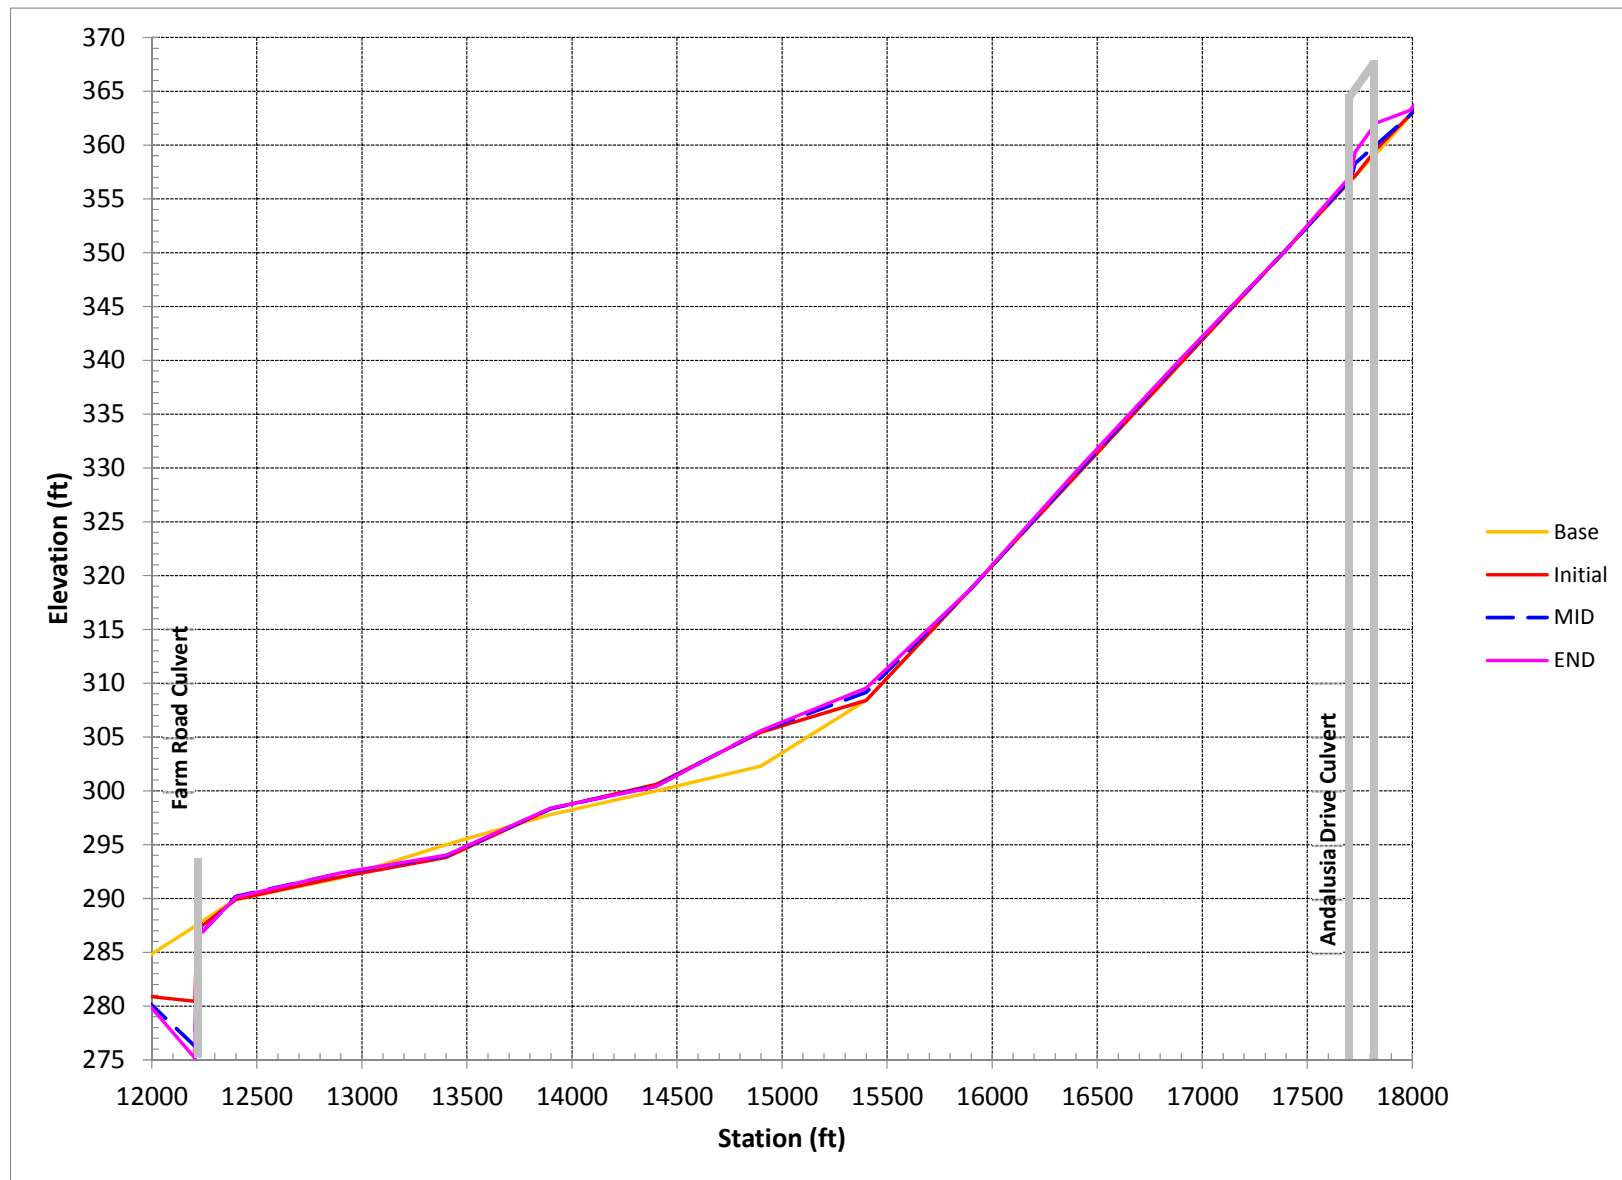
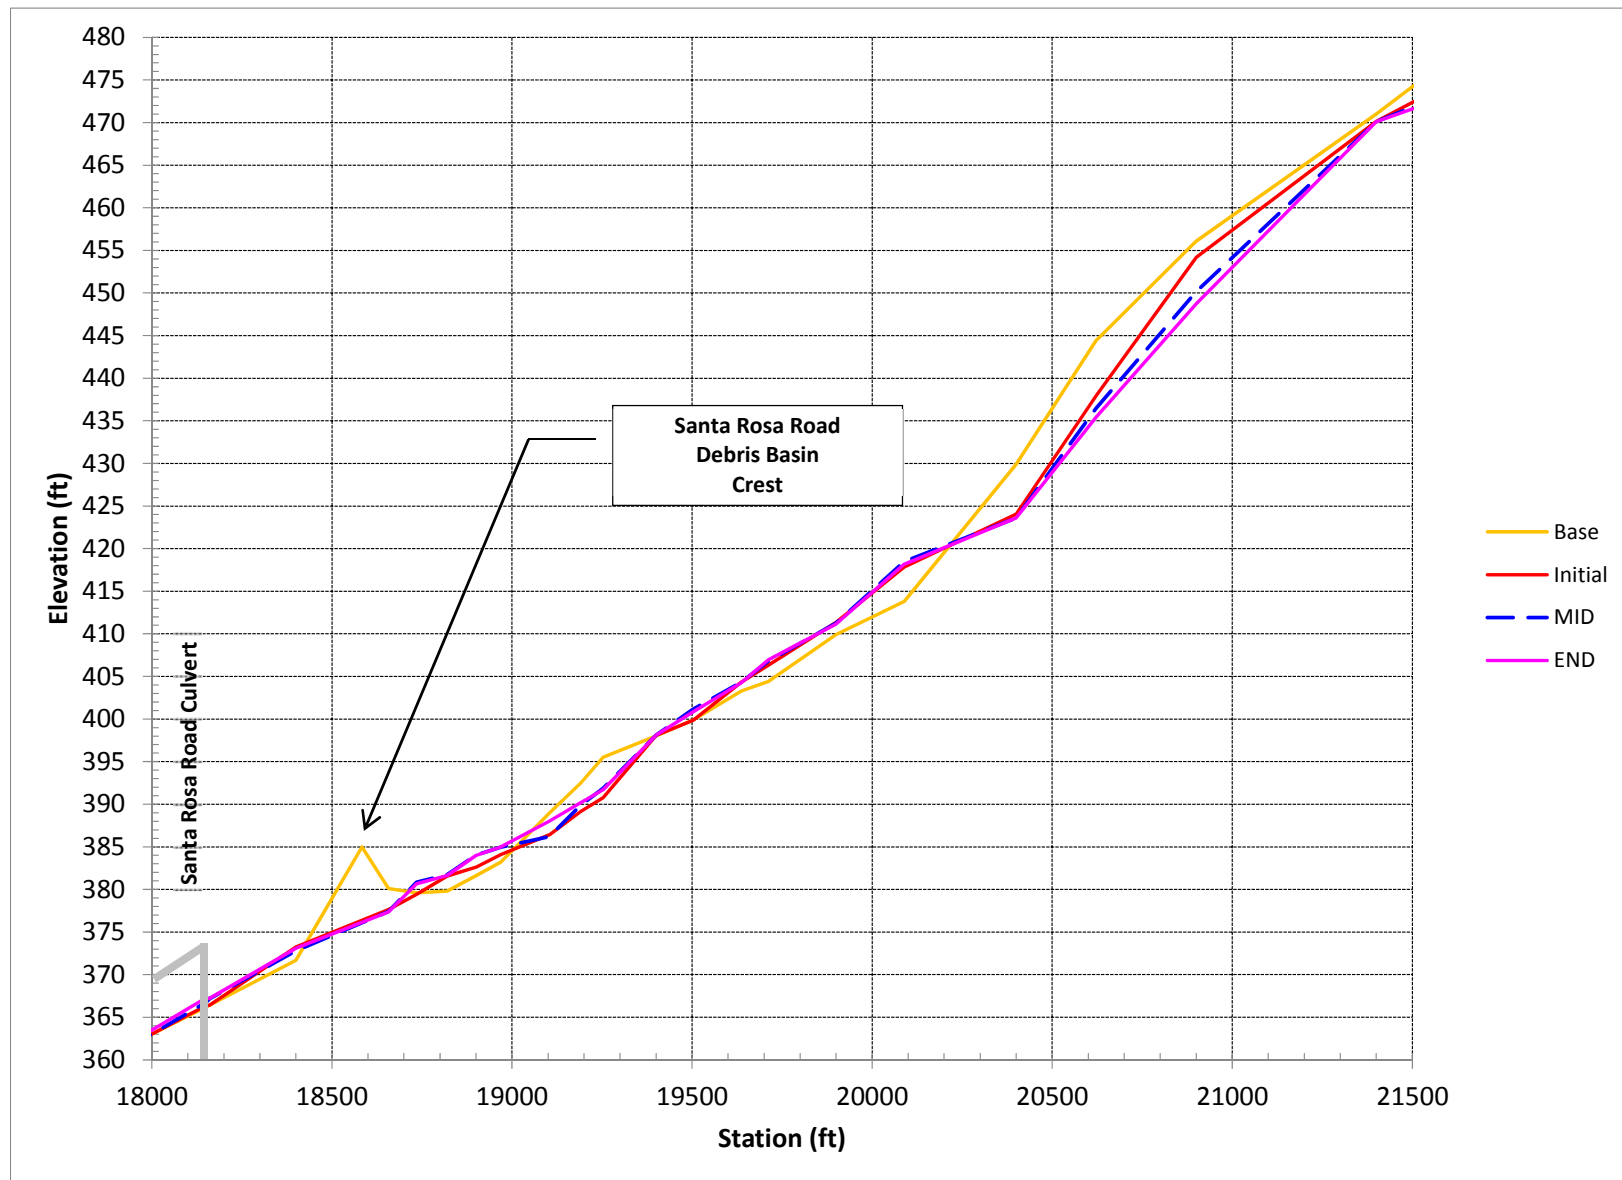
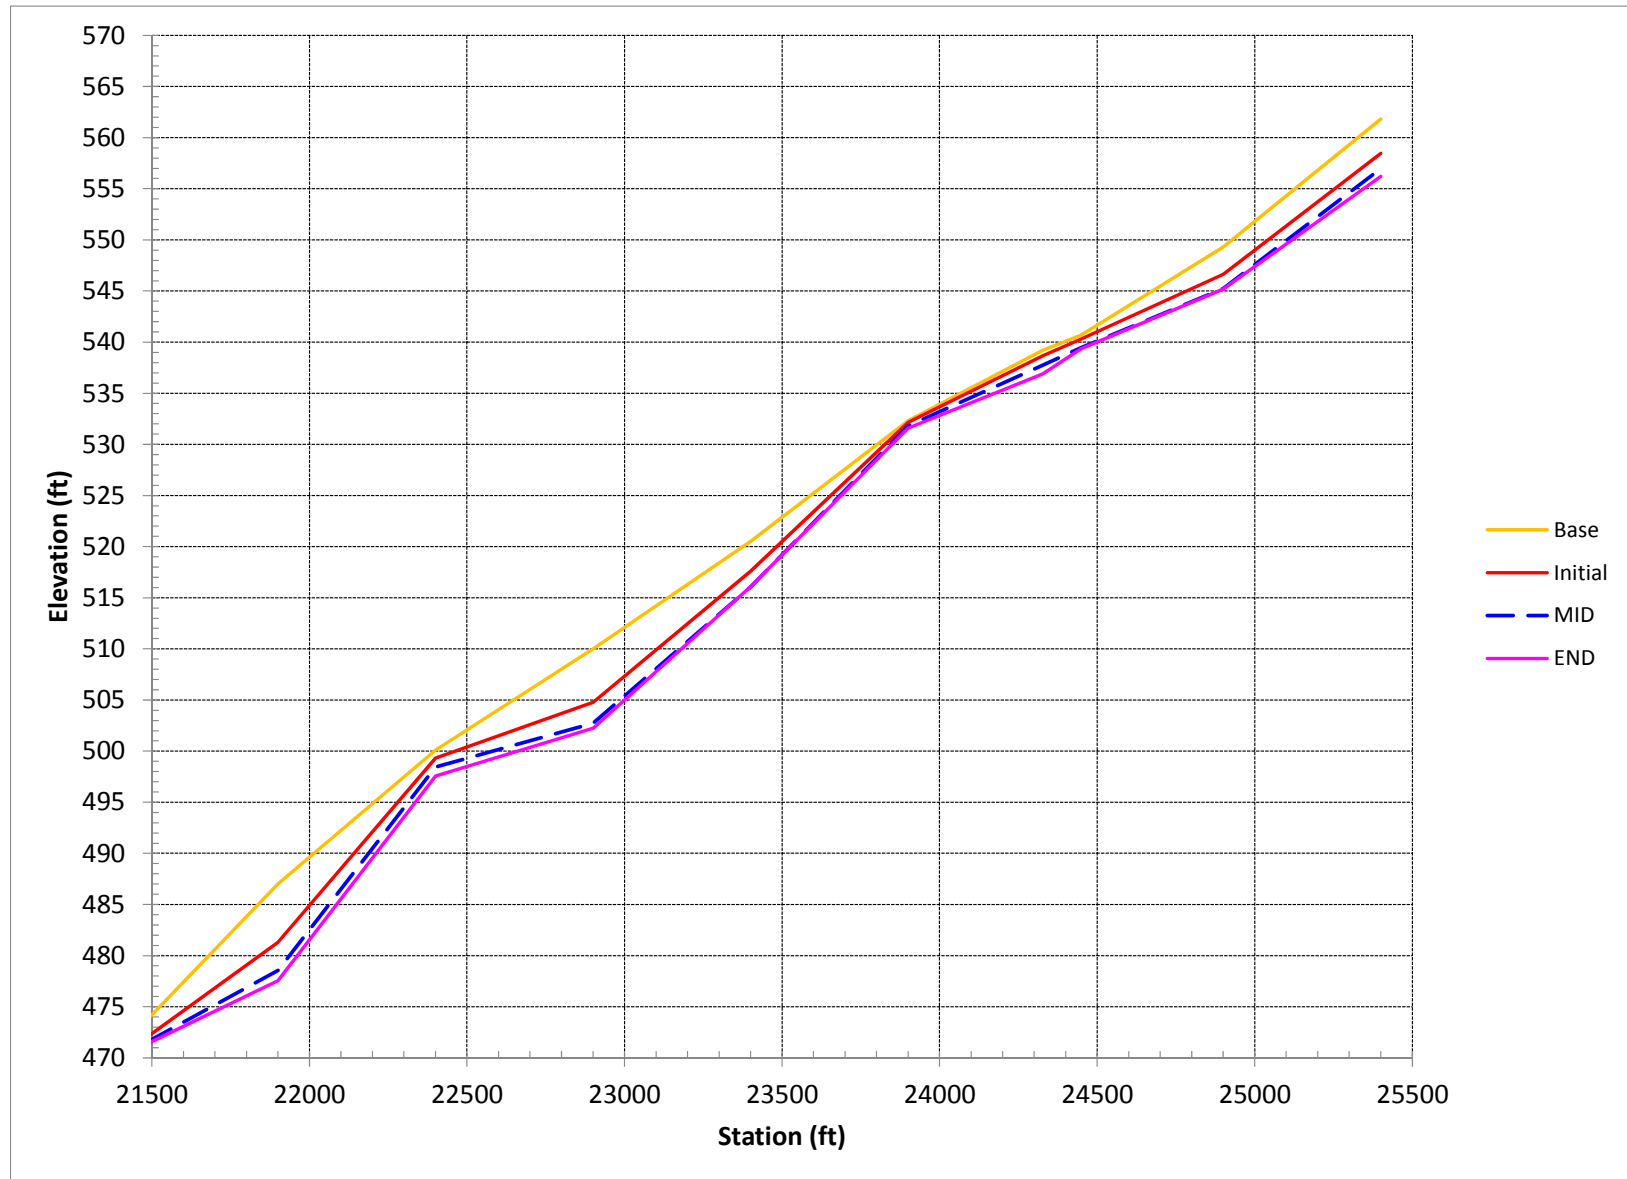
Santa Rosa Basin Proposed Conditions (Removal) Invert Profile for “Load B” – Base (before long-term simulation), Initial (after long-term simulation), Mid (peak of 100-year event), and Final Conditions.
