## Lockwood Valley Road Emergency Repairs (MP 1.75)

### Habitat Mitigation and Monitoring Plan

**Ventura County Public Works Agency**

**February 2026**

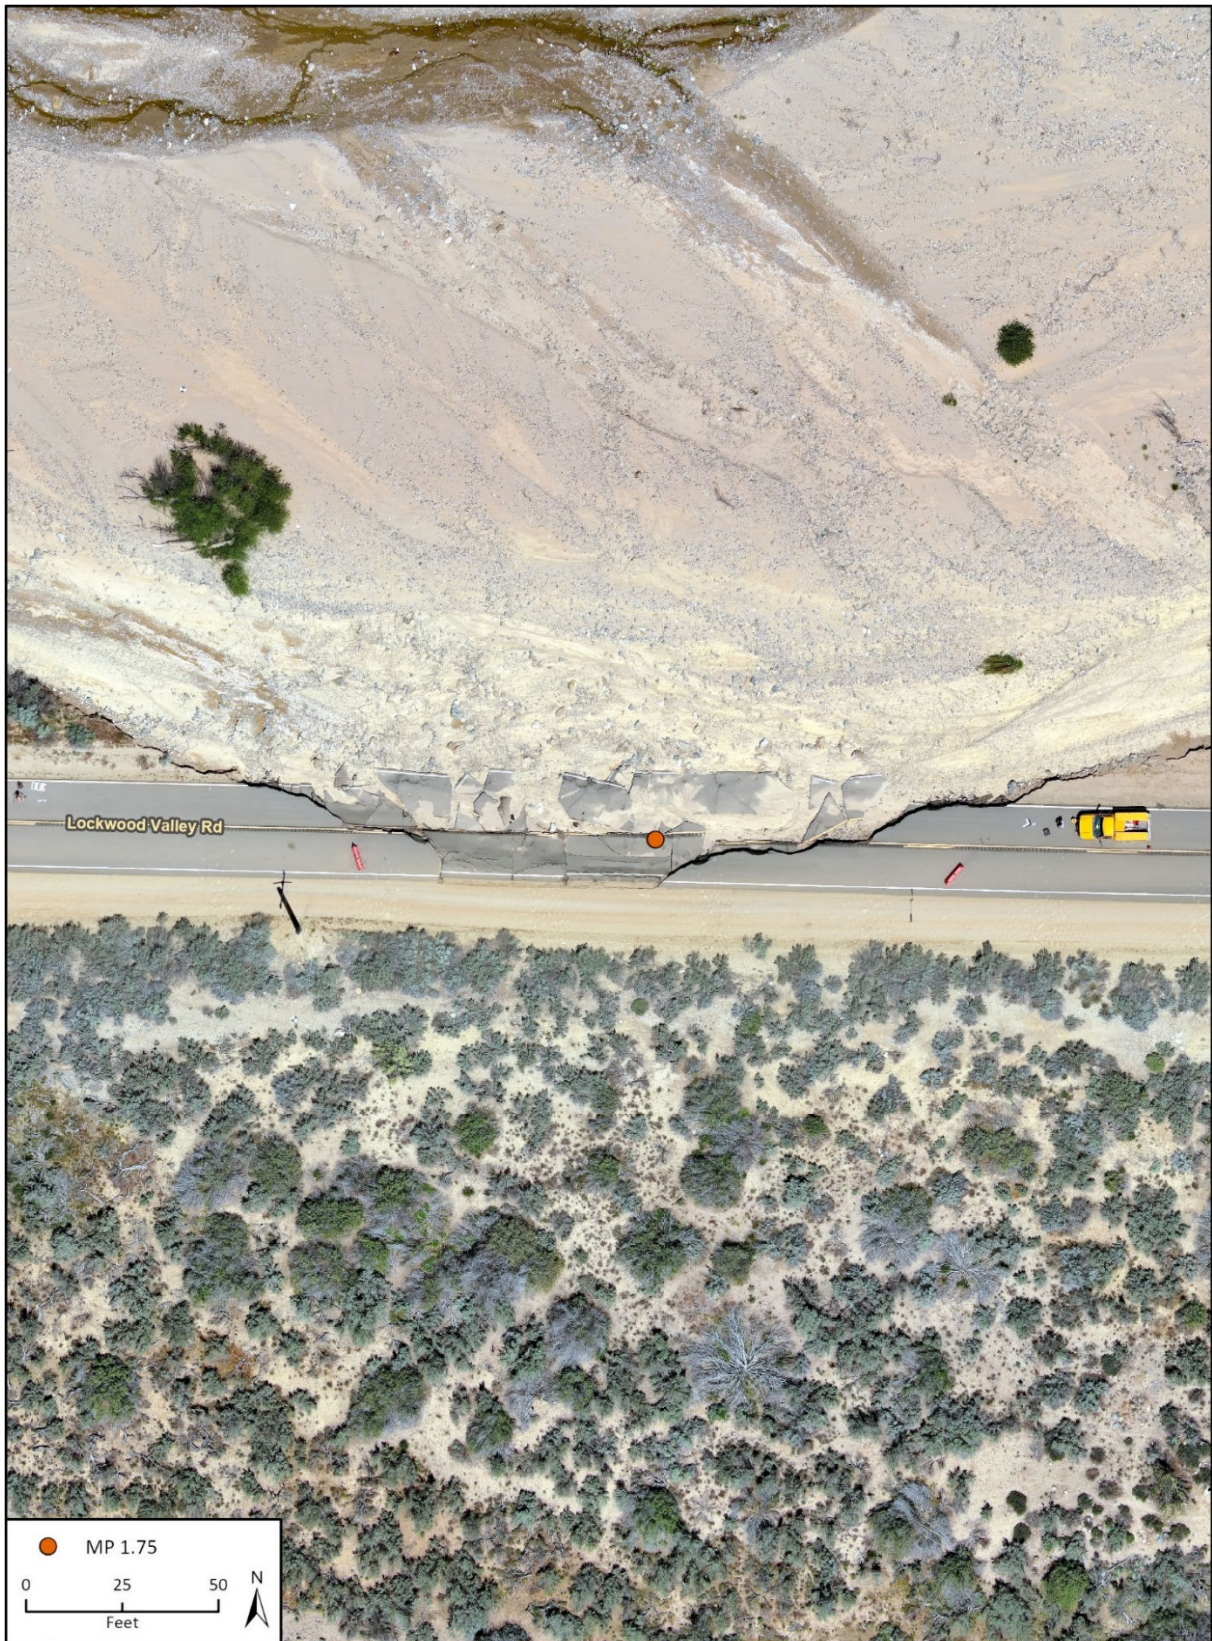
**Figure 2 Project Location**

The project site is situated within the Los Padres National Forest, adjacent to the Cuyama River, and identified by Assessor Parcel Number 002-014-010. The proposed work involves the reconstruction of approximately 310 linear feet of roadway at MP 1.75 (Figure 2). Key activities include:

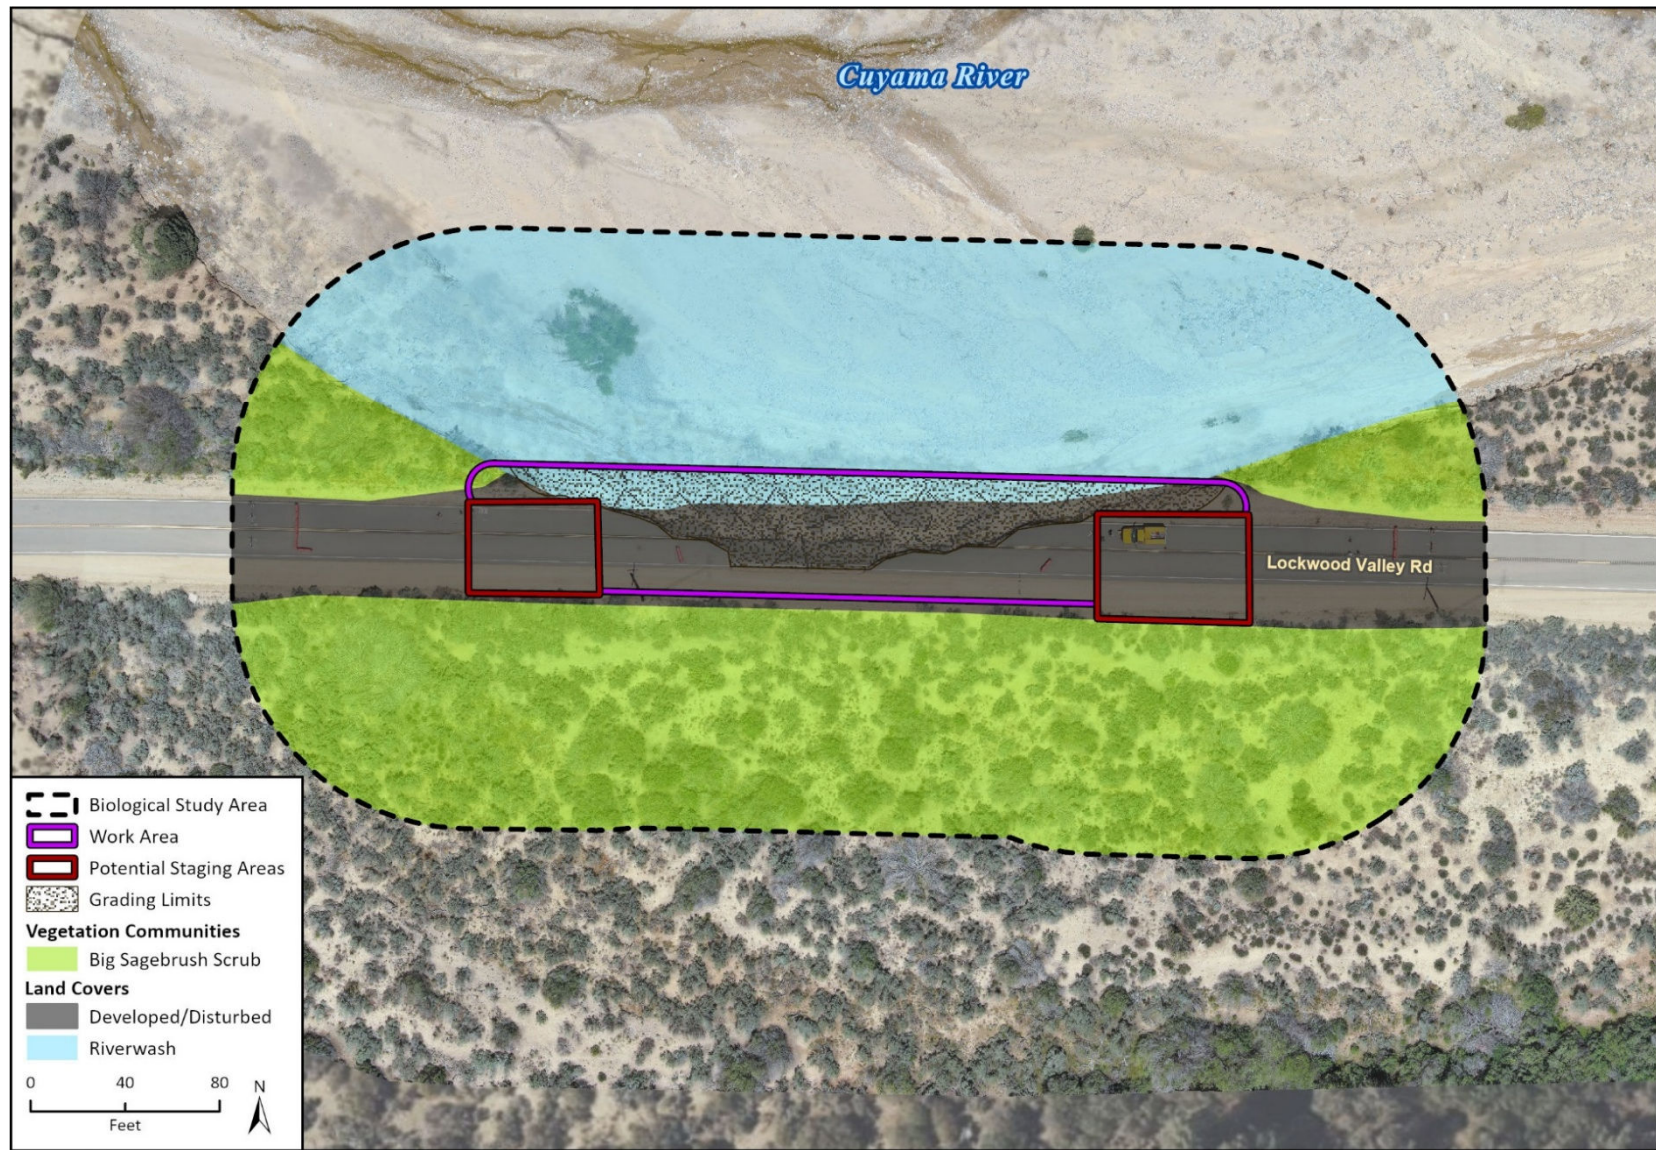
Figure 3 Vegetation and Land Cover

In total, approximately 1.26 acres of big sagebrush scrub were mapped within the biological study area at MP 1.75 (Figure 3). Big sagebrush scrub is the only vegetation community documented within the study area. Land cover types also include riverwash and developed/disturbed areas. Portions of the big sagebrush scrub occur in a patchy, discontinuous pattern, where native shrub cover is interspersed with openings dominated by non-native herbaceous species. These inclusions consist largely of invasive annual grasses and forbs, such as red brome (*Bromus rubens*), cheatgrass (*Bromus tectorum*), Mediterranean grass (*Schismus barbatus*), annual beard grass (*Polypogon monspeliensis*), rattail six-weeks grass (*Festuca myuros*), bur clover (*Medicago polymorpha*), and coastal heron's bill (*Erodium cicutarium*), which commonly establish in disturbed areas within the scrub.

Vegetation and land cover types at MP 1.75 include big sagebrush scrub (*Artemisia tridentata*) on upland/shoulder positions, river wash within the active channel, and developed/disturbed roadway margins. The riparian vegetation is limited, with scattered arroyo willow (*Salix lasiolepis*) and sandbar willow (*Salix exigua*) along local micro-sheltered margins. Big sagebrush is the dominant shrub species, accompanied by subdominant shrubs such as thick-leaved yerba santa (*Eriodictyon crassifolium*), rubber rabbitbrush (*Ericameria nauseosa*), chaparral yucca (*Hesperoyucca whipplei*), and coffeeberry (*Frangula californica*). The herbaceous layer is primarily composed of red brome (*Bromus rubens*), flat-spine bur ragweed (*Ambrosia acanthicarpa*), and tarragon (*Artemisia dracunculus*).

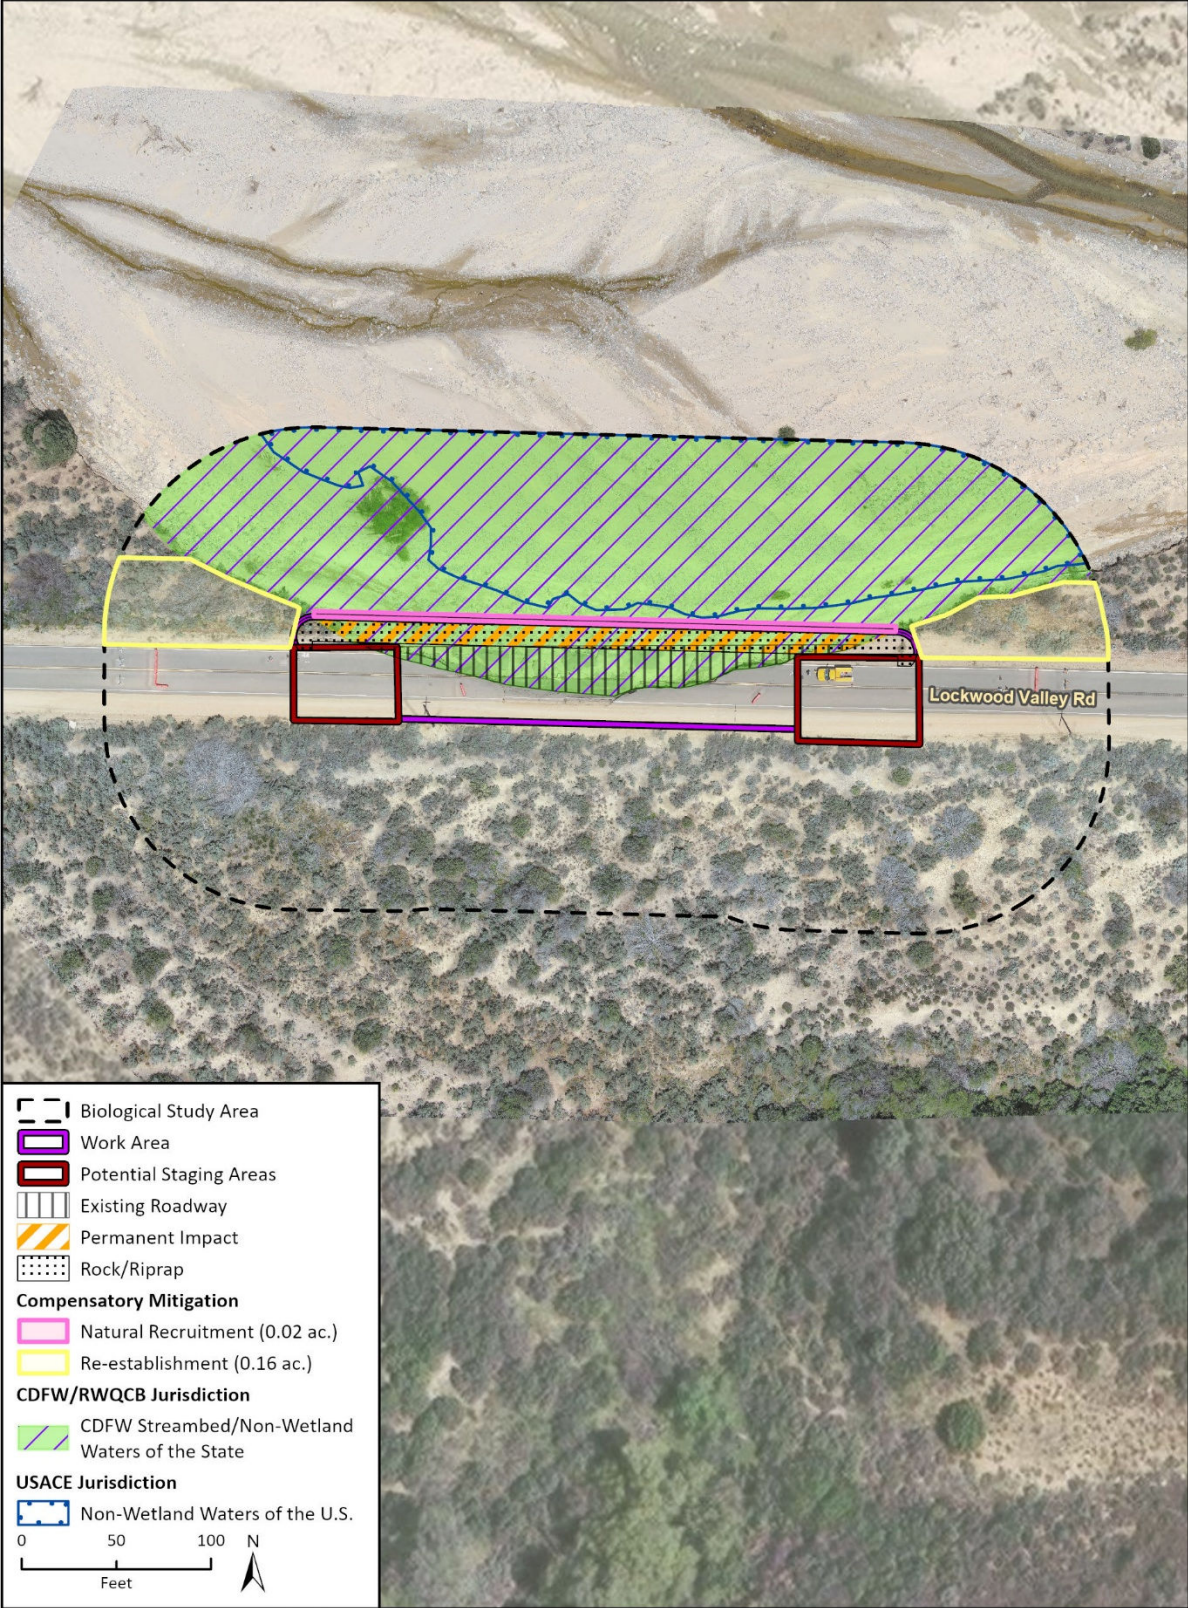
Figure 5 Compensatory Mitigation

To mitigate permanent impacts on big sagebrush scrub, the project includes reestablishing non-native inclusions to native sagebrush scrub, thereby improving habitat structure, composition, and overall ecological integrity. Two areas located east and west of the permanent RSP have been designated for reestablishment (Figure 5).
