COUNTY OF VENTURA  
DEPARTMENT OF PUBLIC WORKS  
VENTURA, CALIFORNIA

REVIEW OF MATILIJA DAM  
1967

Prepared By  
BECHTEL CORPORATION  
SAN FRANCISCO  
AUGUST 1967

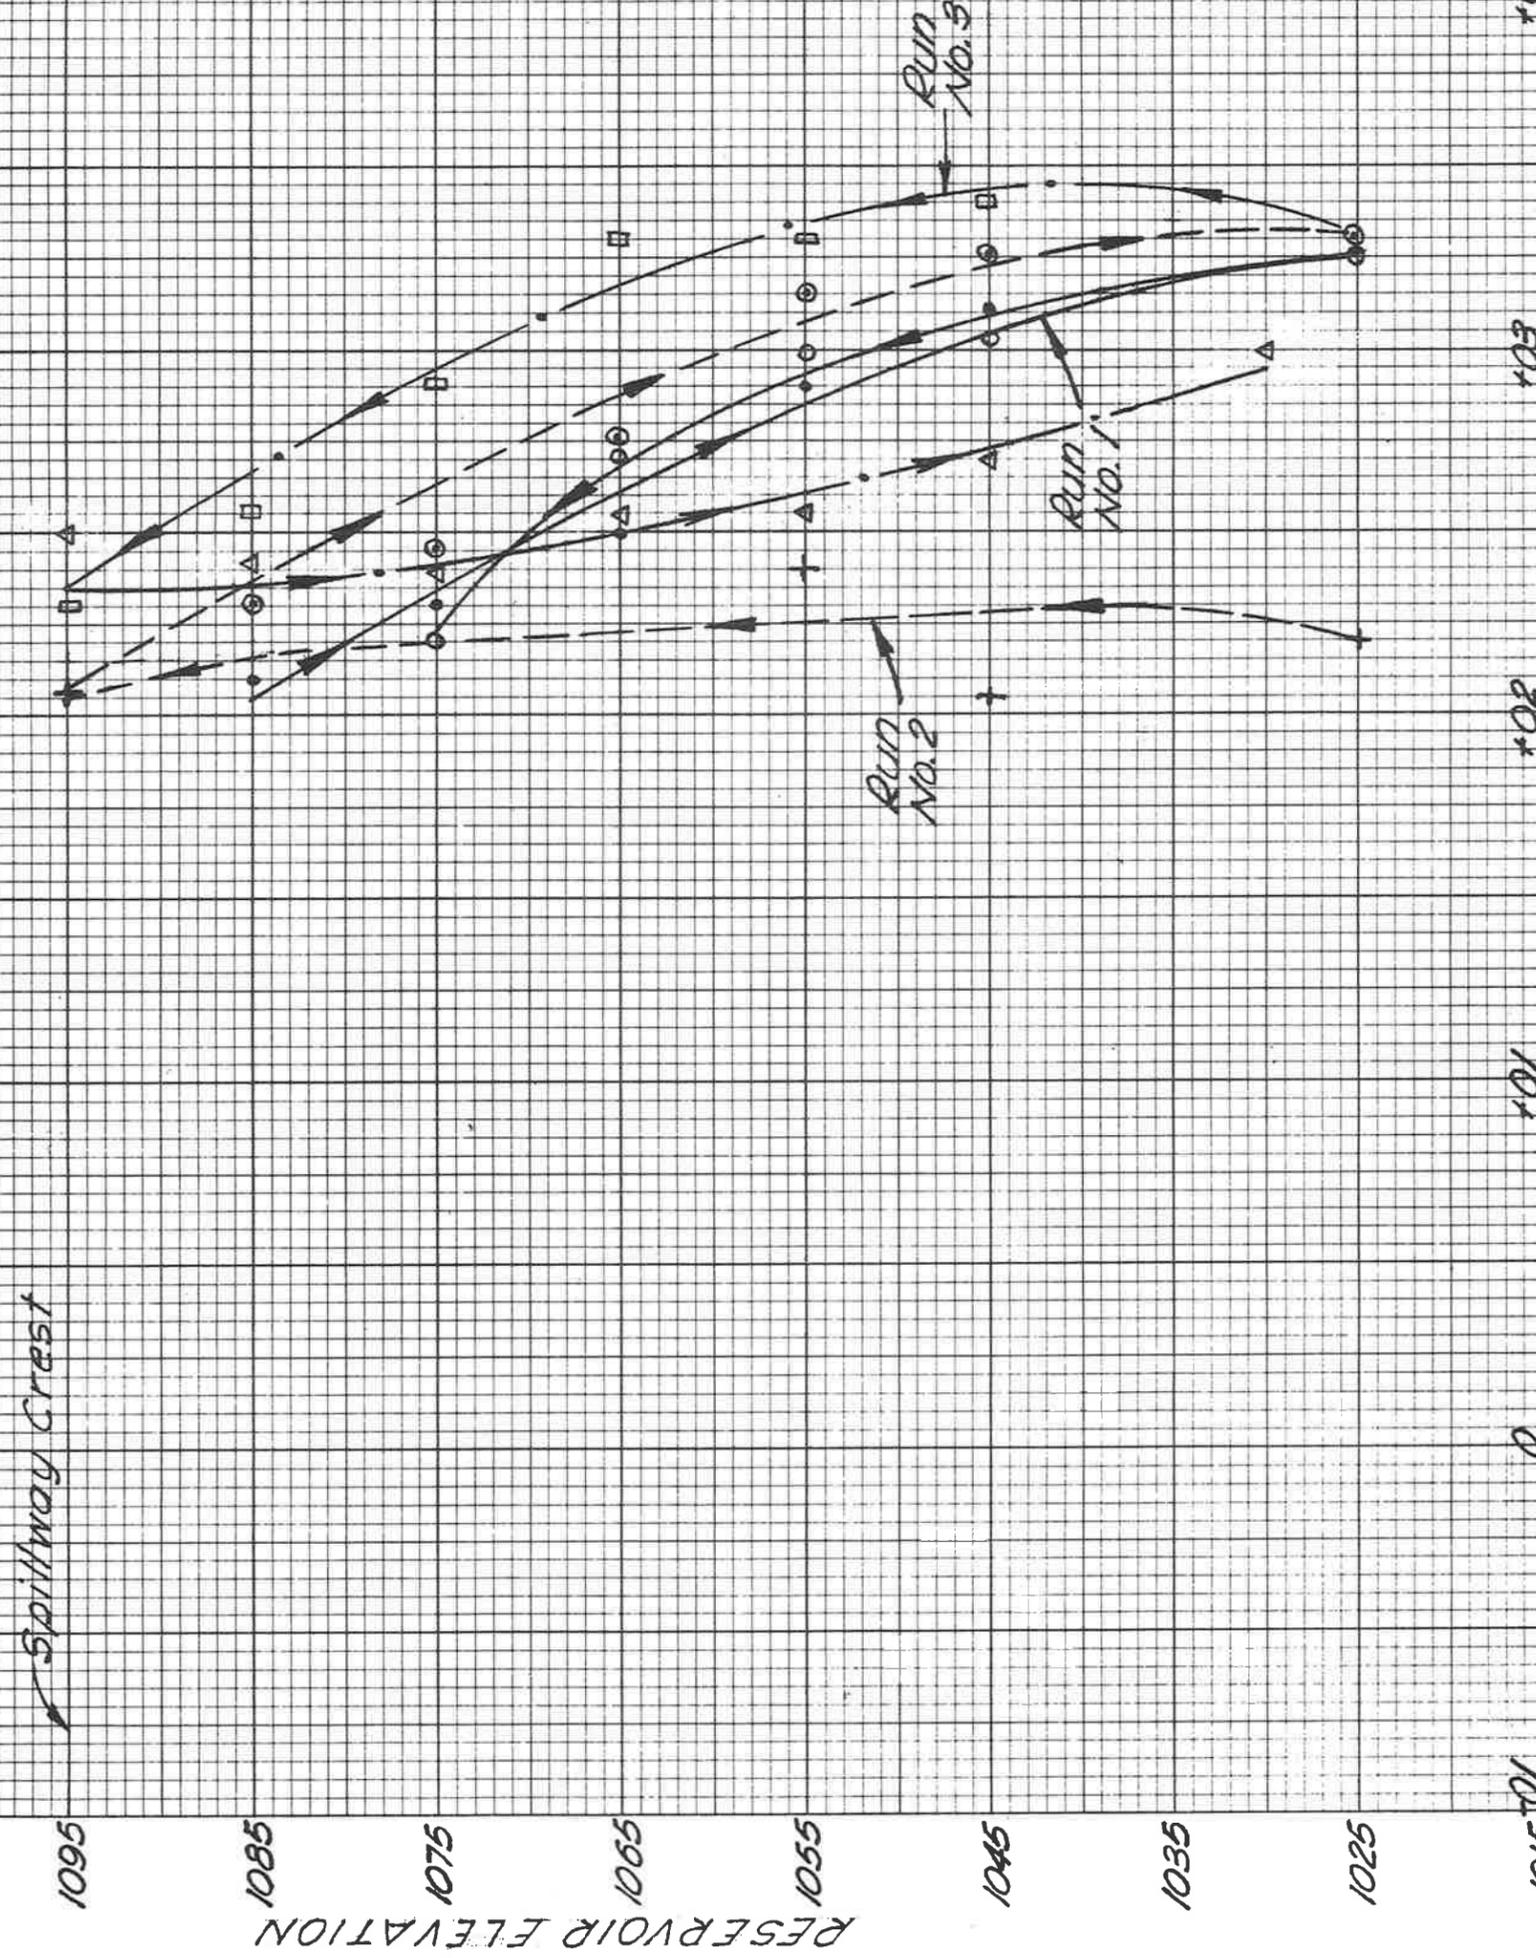
FIG. 3.3

In analyzing the various plots, it is apparent that of the two abutments, the left exhibited more movement than the right. Further, of all the meters, meter DH-1L (Figure 3.3) which is the uppermost on the left abutment, showed the maximum movement. Meter DH-1R (Figure 3.7), the uppermost on the right abutment, showed the maximum movement for that abutment. For both DH-1L and DH-1R, the plots appear to be more erratic than those of the remaining meters. Particularly erratic is the plot showing the relationship between the meter reading and reservoir elevation for the filling cycle of Run No. 2.

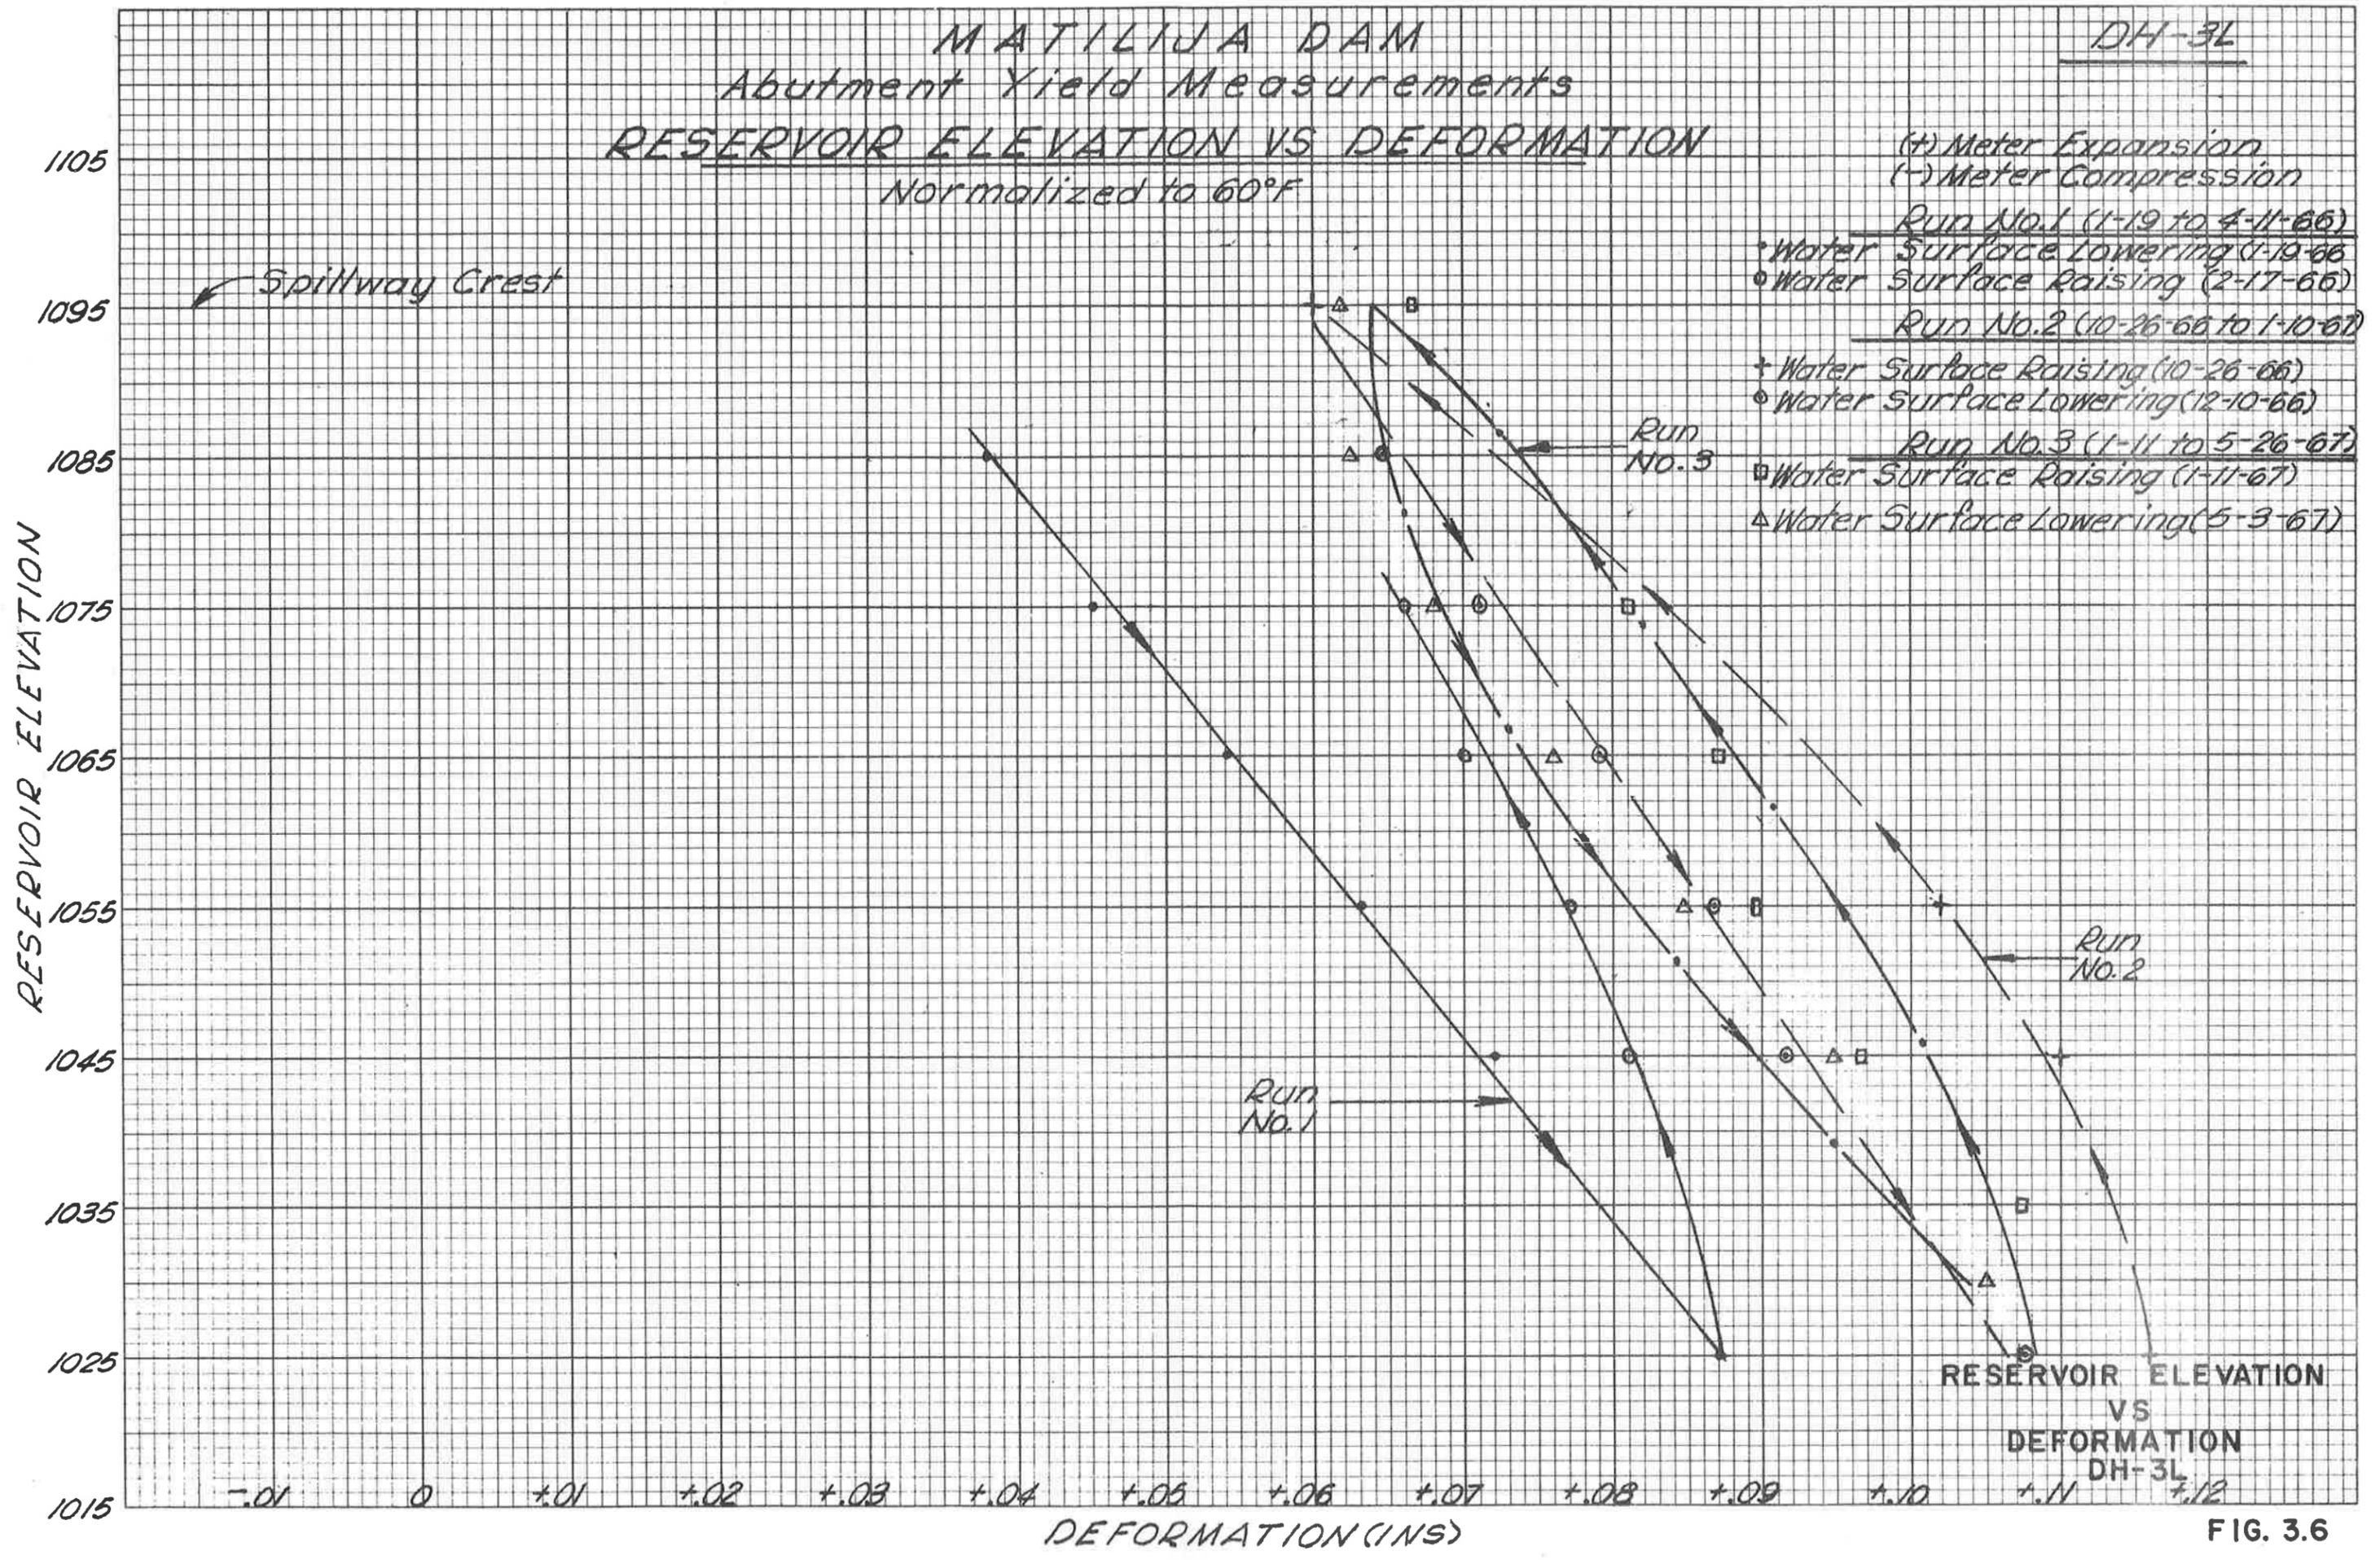
FIG. 3.6

Near the bottom of the dam, the right abutment moved a negligible amount (Figure 3.10) whereas the left abutment (Figure 3.6) shows a slight permanent movement where the rock appears to have expanded, or the dam to have moved slightly in a direction away from the abutment. As seen, there is approximately 0.02 inch expansion of Meter DH-3L when normalized readings for Run No. 1 are compared to those for Run No. 3 for the same reservoir level. This phenomenon could be attributed to the fact that when the spillway was lowered the average reservoir pressure over the two years of observation was permanently decreased. This decrease relieved some of the pressure on the abutment which allowed the rock to rebound somewhat and show the expansion as measured by the meter.

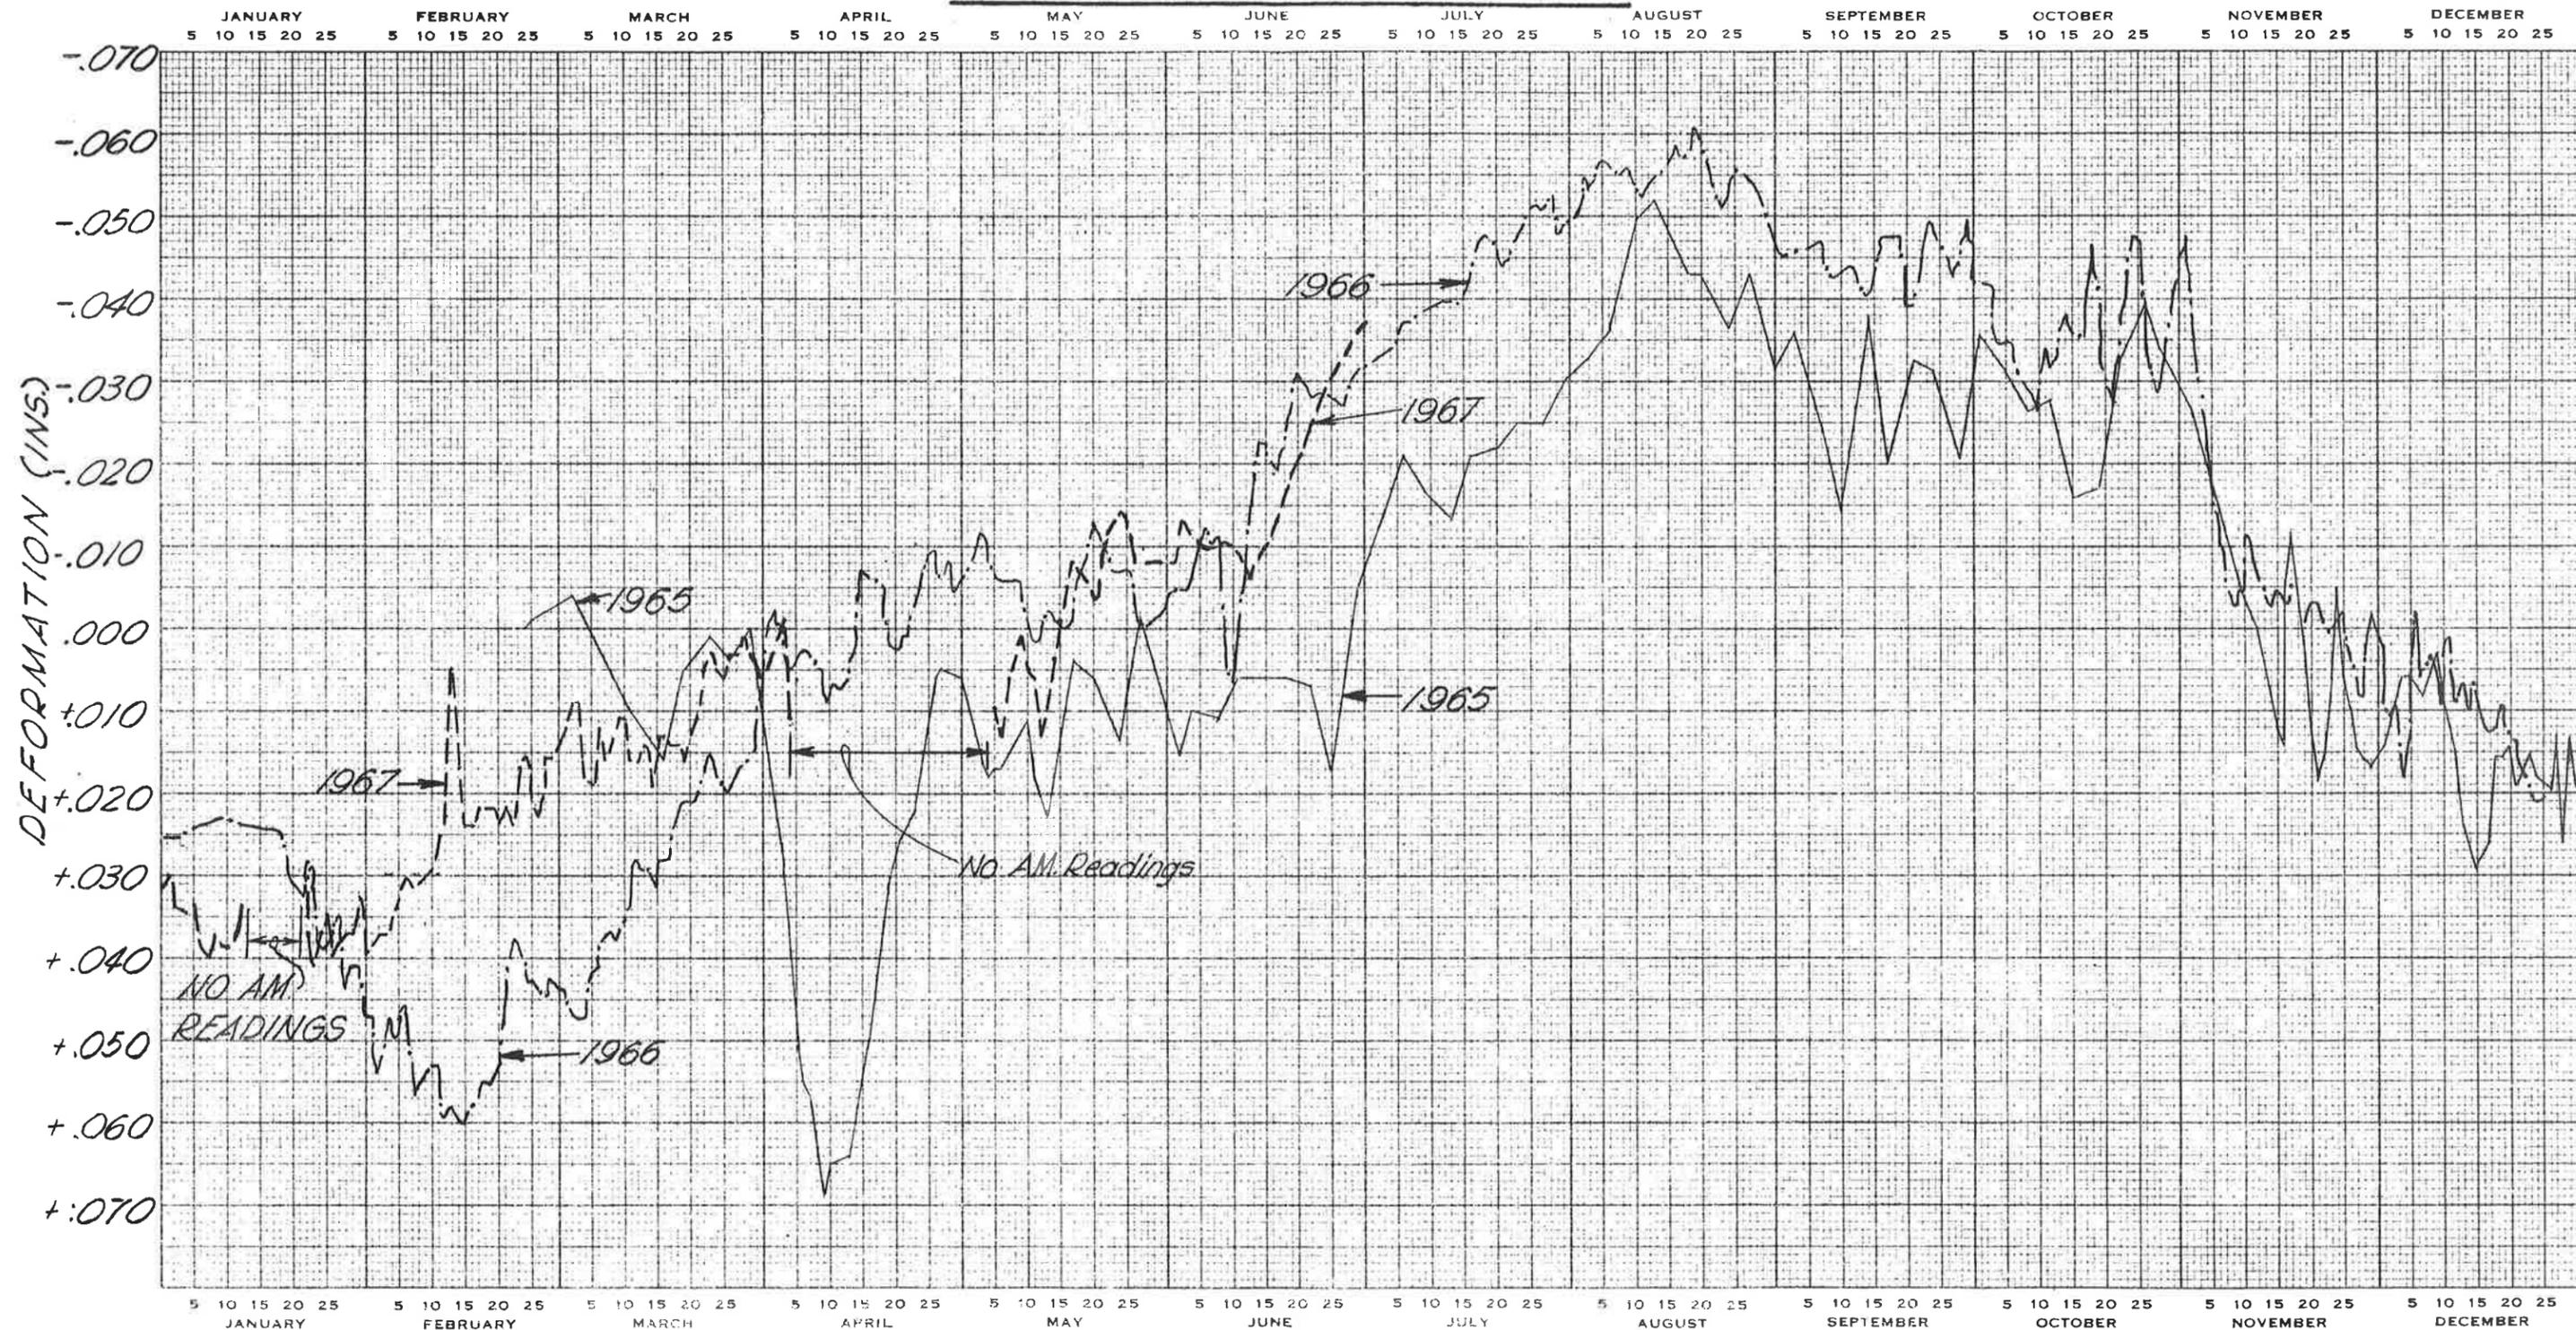
DEFORMATION  
VS  
TIME  
DH-1L  
FIG. 3.11

Elevation 1113 for DH-1R, which are above the normal maximum pool (El. 1095) and just at maximum flood level during a maximum probable flood (El. 1113.7). This would render them most susceptible to temperature changes, further magnified by their exposed locations. Figures 3.11 and 3.15 are plots of Deformation versus Time for DH-1L and DH-1R. These plots appear to justify the explanation that temperature is in fact a probable cause of the anomalous behavior of the meters in that they appear to fluctuate generally with the seasons, in a more or less cyclic fashion. With certain exceptions, their behavior was not unlike that of Temperature versus Time shown on Figure 3.19. This type of behavior was evidenced for all three years for which the plots were prepared. During the warm months the dam expands and pushes into the abutment causing the meter to show compression and during the cold months the movement is reversed. The other meters did not exhibit such pronounced seasonal cyclic behavior.

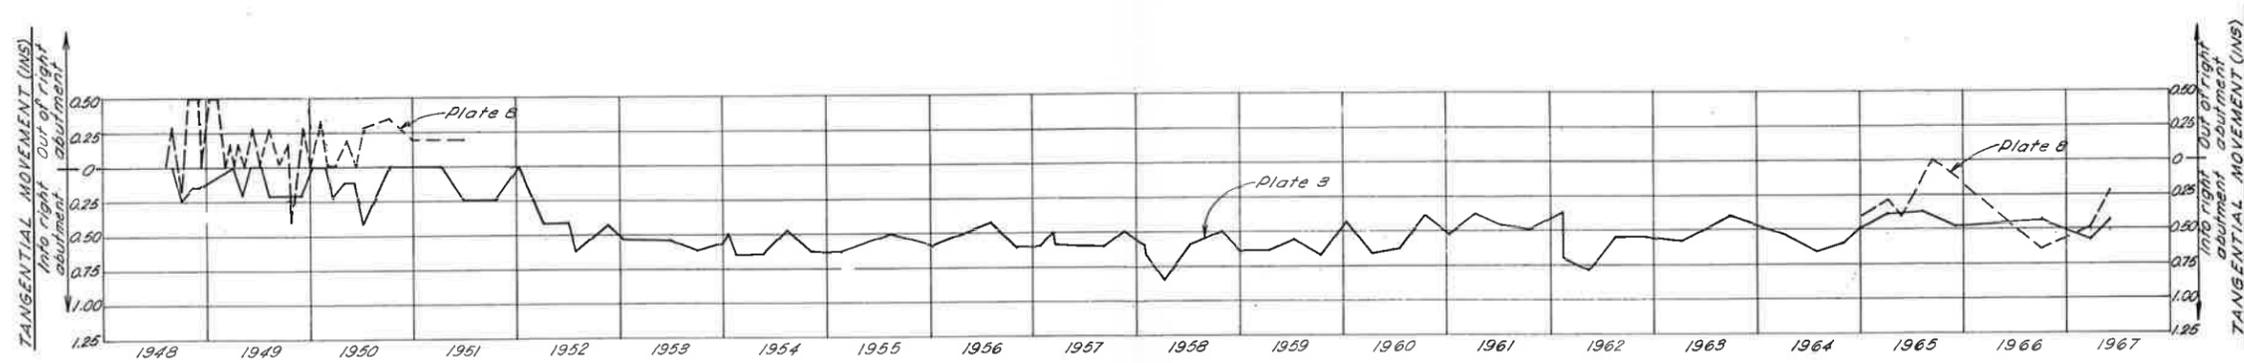
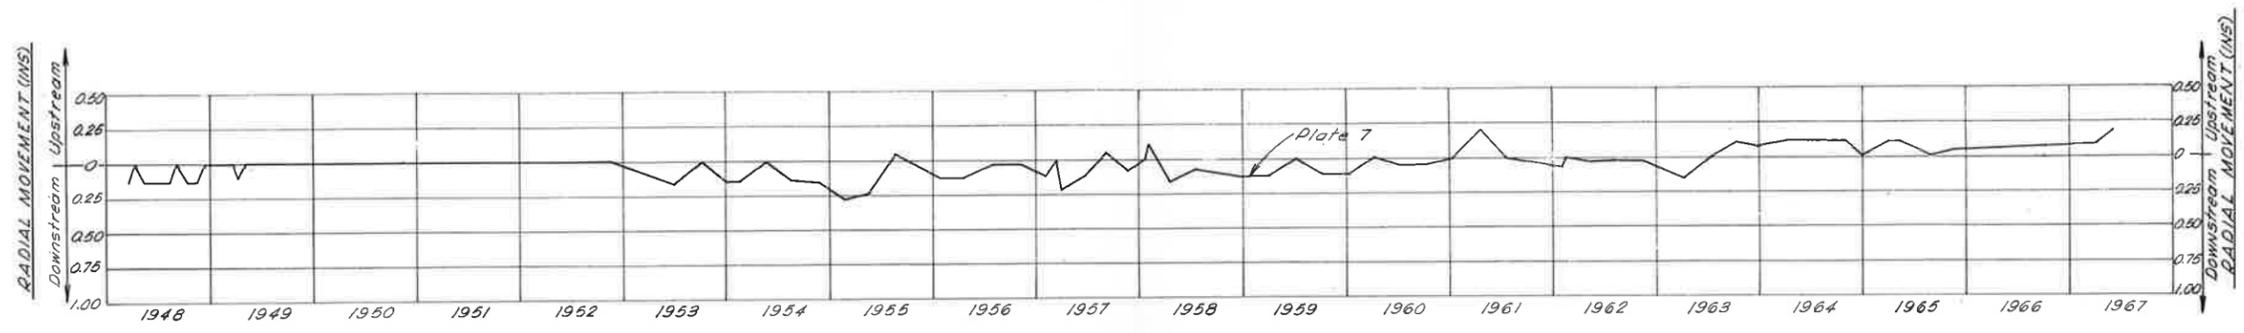
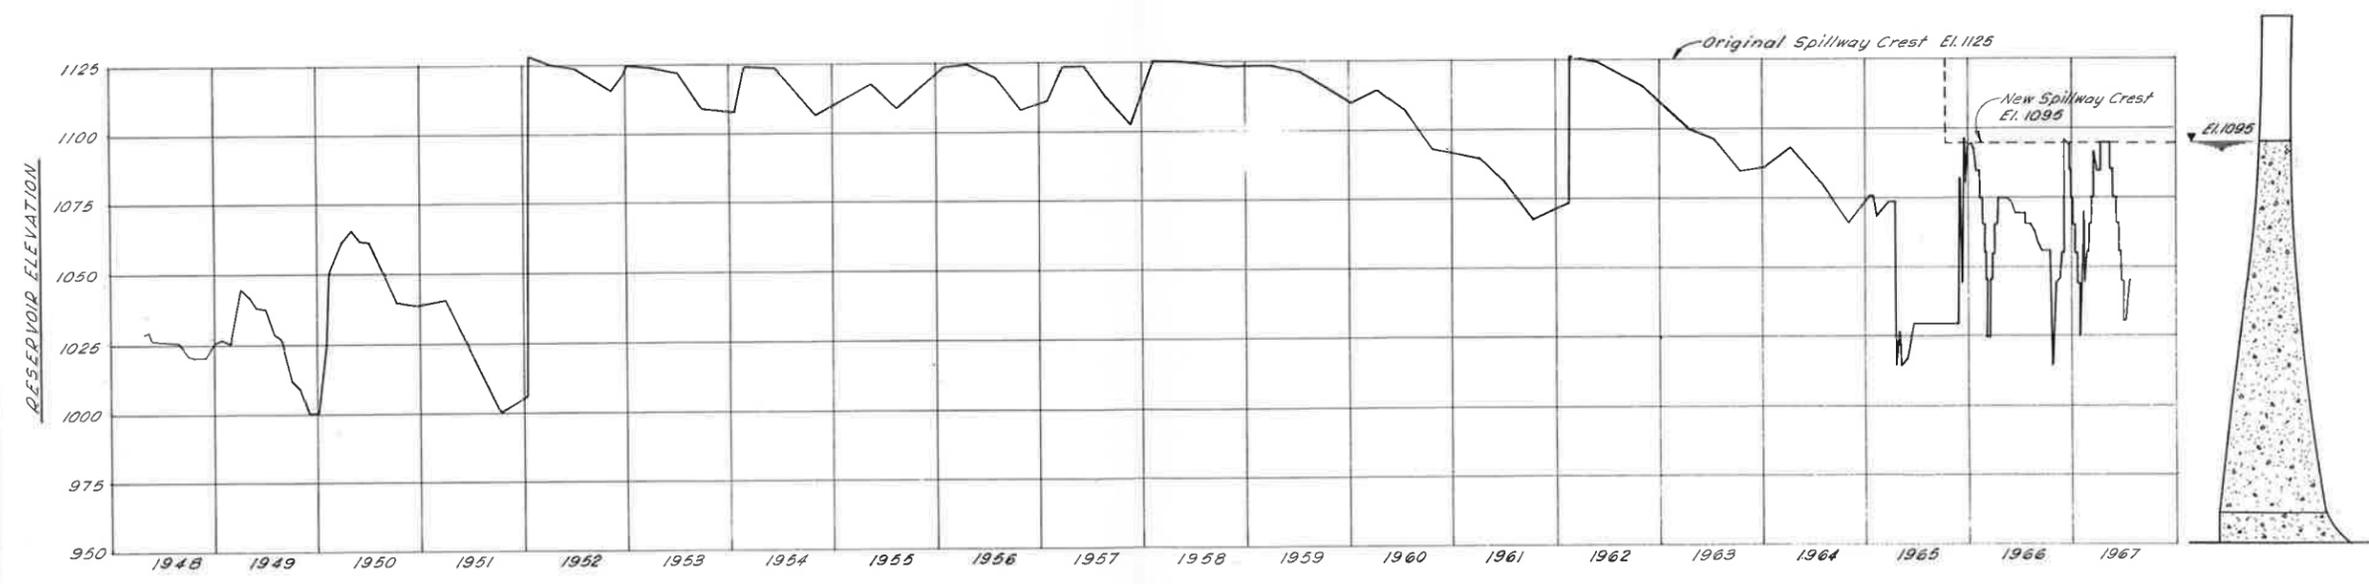
4.2.2 The Right Abutment. Movement at the right abutment as recorded by the measurements is shown on Drawing 5716-67-5. Movement tangential to the curve of the arch is measured at Plate 3 and movement in a radial direction at Plate 7. Plate 7 is located in the deck of the walkway, which is the top lift of the dam itself at the abutments; Plate 3 is in the top of the walkway wall and could therefore give readings which are not indicative of the movements of the dam itself.

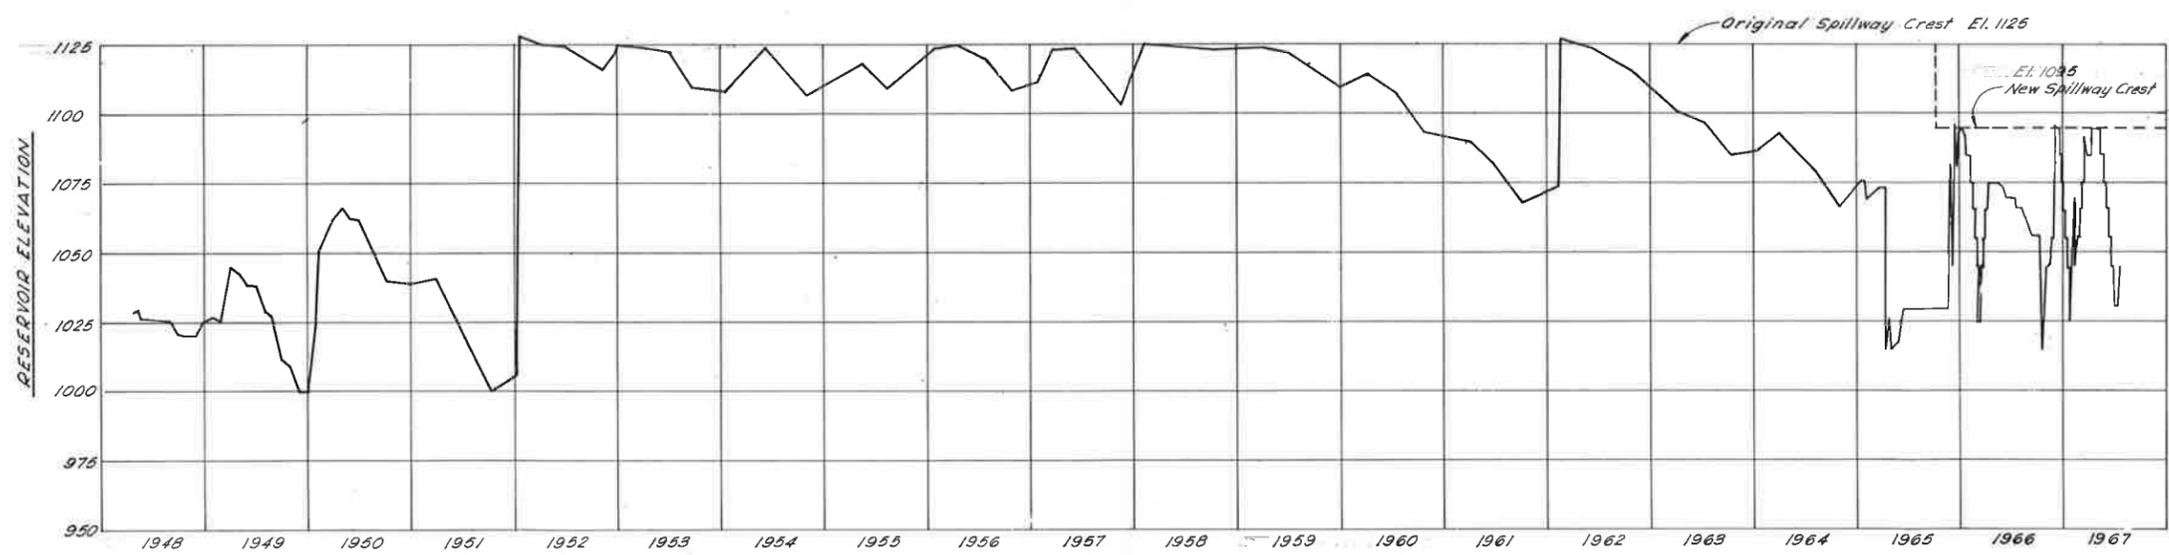
REVISION	DATE	BY	CHKD	APP'D
1	8/1/67	M. Morris	S. Brown	
BECHTEL CORPORATION SAN FRANCISCO COUNTY OF VENTURA DEPARTMENT OF PUBLIC WORKS FLOOD CONTROL DISTRICT REVIEW OF MATILIJA DAM—1967 DAM MOVEMENT AT CROWN				
JOB No.	DRAWING No.	SHEET		
5716	5716-67-6	571

4.2.3 The Crown of the Arch. Movement at the crown of the arch as recorded by the measurements is shown on Drawing 5716-67-6. Movement in a radial direction, upstream and downstream, was measured at Plates 2 and 6, until they were destroyed when the dam was modified in 1965. Plate 2 was embedded in the walkway wall and Plate 6 in the floor slab of the walkway. Since the walkway at the center of the dam was a bridge on piers spanning over the spillway, a component part of the movement recorded may have occurred only in the bridge and not in the dam itself. Since both plates showed radial movement at the same location, it might be expected that they would give equal readings. Differences between them could be due partly to a rotation of the walkway wall relative to the floor slab and partly reflect the limit of accuracy of the method of measurement.
