1997 SUPPLEMENT TO
MATILIJA DAM

1996 CONCRETE EVALUATION

VENTURA COUNTY PUBLIC WORKS AGENCY
VENTURA COUNTY FLOOD CONTROL DISTRICT
NOVEMBER 1997

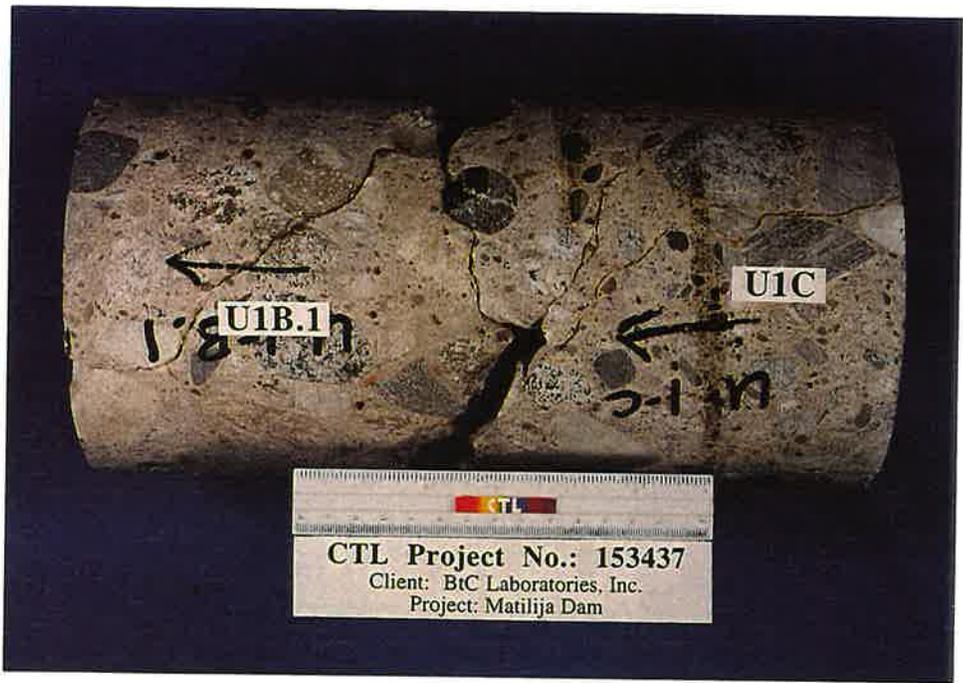
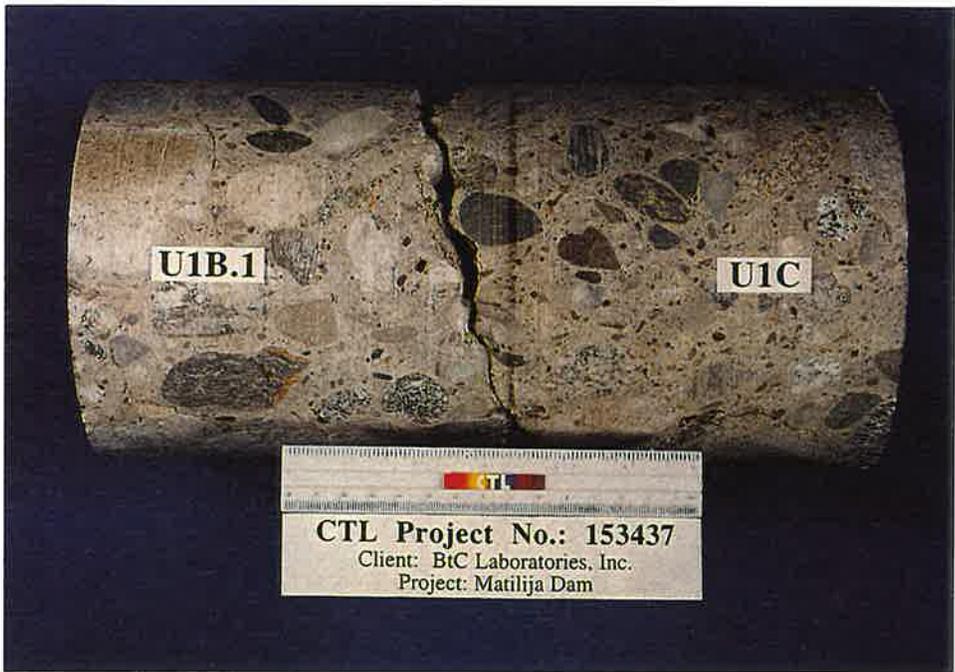
1a.

Fig. 1 Opposing side views of Core Segments U1B and U1C, as received for examination.

Sample	Core Dimensions	Aggregate*	Paste Properties	Cracks and Large Voids	Secondary Deposits	Additional Features/Comments	Damage Attributed to ASR**
UIB.1/ UIC	Diameter = 6 in.; Length = 12 in. (reassembled). Both ends are sawcut perpendicular to core length.	CA: Natural gravel composed of a variety of mainly siliceous metamorphic and altered volcanic rocks, including granite gneiss, gneiss, schist, quartzite, amphibolite, granodiorite, dacite porphyry, and other porphyritic and felsitic volcanic rocks; rounded to subangular; fairly well graded to nominal top size of 1.5 in. FA: Natural sand containing grains of quartz, feldspar, shale, chert, and other rocks similar to CA. Coarse sand fractions are rich in sandstone, shale, and chert.	Buff to light gray, moderately hard to hard, and subvitreous. Moderately tight paste-aggregate bond. No mineral admixtures observed. Original water-cement ratio is interpreted as moderately low, based on abundance of in-situ hydrated portland cement clinker particles in the paste.	The core was received in two main pieces. The two large pieces represent two halves of a core segment split by a mid-length transverse crack. Several hairline cracks and a few large cracks extend diagonally and longitudinally through both core segments. Some radiate from reacted sand grains. Most cracks pass mainly around CA but through numerous FA. Numerous small entrapped air voids are observed.	Clear to milky white, amorphous and partially crystallized deposits of alkali-silica reaction (ASR) gel partially soak some paste and line or fill cracks and voids adjacent to numerous alkali-reactive coarse sand particles of chert and shale. Moderate amounts of secondary ettringite crystals ($3 \text{ CaO} \cdot \text{Al}_2\text{O}_3 \cdot 3 \text{ CaSO}_4 \cdot 32 \text{ H}_2\text{O}$), calcium carbonate crystals, and other microcrystalline compounds are also observed in some cracks and voids, mostly away from reactive aggregates.	Reaction rims are observed along the periphery of most reactive chert and shale particles, as well as a few CA. The concrete is not air entrained. Microcracks are abundant; many radiate from reacted sand grains.	Moderate.

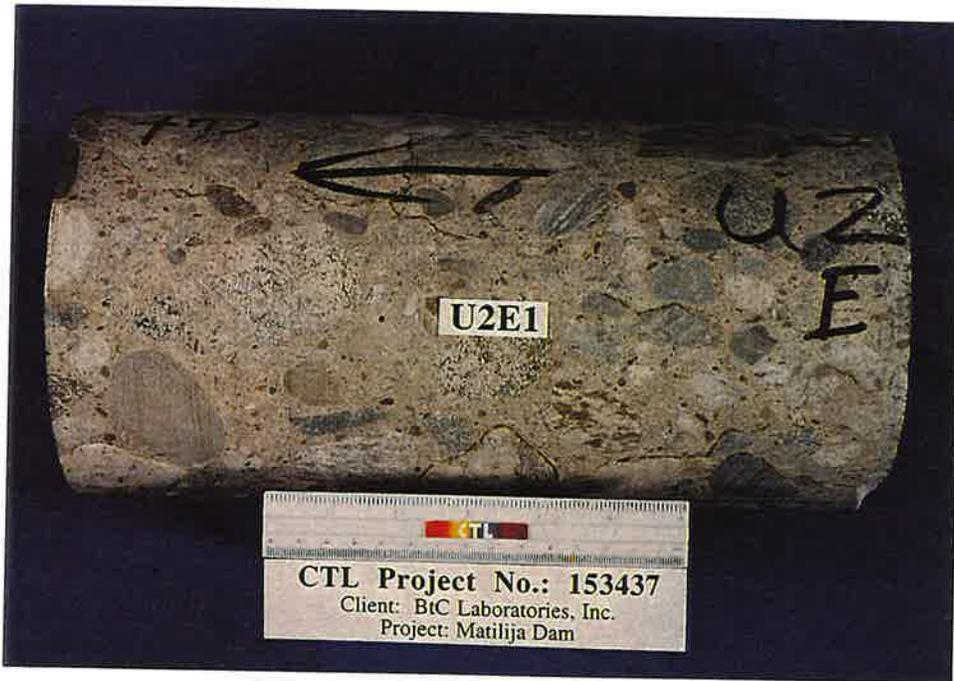
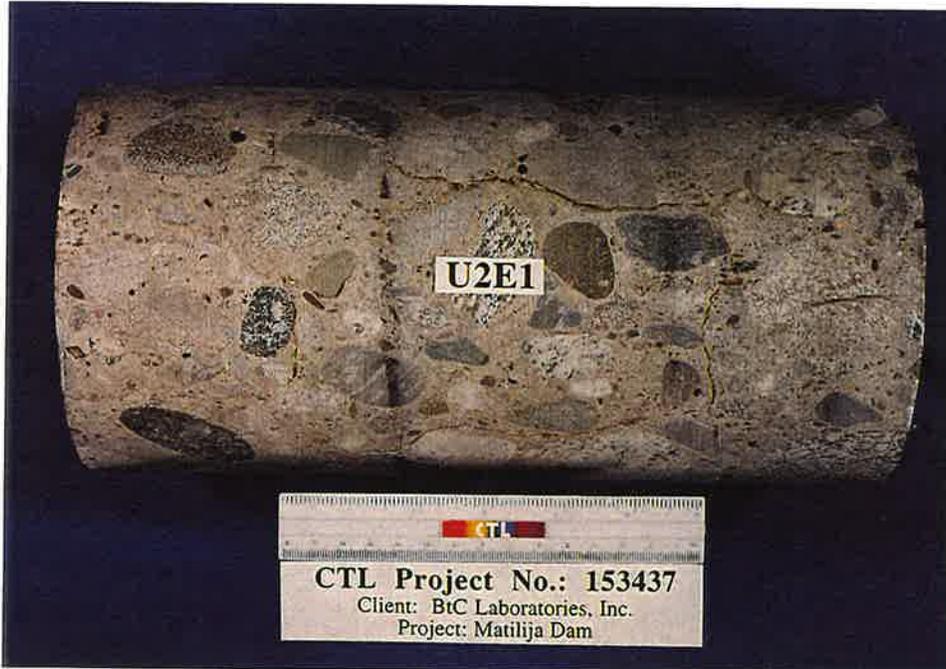
2a.

Fig. 2 Opposing side views of Core Segment U2E1, as received for examination.

Sample	Core Dimensions	Aggregate*	Paste Properties	Cracks and Large Voids	Secondary Deposits	Additional Features/Comments	Damage Attributed to ASR**
U2E1	Diameter = 6 in.; Length = 12 in. Both ends are sawcut perpendicular to core length.	CA: Natural gravel composed of a variety of mainly siliceous metamorphic and altered volcanic rocks, including granite gneiss, gneiss, schist, quartzite, amphibolite, granodiorite, dacite porphyry, and other porphyritic and felsitic volcanic rocks; rounded to subangular; fairly well graded to nominal top size of 1.5 in. FA: Natural sand containing grains of quartz, feldspar, shale, chert, and other rocks similar to CA. Coarse sand fractions are rich in sandstone, shale, and chert.	Buff to light gray, moderately hard to hard, and subvitreous. Moderately tight paste-aggregate bond. No mineral admixtures observed. Original water-cement ratio is interpreted as moderately low, based on abundance of in-situ hydrated portland cement clinker particles in the paste.	The core was received in one piece with several hairline cracks and a few discontinuous larger cracks extending diagonally and longitudinally through the core. Some cracks radiate from reactive sand grains. Cracks pass mainly around CA but through numerous FA. Several small entrapped air voids are observed.	Clear to milky white, amorphous and partially crystallized deposits of alkali-silica reaction (ASR) gel partially soak some paste and line or fill cracks and voids adjacent to numerous alkali-reactive coarse sand particles of chert and shale. Moderate amounts of secondary ettringite crystals ($3 \text{ CaO} \cdot \text{Al}_2\text{O}_3 \cdot 3 \text{ CaSO}_4 \cdot 32 \text{ H}_2\text{O}$), calcium carbonate crystals, and other compounds are also observed in some cracks and voids, mostly away from reactive aggregates.	Reaction rims are observed along the periphery of most reactive chert and shale particles, as well as a few CA. The concrete is not air entrained. Microcracks are abundant; many radiate from reacted sand grains.	Moderate.

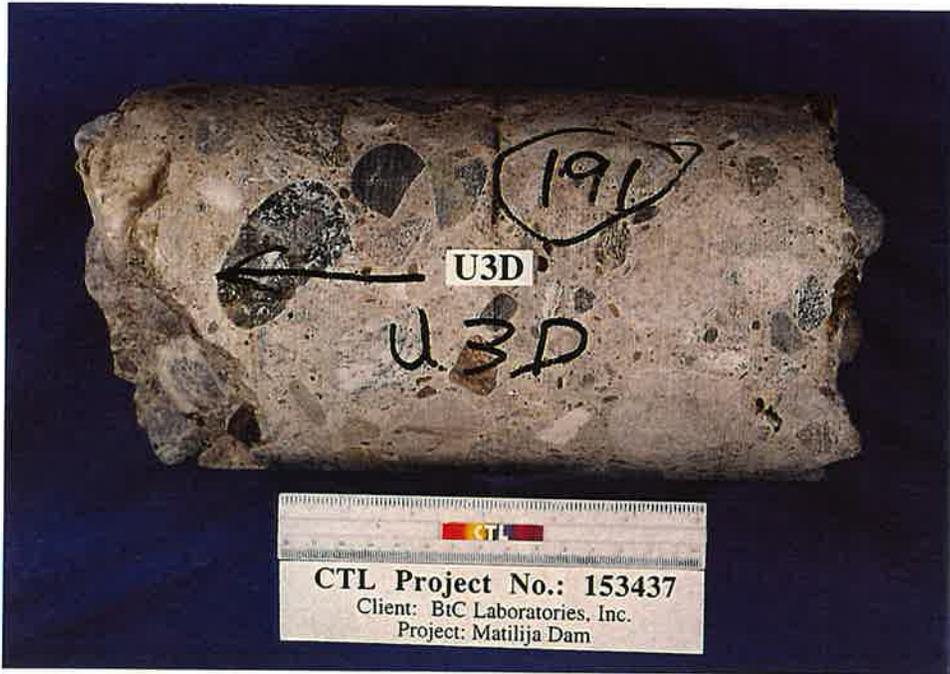
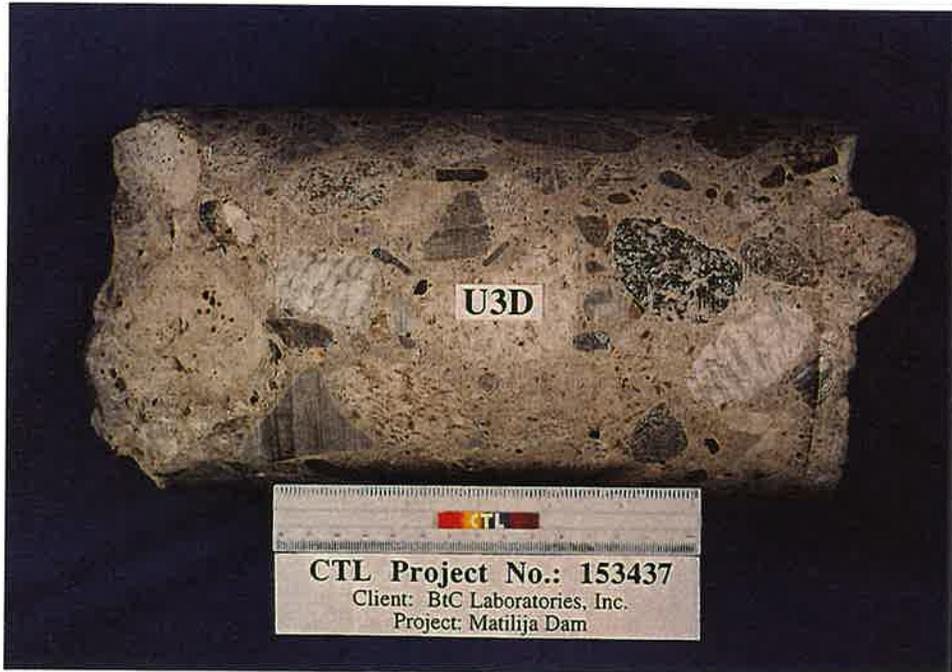
3a.

Fig. 3 Opposing side views of Core Segments U3D, as received for examination.

Sample	Core Dimensions	Aggregate*	Paste Properties	Cracks and Large Voids	Secondary Deposits	Additional Features/Comments	Damage Attributed to ASR**
U3D	Diameter = 6 in.; Length = 11.5 in.	<p>CA: Natural gravel composed of a variety of mainly siliceous metamorphic and altered volcanic rocks, including granite gneiss, gneiss, schist, quartzite, amphibolite, granodiorite, dacite, and other felsitic and porphyritic volcanic rocks; rounded to subangular; fairly well graded to nominal top size of 2 in.</p> <p>FA: Natural sand containing grains of quartz, feldspar, shale, chert, and other rocks similar to CA. Coarse sand fractions are rich in sandstone, quartzite, gneiss, and lesser amounts of shale, and chert.</p>	<p>Light gray, moderately hard to hard, and subvitreous. Moderately tight paste-aggregate bond.</p> <p>No mineral admixtures observed.</p> <p>Original water-cement ratio is interpreted as moderately low.</p>	<p>The core was received in one piece with a small amount of rubble. Both ends of core are fractured. No major cracks observed. A few hairline cracks and microcracks are observed adjacent to some reacted coarse sand grains of chert and shale and a few internally cracked CA.</p> <p>Several small to large air voids (up to 0.25 in.) are randomly dispersed in the core.</p>	<p>Clear to milky white, amorphous and partially crystallized deposits of alkali-silica reaction (ASR) gel partially soak some paste and line or fill cracks and voids adjacent to a few alkali-reactive coarse sand particles of chert and shale. Small amounts of secondary ettringite crystals ($3 \text{ CaO} \cdot \text{Al}_2\text{O}_3 \cdot 3 \text{ CaSO}_4 \cdot 32 \text{ H}_2\text{O}$) and calcium carbonate crystals are also observed in some cracks and voids, mostly away from reactive aggregates.</p>	<p>Reaction rims are observed along the periphery of most reactive chert and shale particles, as well as a few CA.</p> <p>The concrete is not air entrained.</p> <p>Several microcracks are observed; some radiate from reactive sand grains.</p>	Minor.
