**FEMA Levee Certification
Ventura County, California**

**Ventura River Levee and Floodwall (VR-3)
At Live Oaks**

**Evaluation Report
February 13, 2009**

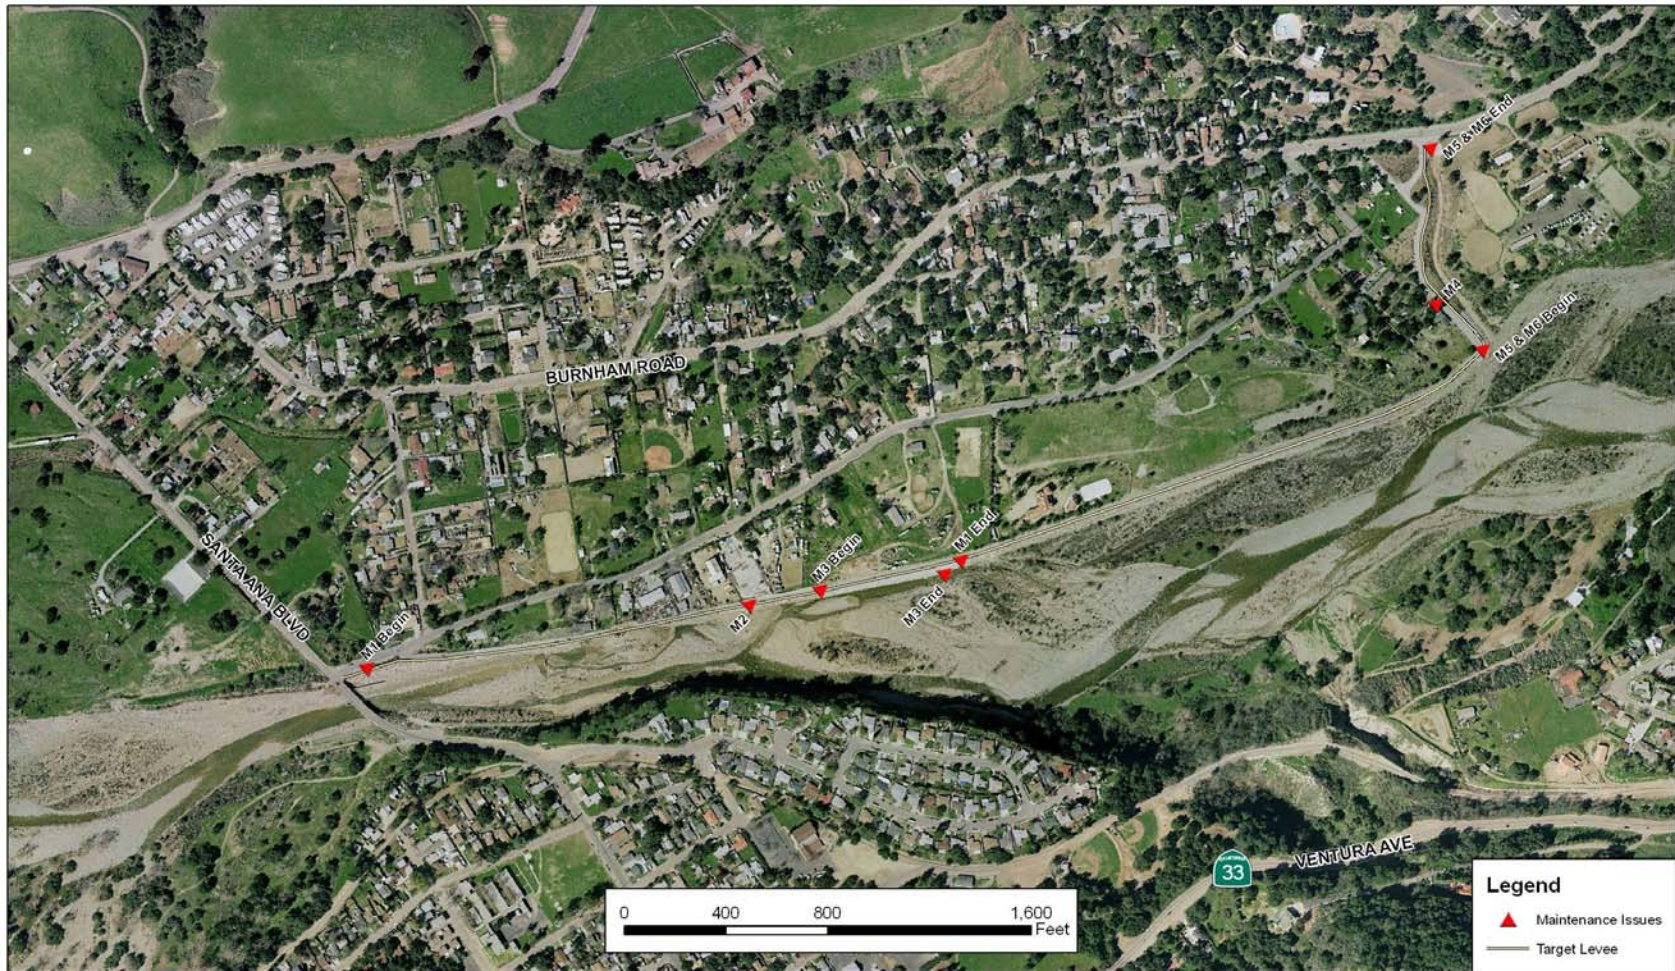
Appendix C – Photograph Locations of Maintenance Required Areas along Ventura River Levee and Floodwall (VR-3)

During the site visit, erosion at the toe of the riverside levee slope was observed and erosion of the toe was undermining the revetment. Evaluation of this erosion should be conducted.

M3	Erosion along levee toe below revetment (Riverward side)	Re-establish bank revetment with adequate toedown protection. Additional engineering analysis recommended.	C3/C4	E3	Endangered species habitat			
Ventura River Levee and Floodwall (VR-3) - Along Live Oak Diversion Outlet Channel, Category 3								
M4	Encroachment. Structures and trees within 15' of toe (Landward Side)	Remove structures and trees within the 15'-zone as appropriate.	C5 - letter to landowners before removing trees, and structure	E2	Try to avoid removing large oaks	X		
M5	Vegetation within 15' of toe (Landward Side)	Remove vegetation and root ball, fill voids with impervious material and firmly compact. Remove irrigation lines within levee embankment.	C2, C5 - Mitigation project, work with Pam	E3	WPD mitigation site, will need to replace veg elsewhere	X	Definition of impervious material	For all vegetation removal under 4" trunk diameter, no documentation is necessary. For larger rootball removal where excavation & compaction is required, documentation of the impacted material shall be conducted by a certified testing & materials lab familiar to the District. The documentation shall include a report provided by the lab. AMEC will periodically observe these locations & will require a copy of the report for documentation & review. Figure 2 attached outlines the excavation & compaction details. Documentation of the removal & replacement/re-compaction of the impacted material shall be conducted by a certified testing & materials lab familiar to the District. The documentation shall include a report provided by the lab. AMEC will periodically observe these locations & will require a copy of the report for documentation & review. In-kind backfill would be materials free of organic or deleterious debris that has similar or lower permeability than the levee material. These materials could consist of excavated soil, imported soil, concrete, or slurry, & shall be evaluated by the lab.

M6	Vegetation on Levee embankment and toe (Riverward Side). Vegetation is currently maintained by the County.	Remove vegetation and root ball, fill voids with impervious material and firmly compact. Remove irrigation lines within levee embankment.	C2, C5 - Mitigation project, letter to landowners, work with Pam	E3	WPD mitigation site, will need to replace veg elsewhere	X	Definition of impervious material	For all vegetation removal under 4" trunk diameter, no documentation is necessary. For larger rootball removal where excavation & compaction is required, documentation of the impacted material shall be conducted by a certified testing & materials lab familiar to the District. The documentation shall include a report provided by the lab. AMEC will periodically observe these locations & will require a copy of the report for documentation & review. Figure 2 attached outlines the excavation & compaction details. Documentation of the removal & replacement/re-compaction of the impacted material shall be conducted by a certified testing & materials lab familiar to the District. The documentation shall include a report provided by the lab. AMEC will periodically observe these locations & will require a copy of the report for documentation & review. In-kind backfill would be materials free of organic or deleterious debris that has similar or lower permeability than the levee material. These materials could consist of excavated soil, imported soil, concrete, or slurry, & shall be evaluated by the lab.
