ALKALI-SILICA REACTIVITY IN FIVE DAMS IN SOUTHWESTERN UNITED STATES

July 1985 Engineering and Research Center

Bureau of Reclamation

REC-ERC-85-10

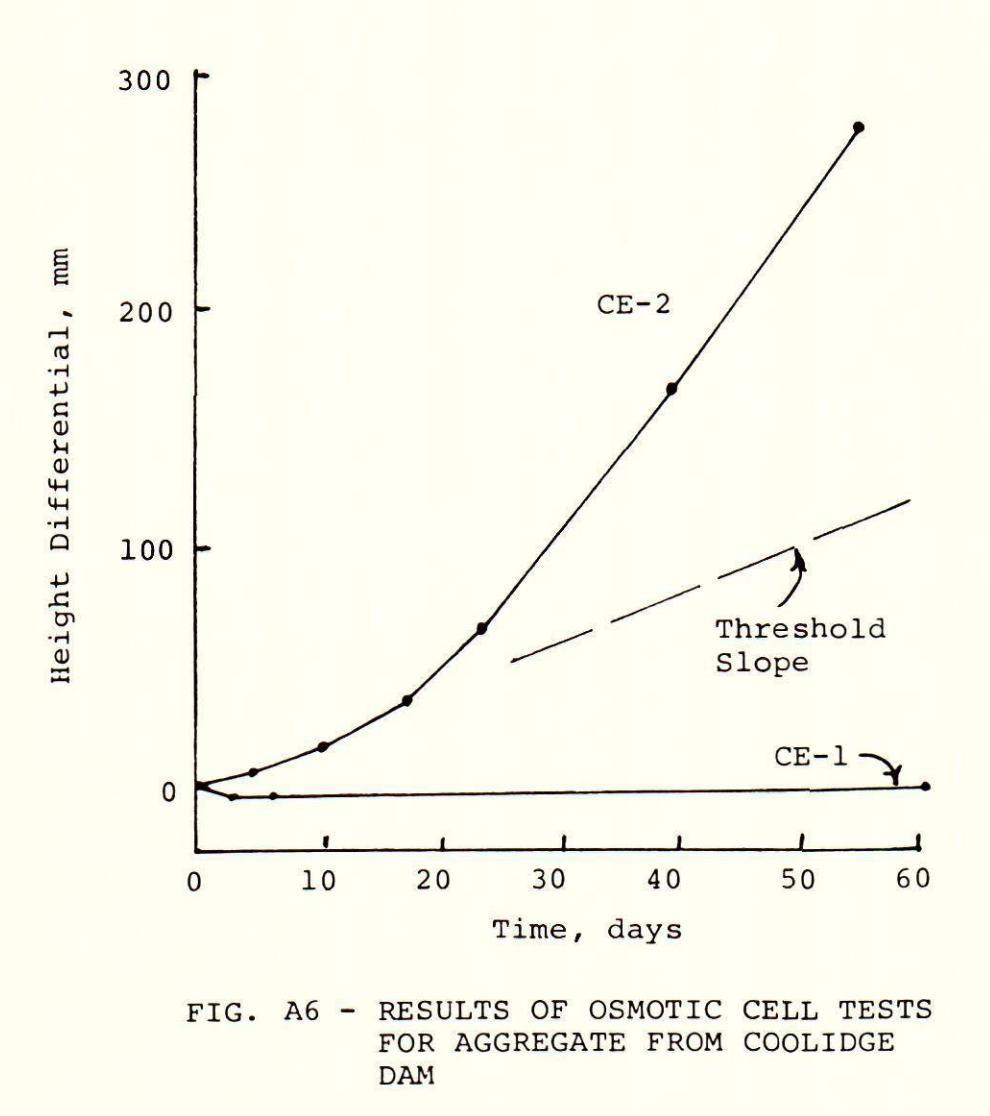
NO.	LOCATION	DESCRIPTION	FLOW RATE, mm/DAY
CE-1	3 to 5 in. from exterior end of core CE, taken into west face of right buttress, 4 ft up from ground level.	Dense crystalline, purple-red andesite porphyry, 3-in. parti- cle. No evidence of previous reactivity.	<0.0
CE-2	Same core as above. Particle located 1 to 3 in. from external surface.	Somewhat weathered and porous, purple-red andesite porphyry. 2-1/2-in. particle size. No evidence of previous reactivity.	7.3

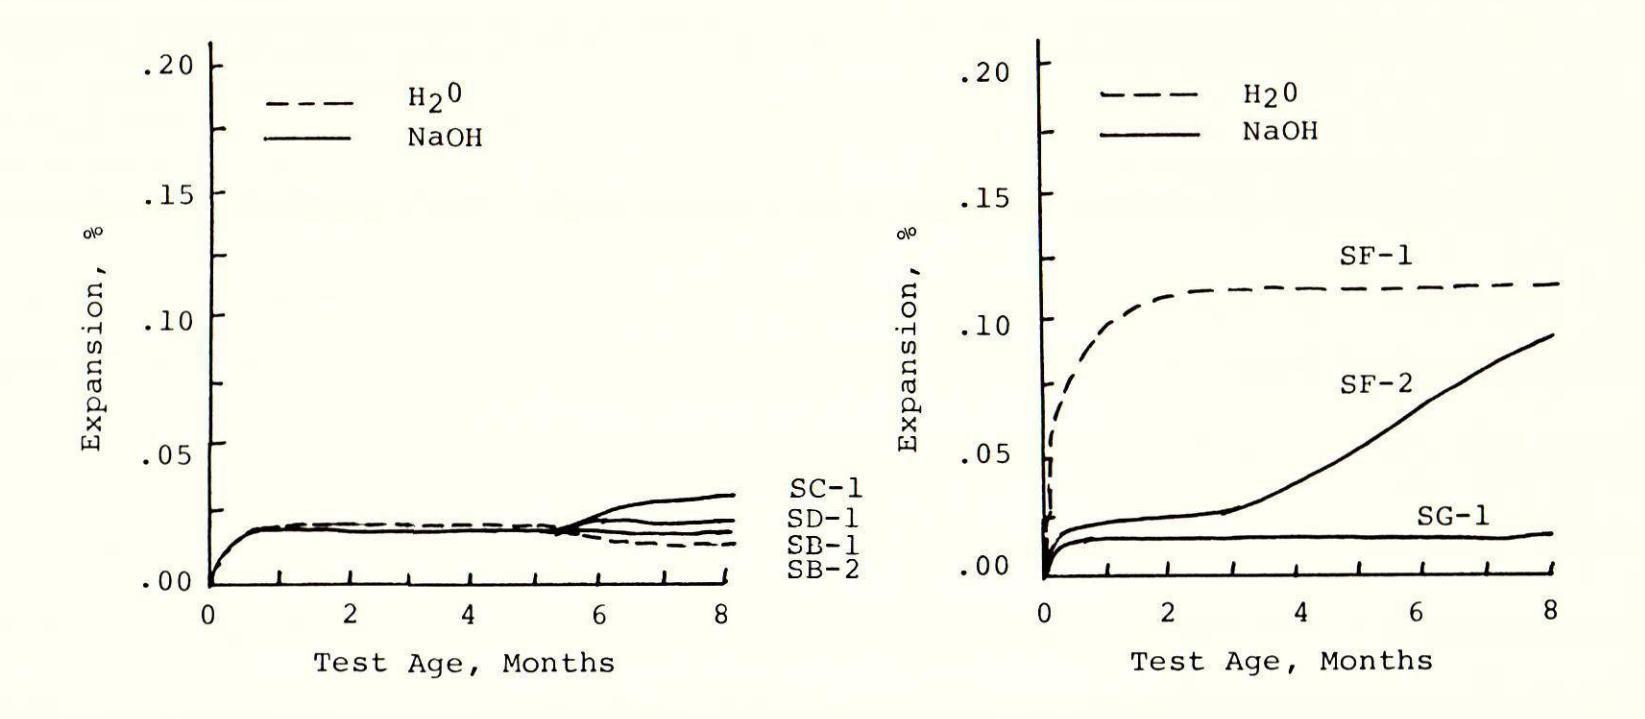
FIG. E5 - LENGTH CHANGES OF STEWART MOUNTAIN DAM CORES IMMERSED IN WATER OR 1N NAOH SOLUTION AT $100^{\rm O}{\rm F}$

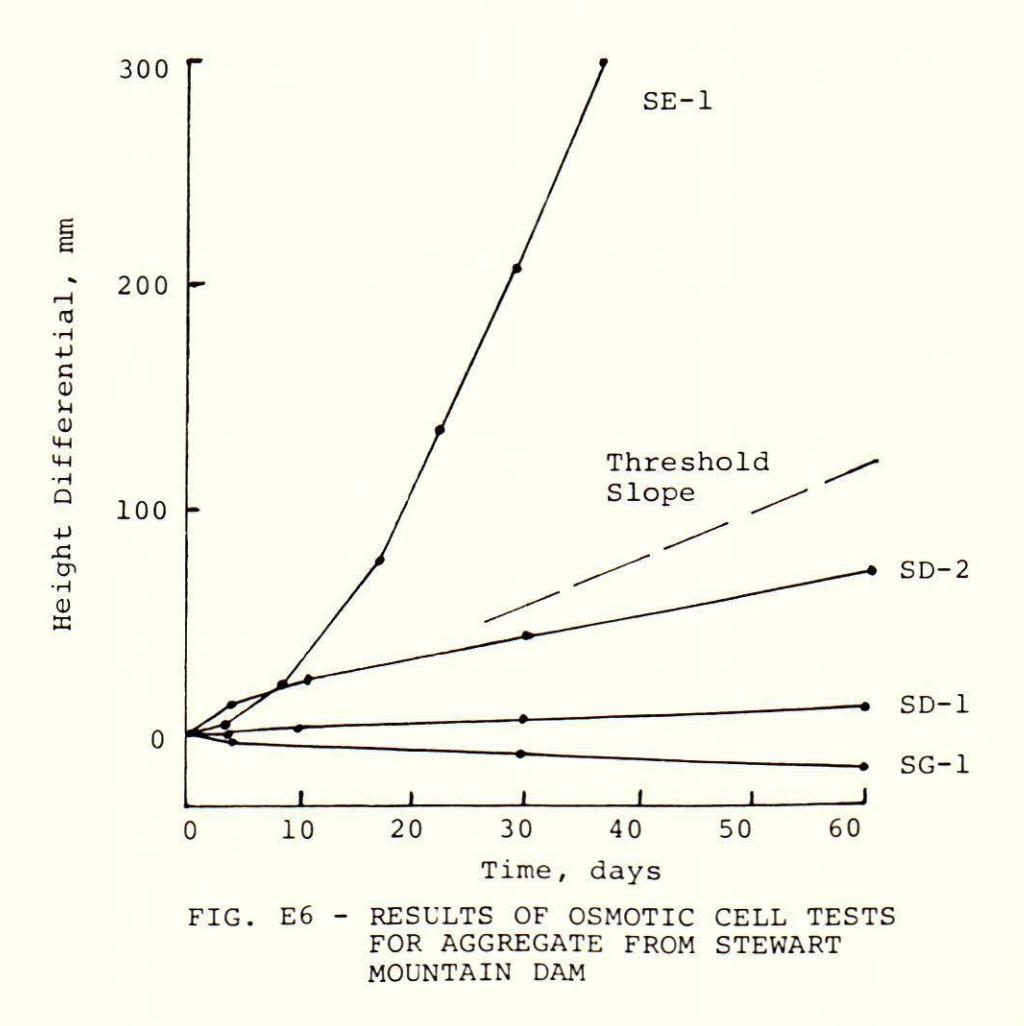
NO.	LOCATION	DESCRIPTION	FLOW RATE, mm/DAY
SD-1	At 8-1/2 in. depth from exterior end of core DH-SD, taken on roadway on right thrust block.	Quartzite, 3 in. particle size. No evidence of reactivity.	0.3
SD-2	At 12-16 in. depth from exterior end of core DH-SD, taken on roadway on right thrust block.	Dense, reddish, brown granite, 3 in. particle size. No evidence of reactivity.	0.9
SE-1	At 26-30 in. depth from exterior end of core DH-SE, taken into face of dam, on powerhouse roof, 3-1/2 ft above roof.	Reddish-purple andesite, 4 in. particle. Reaction rims, some microcracking, minor gel reaction product.	10.2
SE-1	At 15-18 in. depth from exterior end of core, taken into right thrust block, 17-1/2 ft from nose of block, 3-1/2 ft above roadway at ground level.	Black rhyolite, 2-1/2" particle, contains reaction rim, but no interval microcracks or gel reaction product.	<0.0
