GEOTECHNICAL INVESTIGATION

Yerba Buena Road Distress Ventura County Public Works Agency Ventura County, California

April 2025

SUBJECT:Geotechnical InvestigationRE:Yerba Buena Road DistressVentura County, California

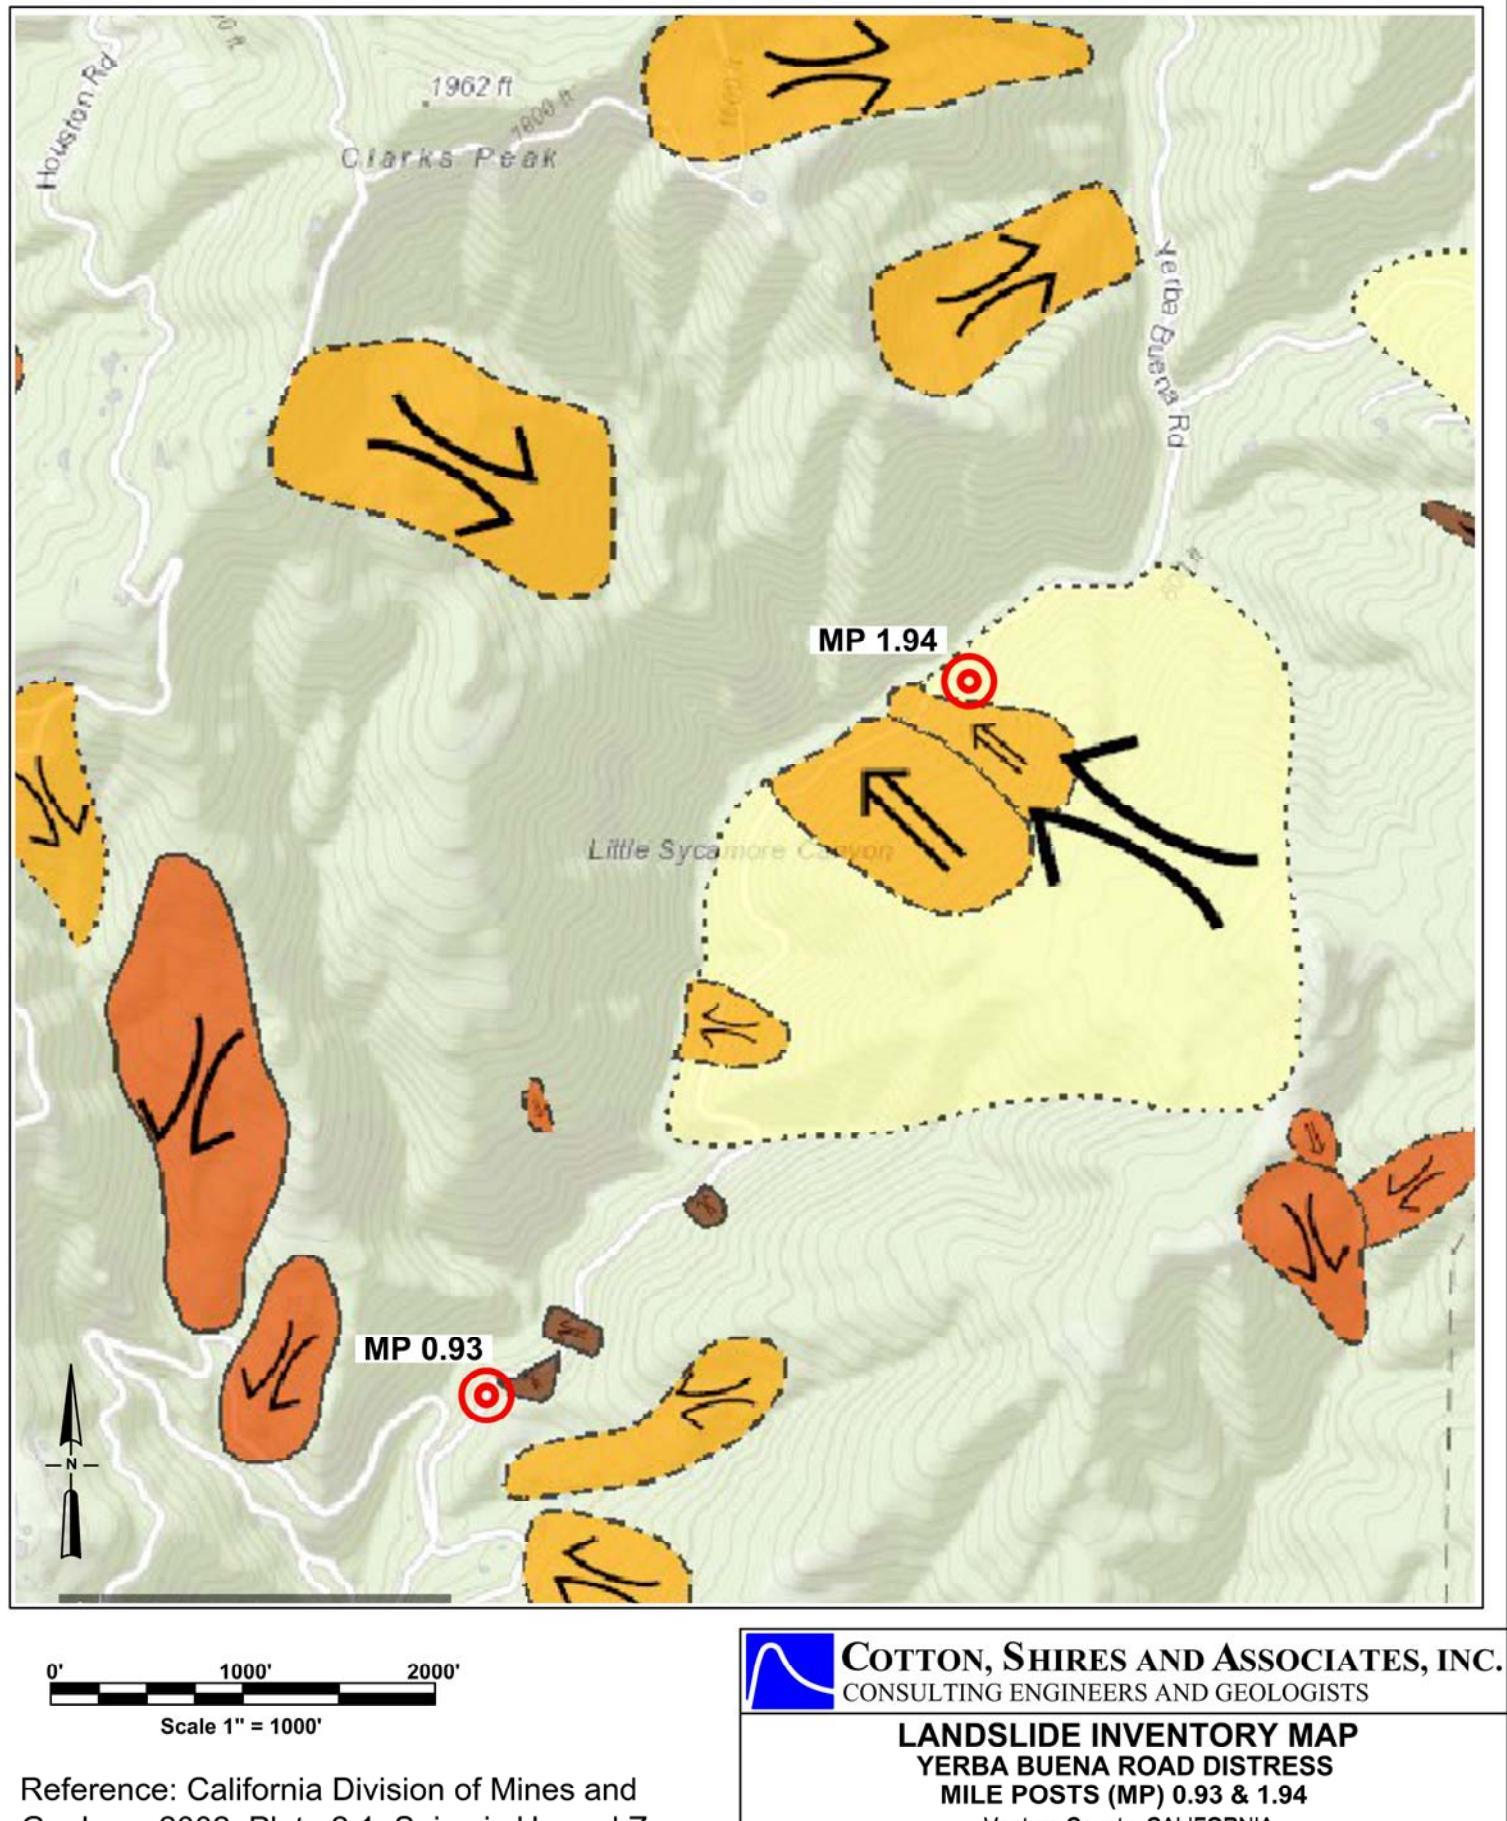
Ventura County, CALIFORNIAGEO/ENG BY
EPB/MJJSCALE
AS SHOWNPROJECT NO.
SC6164APPROVED BY
MJJDATE
APRIL 2025FIGURE NO.
3a

The project located at MP 1.94 is shown within the suspected (questionable, 50% confidence) limits of large inactive landslide complex and on the northern margin of a smaller, inactive landslide mapped with 75% confidence (Figure 3a). Our field mapping and subsurface exploration has confirmed the presence of landslide-affected materials at MP 1.94, and both to the north and south of MP 1.94. Further, landslide deposits were encountered in the subsurface and mapped at the northern end of the MP 2.61 project limits, and a slump affecting the roadway embankment was mapped at MP 2.96 (see Figures 7a and 7b). Landslide-affected materials within the four (4) project limits are depicted on Figures 4a through 7a.

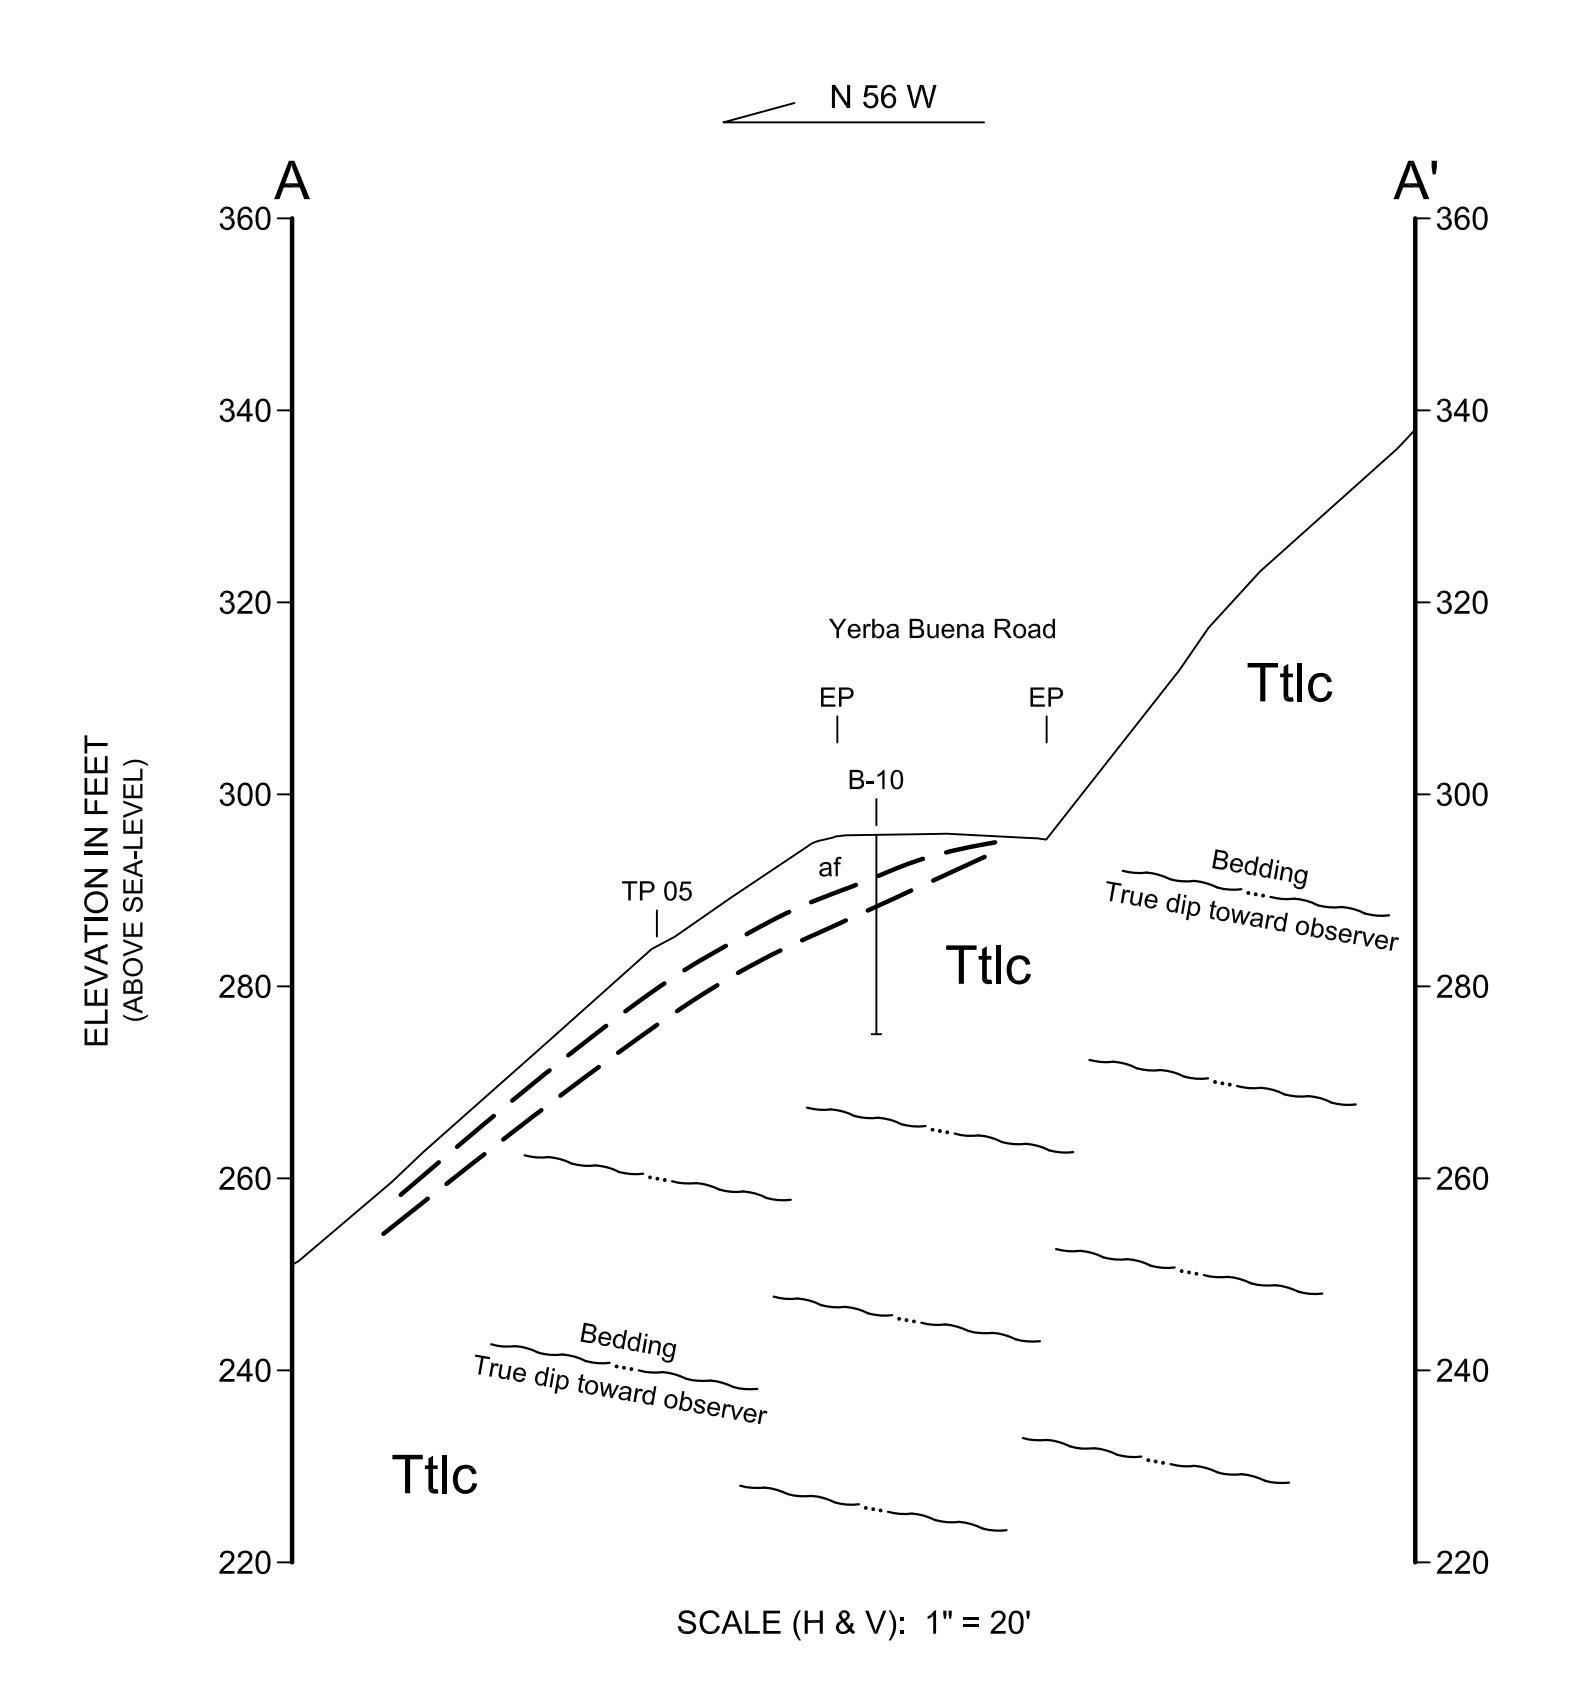
- Discontinuous, sub-linear to arcuate cracking along the graded dirt shoulder and western portion of the southbound travel lane, with the majority of this distress occurring between borings B-9 and B-10 (see Figure 4a). Roughly located in the center of the distressed area is a section of pavement, shoulder and embankment that has broken and vertically dropped approximately six to twelve inches (6"-12"), as measured along the top-of-slope.

- Evidence of relatively recent, relatively thin and localized slope failures was observed in the ascending slopes along the east side of the roadway. This includes instability in colluvium at the northern end of the County-provided mapping, where field mapping and logging of boring B-9 (Figure 4a) indicate the presence of an inactive, deeper landslide feature.
